CAPE LOOKOUT NATIONAL SEASHORE  
**Coca-Cola House**

# HISTORIC STRUCTURE REPORT

2004  
Historic Structure Report  
Coca-Cola House  
CAPE LOOKOUT NATIONAL SEASHORE  
Cape Lookout Village  
LCS#: 091837

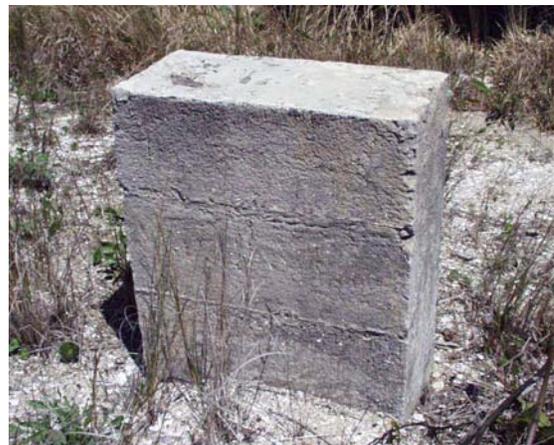
**Figure 20** View of typical concrete pier. (NPS-SERO-CR, 2002)

Except for some of the buildings at the old Coast Guard and Lighthouse stations, which were built on brick piers, most of the residences at Cape Lookout were built on wood pilings. The wood frame of the Coca-Cola House, however, was built on poured concrete piers, spaced about six feet apart, and probably set on some sort of spread footing. Piers are about 8" by 15" in plan and 15" high. All of the piers remain in relatively good condition, except where the original porch was removed along the south sides of the house, allowing some of the piers to be overturned or destabilized.

- Eliminate wood- to- ground contact at all locations, repairing damaged beams as necessary.
- Install metal termite shields at all piers.

- Reset concrete piers for missing porches as necessary.

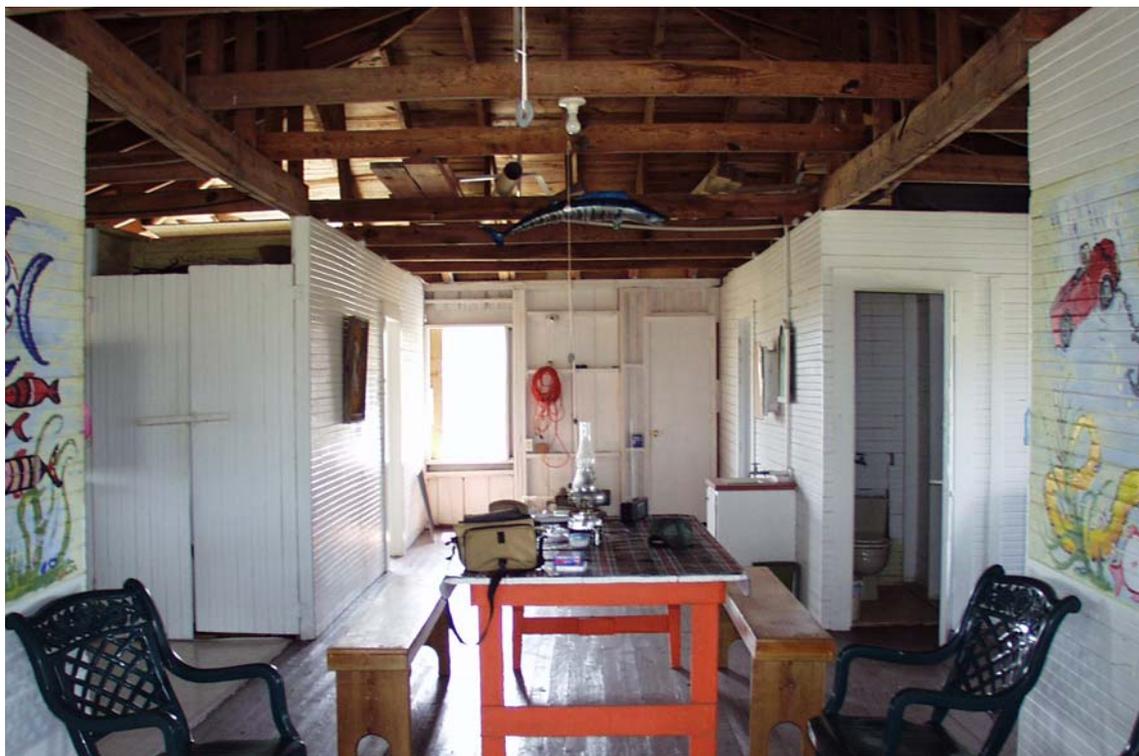
**Figure 24** View to southeast showing back door now opening to the garage. (NPS-SERO-CR, 2003)

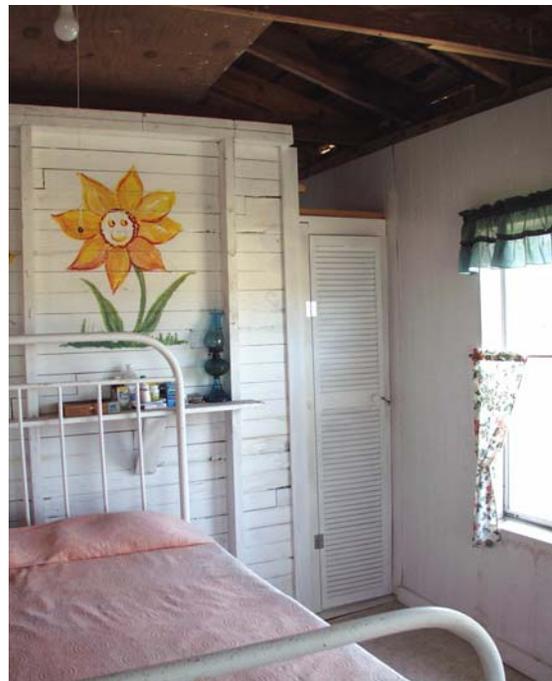
**Figure 31** View south in Room 102, showing altered wall and added closet door. (NPS-SERO-CR, 2003)
