Cape Lookout National Seashore  
O'BOYLE - BRYANT HOUSE  
**HISTORIC STRUCTURE  
REPORT**

**Historical Architecture, Cultural Resources Division  
Southeast Regional Office  
National Park Service**

**2004**

2004  
Historic Structure Report  
O'Boyle- Bryant House  
CAPE LOOKOUT NATIONAL SEASHORE  
Cape Lookout Village  
LCS#: 271581

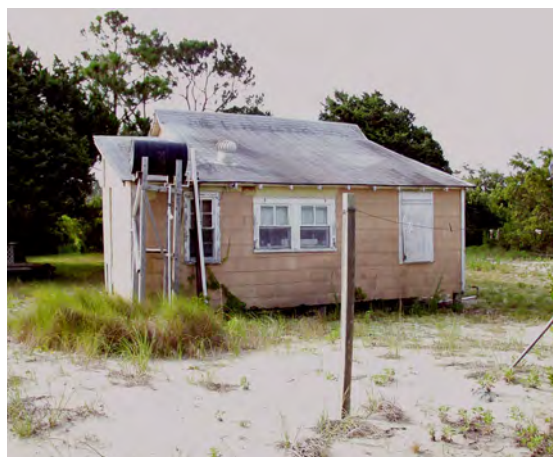
**Figure 25** View to south of O'Boyle-Bryant House, showing elevated water tank. (NPS-SERO-CRS, 2002)

Against the northern end of the rear wall of the house is a wooden structure on which a small elevated metal water tank is mounted. Too high to function as a cistern, this tank is used to provide water for an outdoor shower and for flushing the broken toilet inside the house.

- repair and maintain garage;
- repair or reconstruct elevated water tank at rear of house;
- remove modern structure in front yard;

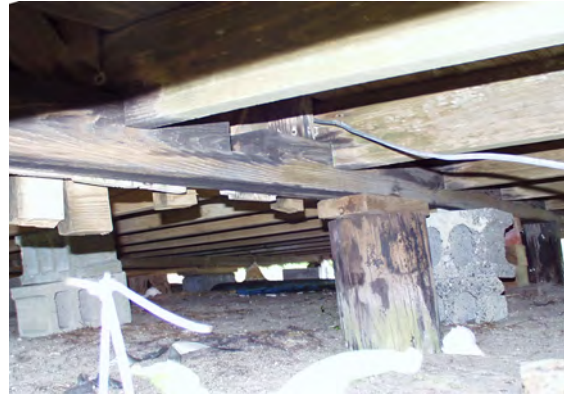
**Figure 27** View of front sill of original house. Original siding extends below the bottom of the sill to left of center in this image. (NPS-SERO-CRS, 2002)

at the rear of the house has been severely damaged by termite infestation. Floor joists for this historic addition are around 1- 3/4" by 5- 5/8" as are those in the post- WWII bathroom extension.

- raise house and replace all wood piles, replicating the size and placement of existing piles;
- strengthen connection of the house's sills to the foundation piles.

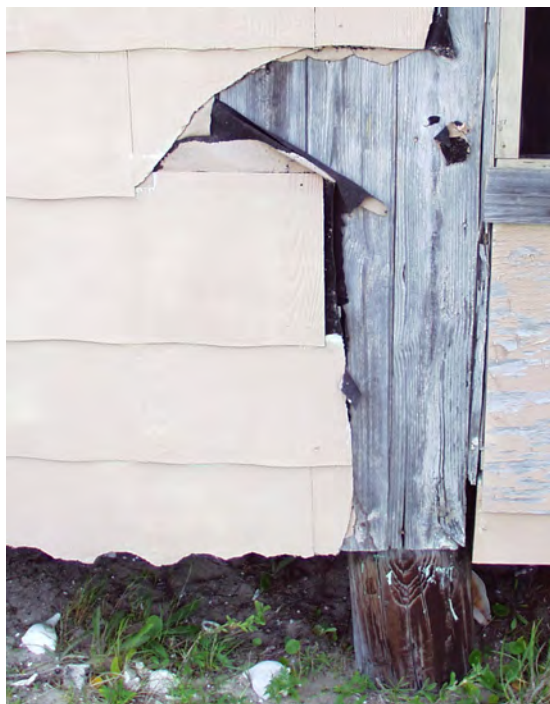
**Figure 28** View of south corner of house showing original siding at center, asbestos siding at left, and modern plywood at right. (NPS-SERO-CRS, 2002)

- repair and preserve asbestos siding;
- repair underlying wood siding as necessary;
- repair window sills, casing, and trim to match those at W- 1 and W- 2, but repair and preserve aprons at W- 8 and W- 9;
- repaint siding, eaves, and other exposed woodwork white, except for window and door sills, casing, sash, and trim and the front porch ceiling, all of which should be painted dark green.

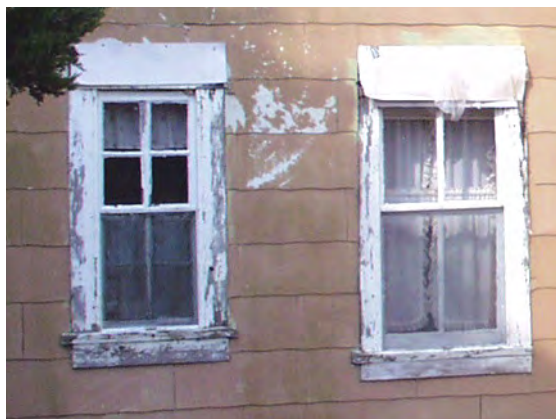
**Figure 31** View of Windows 8 and 9 on northeast side of house. (NPS-SERO-CRS, 2002)
