Cape Lookout National Seashore  
**GASKILL - GUTHRIE HOUSE**  
**HISTORIC STRUCTURE**  
**REPORT**

**Historical Architecture, Cultural Resources Division**  
**Southeast Regional Office**  
**National Park Service**

2004

2004  
Historic Structure Report  
Gaskill- Guthrie House  
Cape Lookout Village  
CAPE LOOKOUT NATIONAL SEASHORE  
Harker's Island, NC  
LCS#: 272049

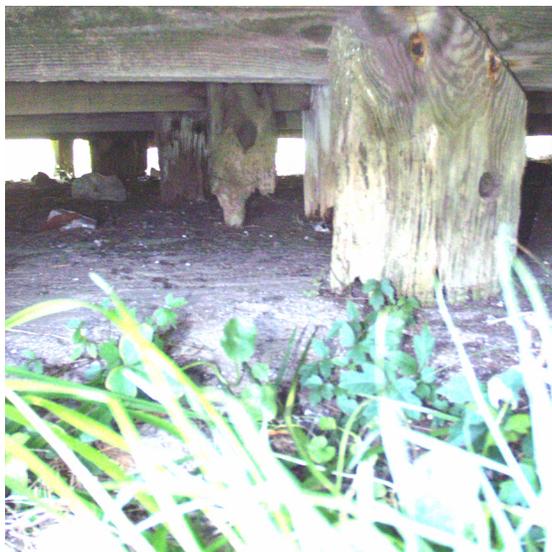
**Figure 20** View of rotted wooden piers that formerly supported floor joists at mid-span. (NPS-SERO-CRS, 2002)

The wood frame of the main body of the house is within inches of the ground, with the sills set on a series of wooden piers, 8" - 12" in diameter, sunk to some indeterminate depth into the ground. Most are, at best, in fair condition, and concrete block have been inserted at some locations to provide additional support.

- Replace all piers, replicating size and placement of originals.

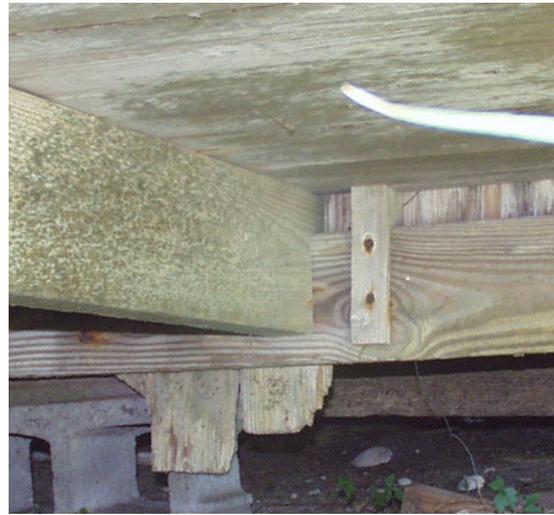
Spacing of joists, studs, and rafters is unusually wide, up to 48" in some cases, and nearly all the framing members are inadequate relative to the demands of modern building codes. An effort was made to storm proof the house, especially in attachment of walls to sills; but overall, the structure is relatively weak and can only have survived 85+ years of coastal storms because of its protected location between the dunes.

**Figure 21** View of front sill of house and typical joist and stud connections. (NPS-SERO-CRS, 2002)

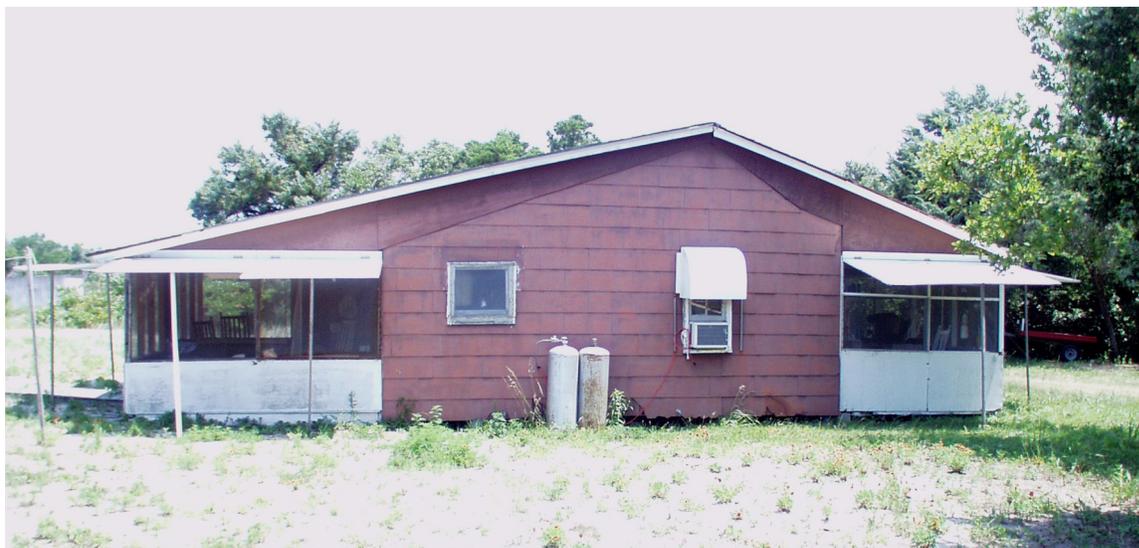
**Figure 23** View of southwest side of house, showing line of original roof prior to installation of present roof after 1976. (NPS-SERO-CRS, 2002)

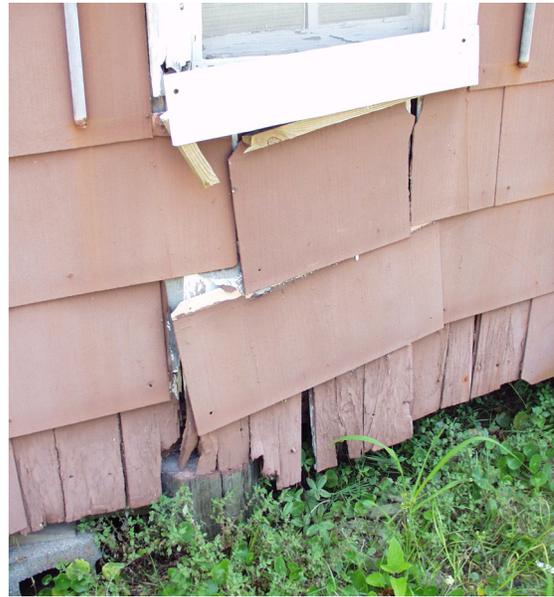
*Floors:* Original floor joists are generally 2" by 6- 1/2" (actual dimension), set on 32" centers. Single 2" by 6- 1/2" boards form the perimeter sills of the original house. As noted above, the mid- span supports for these joists have rotted, which has left the floor system unstable. In addition there has been severe sill damage at several locations, especially on the northeast side of the house.

**Figure 24** View of damaged siding on northeast side of house, the result of major sill damage in this location. Original board siding is exposed across bottom of wall. (NPS-SERO-CRS, 2002)

- Reduce span of joists and rafters by adding intermediate members.
- Repair termite- damaged and/or rotted sills and other framing elements as necessary.
- Reconstruct original porches.
- Restore original roof line.

- Remove asbestos siding, reusing or stockpiling the shingles.
- Repair and preserve underlying tongue- and- groove siding.
