Cape Lookout National Seashore  
**LEWIS- DAVIS HOUSE**

# **HISTORIC STRUCTURE REPORT**

**2004**

2004  
Historic Structure Report  
Lewis- Davis House  
Cape Lookout National Seashore  
Cape Lookout Village  
LCS#: 09t828

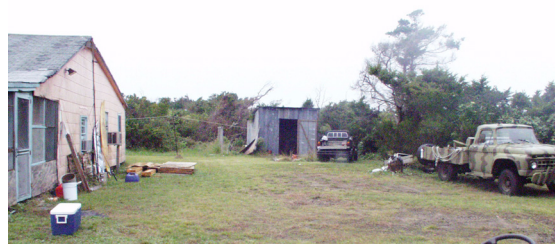
**Figure 21** View to northwest, showing metal storage building in rear yard. (NPS-SERO-CR, 2002)

Like the Gaskill- Guthrie House, the house was built on a lot 50' by 220' that combined two of the original lots laid out by the Cape Lookout Development Company in 1915. In the rear yard is a modern metal storage building, 12'-3" by 15'-3". Partially-burned piles of refuse litter the grounds.

- Clear site of rubbish and debris.
- Remove storage building.
- Follow recommendations of Cultural Landscape Report in determining treatment of the surrounding landscape.
- Improve site drainage and eliminate standing water beneath house.

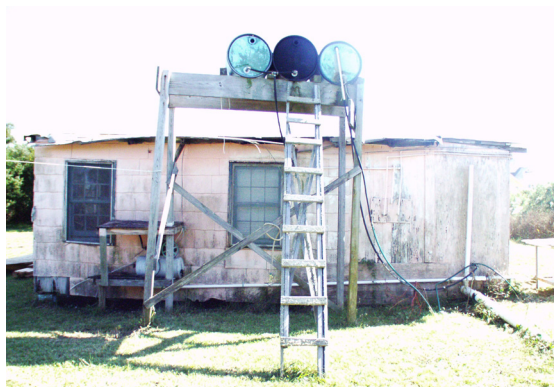
**Figure 22** View of water tanks at rear of house. (NPS-SERO-CR, 2002)

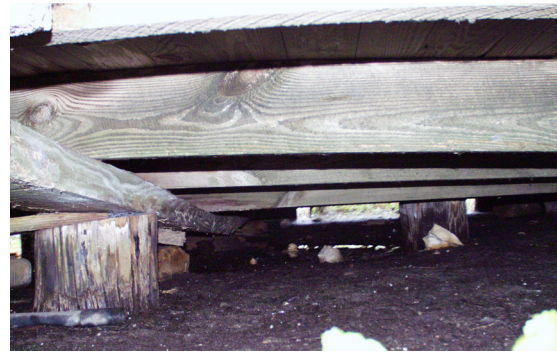
The wood frame of the main body of the house is set on a series of wooden piers, 8" - 12" in diameter, sunk to some indeterminate depth into the ground. Piers are so low that the house's frame is only a few inches above grade. Most are, at best, in fair condition, and concrete block have been inserted at some locations to provide additional support. Water is standing under large areas of the house, contributing to its ongoing deterioration.

**Figure 23** View of crawl space and piers. (NPS-SERO-CR, 2002)

- Raise house and replace all wood piles, replicating the existing size and placement of piles.
- Design and install storm-resistant mechanism to tie the house's wood frame to the foundation piles.

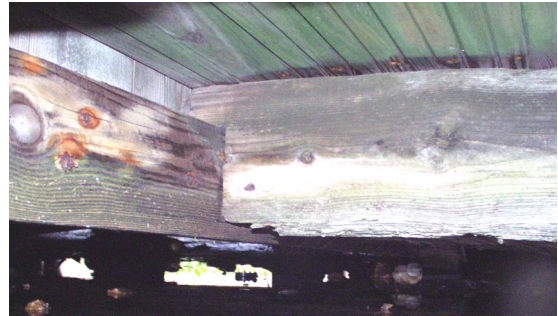
*Floor:* Floor joists appear to be a mix of 2" by 4" and 2" by 6" (actual dimensions could not be ascertained), set on 30" - 36" centers. Deterioration is widespread. Sills appear to be mostly single 2" by 8". Along the northwest side of Room 104, floor joists and sill have collapsed and there is major structural damage in Room

**Figure 24** View of typical joist sill connection. (NPS-SERO-CR, 2002)

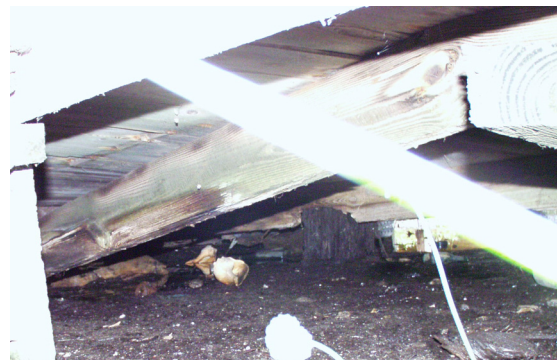
The structure has suffered major damage from termites and a leaking roof. Floors are collapsing in Rooms 101, 104 and 105, and there appears to have been major damage to the sills throughout the house. The roof, too, is in extremely poor condition, with large areas of rotten and termite-ridden rafters and decking. Although most of the historic finishes remain in place, the house as a whole is in very poor condition.

**Figure 25** View of collapsing floor under Room 104. (NPS-SERO-CR, 2002)

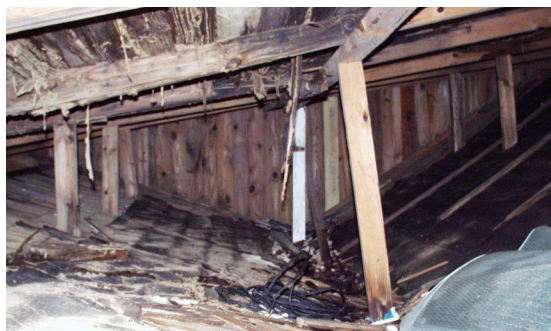
**Figure 26** View of junction of roofs of two original structures; note severe termite damage in rafters and decking at left. (NPS-SERO-CR, 2002)

*Rafters:* There are three main rafter systems in the present structure: one over Rooms 100 and 101, which could not be examined, and another separate system over the rear rooms. When the two halves of the house were joined, a new roof structure was built to cover both of the earlier roofs (see Figure 10). Rafters of this third roof are around 1-3/4” by 3-3/4”, on 30” centers, and woefully undersized for their span and pitch. Rafters at the rear of the house have been severely damaged by termites.

- Stabilize structure before repairs proceed.
- Remove 1950s roof structure and restore original roofs.
- Repair floor, wall, and ceiling framing as necessary and make improvements in connections of framing members to reduce the possibility of significant damage from high winds.
- Remove porch additions and restore porches to their appearance in the 1940s photographs.
- If entire house cannot be salvaged, repair and preserve original structure encompassing Rooms 100 and 101.

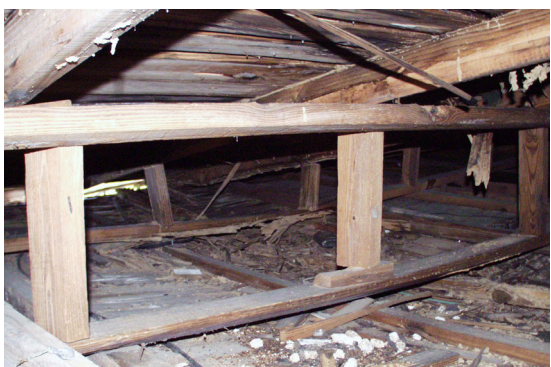
**Figure 28** View of heavily-damaged roof and ceiling structure over Room 104. (NPS-SERO-CR, 2002)

*Ceilings:* Like the walls, the ceilings appear to be very loosely framed, using widely-spaced 2” by 4” joists or, in some cases, 2” by 6” laid flat. The ceiling above Room 104 has been heavily damaged by water penetration and termites.

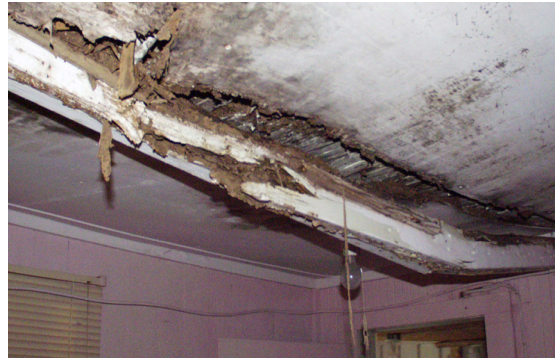
*Ceiling:* The ceiling, like the floor, is on the verge of total collapse due to severe termite and water damage. It was originally finished with double- V- joint, tongue- and- groove boards, 3- 1/2" wide.

**Figure 41** View to east of ceiling in Room 104. (NPS-SERO-CR, 2002)
