CAPE LOOKOUT NATIONAL SEASHORE
PORTSMOUTH
ED STYRON HOUSE
**HISTORIC STRUCTURE
REPORT**

**Cultural Resources, Southeast Region
National Park Service**

2004
Historic Structure Report
Ed Styron House
Cape Lookout National Seashore (CALO)
Portsmouth Village
LCS#: 12516

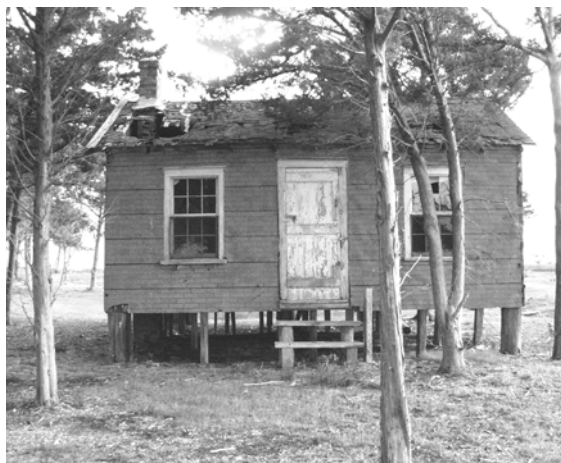
Figure 2 Left, view southeast of front of Styron House. (NPS-SERO-CRS, 2001)

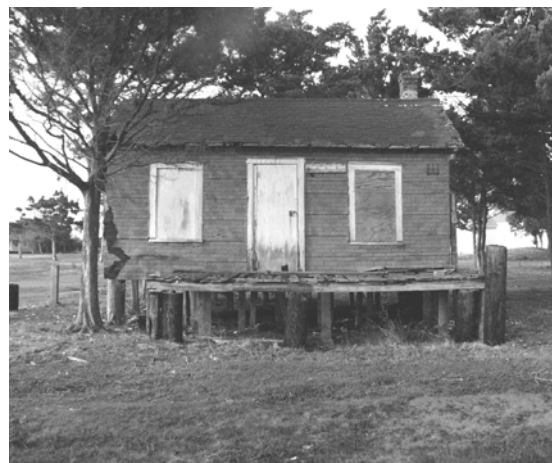
Figure 4 Right, view northwest of rear of Styron House. (NPS-SERO-CRS, 2001)

five now- missing wooden steps on open stringers at the north end of the deck. Set on a variety of posts (none of which are readily identifiable as being original) the deck is framed with modern 1- 1/2" by 5- 1/2" joists running the length of the deck and is floored with 1" - thick boards, 4- 1/2" to 4- 3/4" wide. Remnants of two older joists, about 1- 3/4" by 5- 3/4", survive at the north end of the deck and are an indication that the deck is a feature of the original house.

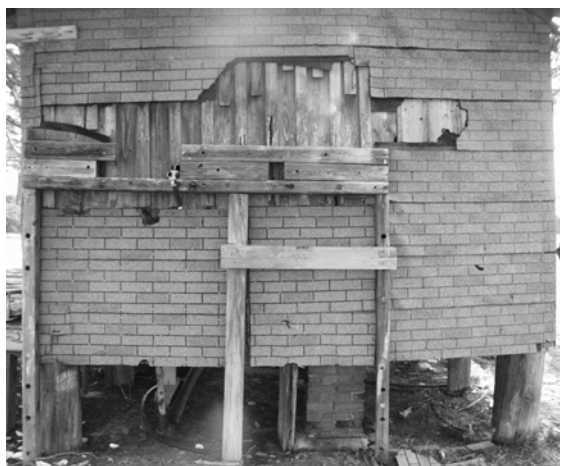
Figure 3 View of remains of wooden frame for cistern at northeast end of house. Parts of a brick foundation remain in the ground below. (NPS-SERO-CRS)

through a gutter from the southeast (rear) shed of the roof. The gutter and tank are now missing, but part of the wooden frame that supported the tank remains attached to the northeast end of the house.

- Preserve brick pad associated with the cistern at north-east end of house.
- Preserve wooden piers associated with missing addition at southwest end of house.

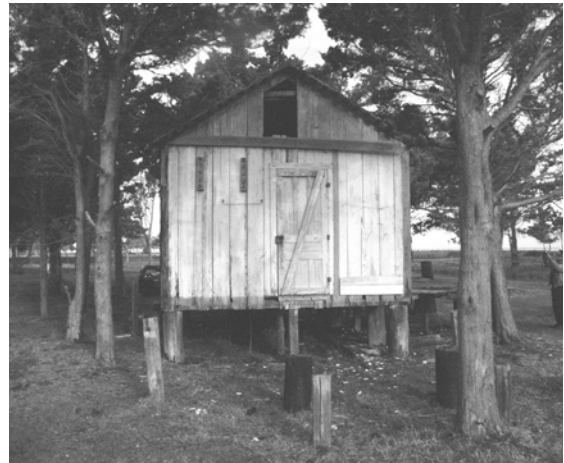
Figure 5 View of southwest end of house; note piers in foreground which supported the modern addition that was removed after 1984. (NPS-SERO-CRS, 2001)

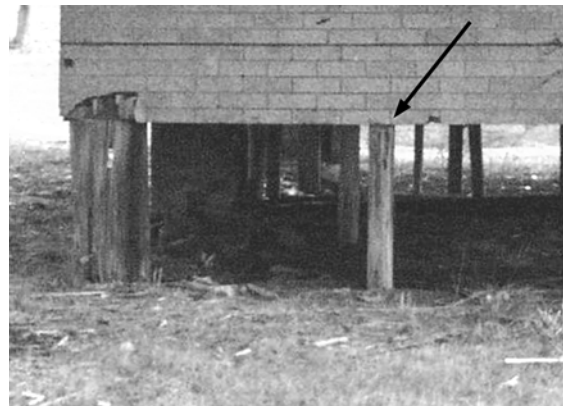
depth into the ground. The original piers appear to be the three 4" by 8" piers on the front of the house, a similar pier at the northwest end, and two 3" by 12" piers under the rear sill of the house. The remainder of the piers appear to have been added or replaced. The most recent piers include the sections of creosoted telephone poles that underpin the four corners of the house.

Figure 6 View of north end of front of house; arrow marks one of several original wooden piers. (NPS-SERO-CRS, 2001)

- Repair and repoint chimney as necessary.
- Replace modern wooden piers with wooden piers that more closely match the original.

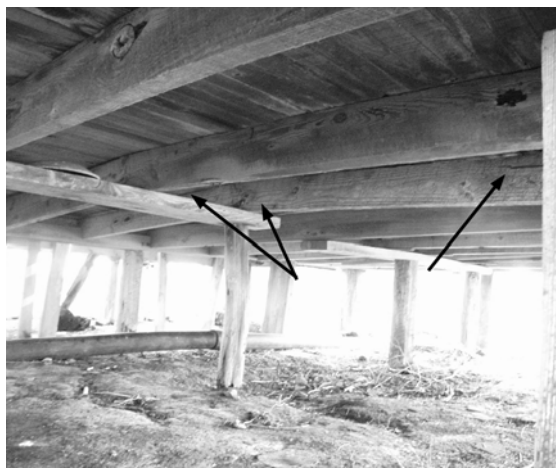
Floor joists are generally 1-3/4" to 2" by 5-3/4" to 6", running from the front to the back of the house and set on centers ranging from 22" to 24". Joists are lapped and nailed to the sills. An added support girder made up with 2 x 6s laid flat on wooden posts runs the length of the building and supports the joists at mid-span. Joists are in good condition except for two under the southwest side of the main room (101) which have split where they lap the sills and are broken where they cross the support girder. This damage is due to the deteriorated sill at the rear of the house which, along with settlement of the piers along that side of the house, especially at the northeast end, has allowed the

framing to settle several inches. In addition to allowing the entire house to sink, the sagging joists have pulled away from the flooring above in several areas. Wall framing could not be examined but appears to be composed of standard 2 by 4s on about 24" centers. Ceiling joists

Figure 7 View of floor framing; arrow at right indicates where joist has split; arrows at center show location of two joists that have broken where they cross the added support beam. (NPS-SERO-CRS, 2001)

- Repair roof structure, preserving existing rafters and reconstructing exposed rafter ends wherever possible.
- Repair or replace rear sill; raise and level building structure.
- "Sister" new floor joists to broken joists.

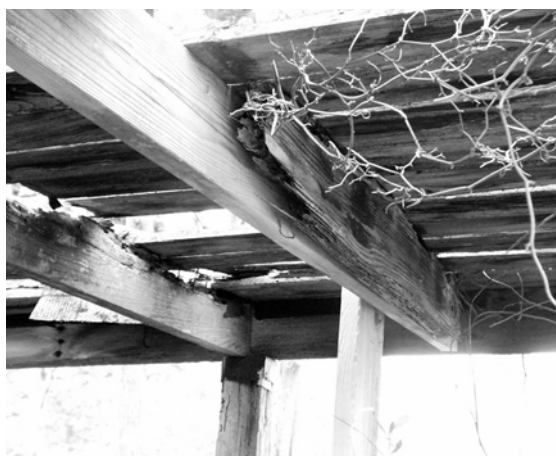
Figure 8 View under north end of rear deck, showing remains of original floor framing. (NPS-SERO-CRS, 2001)

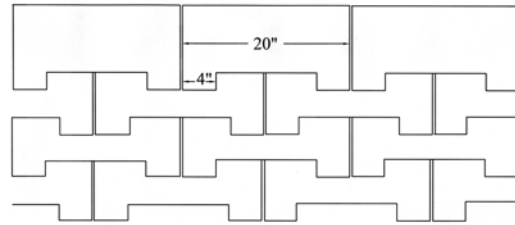
The house has been re-roofed only once, after 1939 when the present textured asphalt composition roofing was first offered for sale by the Rubberoid Company.¹⁰ Textured shingles were widely-used into the 1950s, which is when the present roof was probably installed. This assumption is based on the facts that the original wood-shingled roof would have probably remained serviceable for at least twenty years and that the asphalt roof remained in reasonably sound condition when it was first photographed in 1984.

Figure 10 Pattern of mid-twentieth century asphalt shingles on Styron House. (NPS-SERO-CRS, 2001)

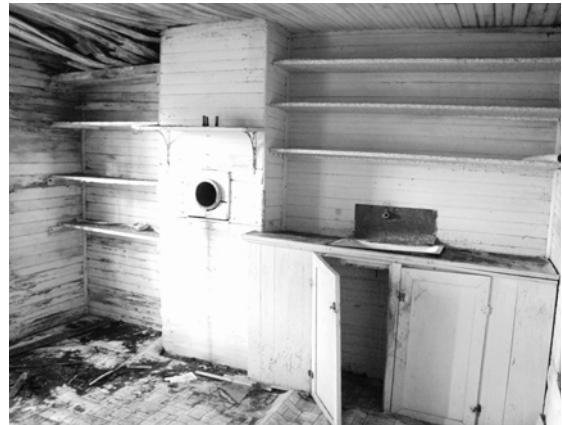
Figure 12 View north in main room (101). Sink is to right of chimney. (NPS-SERO-CRS, 2001)

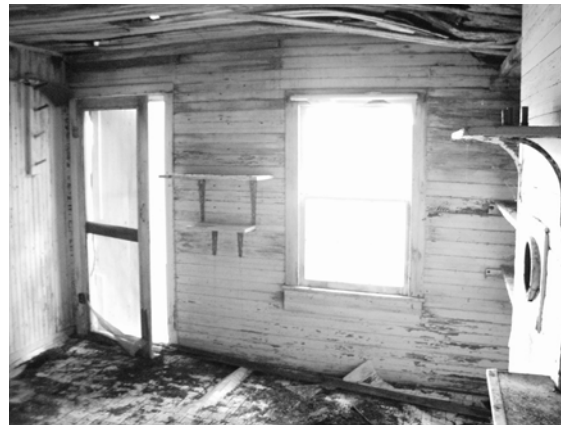
Figure 13 View west in main room. (NPS-SERO-CRS, 2001)

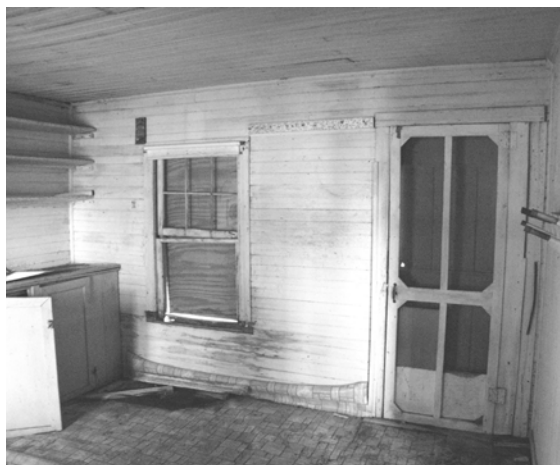
Figure 14 View east in main room. (NPS-SERO-CRS, 2001)

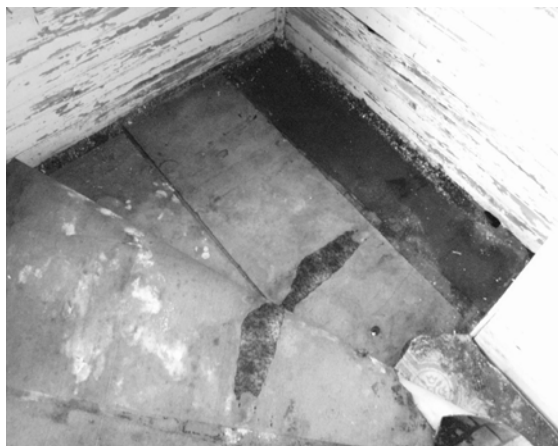
Floor: Flooring is narrow tongue- and- groove with a face 2- 1/2" wide. It appears to have always been painted gray and remains in excellent condition, having been covered by linoleum at an early date. The floor has three layers of floor coverings, none of them in good condition. The top layer is a modern, sheet- vinyl floor covering, probably installed in the 1970s. Beneath it is a green- and- gold patterned, sheet- vinyl floor covering that may date to the 1960s. The earliest layer probably dates to the 1930s or 1940s and is one of the felt- based imitators of linoleum that were widely used before the mass- marketing of modern vinyl floor coverings in the 1950s.

Figure 15 View of floor in northwest corner of main room, showing early felt-based, imitation linoleum under two later floor coverings. (NPS-SERO-CRS, 2001)

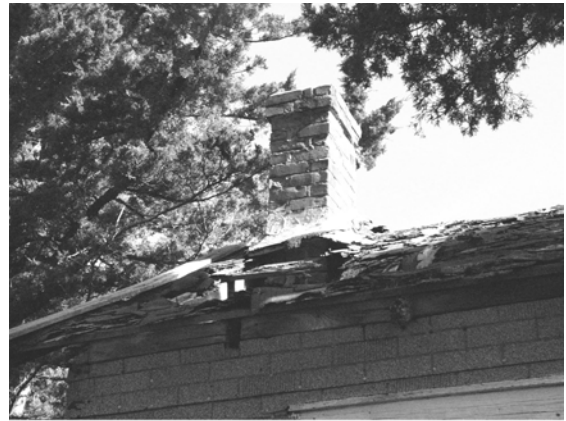
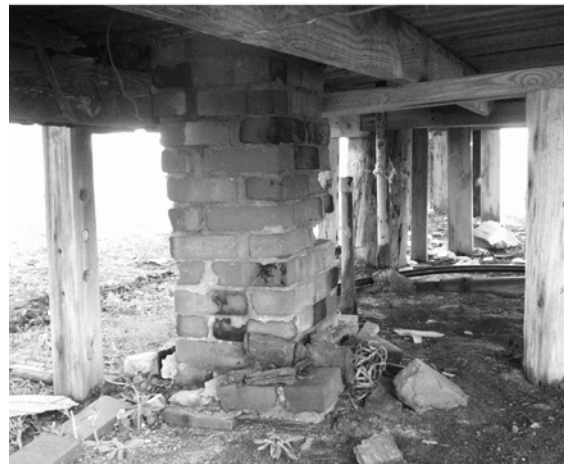
chimney with its 7-1/2", terra-cotta, stove flue. The foundation of the chimney has deteriorated, mostly due to rising damp. The chimney stack above the roof also has some spalling brick; where it rises through the roof, the brick has been disfigured by repeated applications of tar and other sealants.

Figure 16 Top, view of chimney stack; below, view of chimney foundation. (NPS-SERO-CRS, 2001)

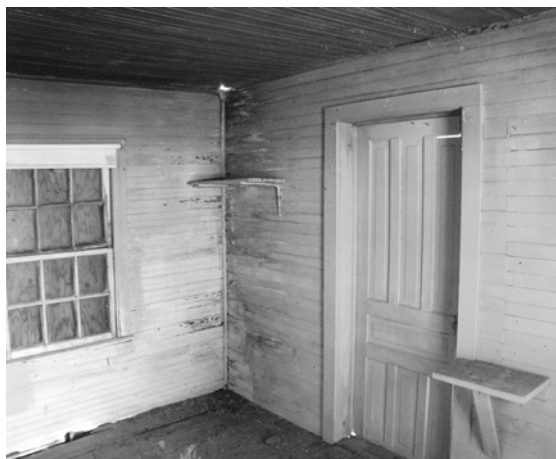
The third exterior door opening is at the southwest end of the house and was installed to replace a window when the now-missing addition was built at that end of the house. The door is 2'-6" by 7'-1" with a single, horizontal, raised panel between four vertical raised panels

Figure 17 View south in Room 101. Door to right was originally a window opening, converted into a door to the addition in the 1950s. (NPS-SERO-CRS, 2001).
