Cape Lookout National Seashore
Portsmouth
GEORGE DIXON HOUSE
HISTORIC STRUCTURE
REPORT

2004
Historic Structure Report
George Dixon House
Cape Lookout National Seashore (CALO)
Portsmouth, NC
LCS#: 12519

Historic Structure Report

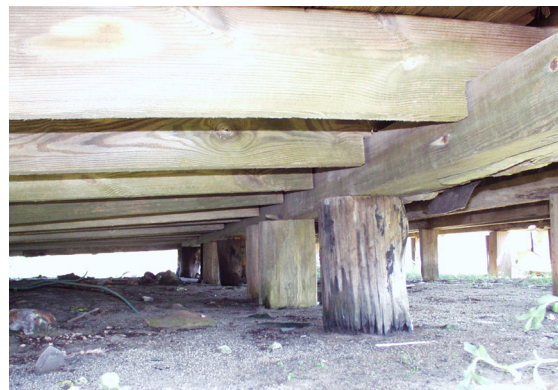
Sills and Plates: Perimeter sills have undergone extensive repairs and modifications, especially on the southeast side of the house where the original sill has been replaced by a stacked trio of boards, 2" by 6- 1/2". The 6" by 8" sill at the front wall of the house appears to be typical of the original sills. A beam, 6' by 7", runs through the house from end to end and supports the walls above that separate front from rear rooms. Support piers near the middle of this beam (under the central hall) appear to have been undermined and/or otherwise been displaced. As a result, the beam has broken and partially collapsed, causing nearby joists to split and allowing the center of the house to drop several inches.

Joists: First floor joists are about 1- 7/8" by 7- 3/4", set about 24" between centers. Joists run front to rear in the house and are notched and lapped over front and rear sills and over the collapsing center beam. Most are in good

Figure 11 View northeast of front sill, showing typical joist/sill connections and wooden piers. (NPS-SERO-CRS, 2002)

condition; but at least one joist has split as a result of the collapsing beam.

- Replace sill at southeast end of house and collapsing sill running through center of the house; repair other sills as necessary; raise and level building structure.
- "Sister" new floor joists to broken joists.
- Inspect stud connections to sills and plates and repair as needed.

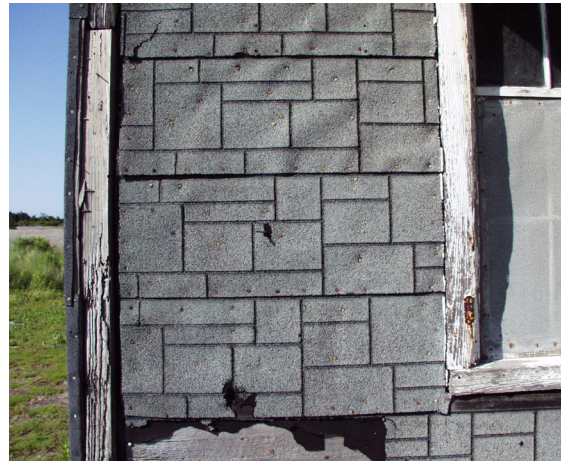
The exterior of the house was also stripped of its original siding. Old siding and material removed from the interior appears to have been used to resheath the house with flush-laid boards that were then covered with the present asphalt composition panels. The old wood-shingled roof covering remained in place but within a few years had been replaced by green, asphalt-composition, "hurricane" shingles.²⁹

Figure 14 View of added asphalt siding. Note part of shutter hinge on adjacent window casing, which is original. (NPS-SERO-CRS, 2002)

- Remove existing asphalt siding, preserving at least one complete panel in the park's permanent collection.
- Identify original 1" by 8" siding material, and re- install all sound material as lapped siding, replacing missing material as necessary.
- Paint siding and trim as dictated by careful analysis of surviving finishes.

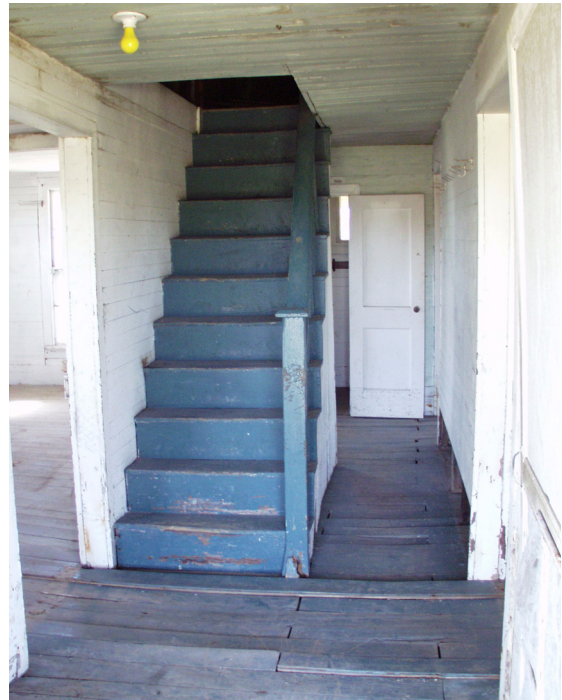
Figure 16 View of hallway (Room 100) from front door. (NPS-SERO-CRS, 2002)

Floors: Flooring is 5"- wide, painted, tongue-and- groove boards. The collapsing sill that runs through the center of the house has

caused major deflection of the floor around the middle of the hall.
