Portsmouth Life- Saving Station

Historic Structure Report

2006

2005
Historic Structure Report
Portsmouth Life- Saving Station
Cape Lookout National Seashore
Portsmouth, NC
LCS#: 012512

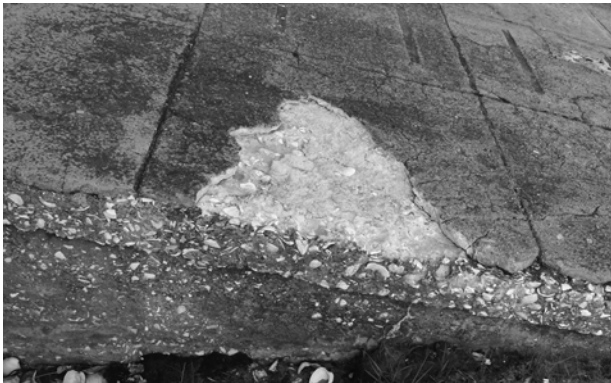
FIGURE 56. View of deterioration on ramp to small boat-room door. (T. Jones, NPS, 2005)

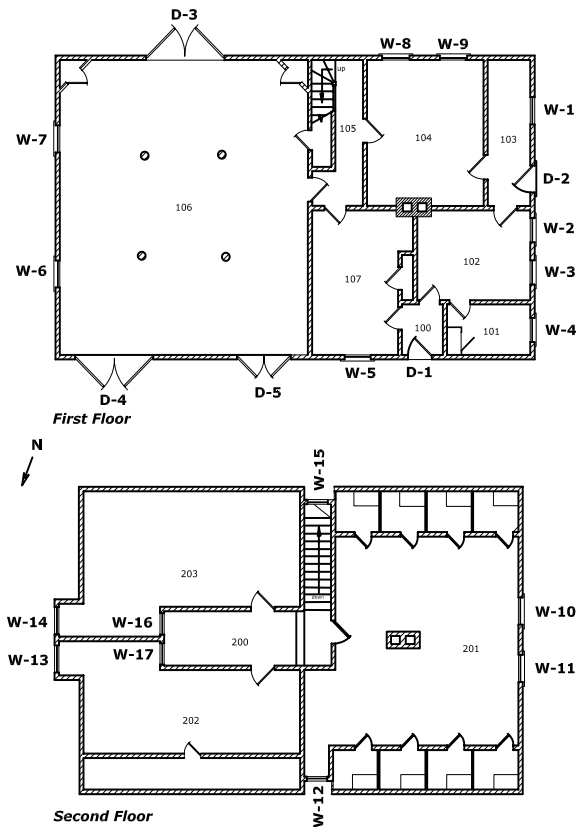
FIGURE 73. Plan showing numbering of windows and doors. (T. Jones, NPS, 2005)

W-1	3'-4" by 2'-9", single sash, nine lights, originally top hinged
W-2	2'-10" by 5'-8", nine over two, double hung, one light broken
W-3	2'-10" by 5'-8", nine over two, double hung, one light broken
W-4	2'-10" by 5'-8", nine over two, double hung, two lights broken
W-5	3'-4" by 5'-10", nine over two, double hung
W-6	3'-4" by 5'-10", nine over two, double hung, sash and frame out of opening
W-7	3'-4" by 5'-10", nine over two, double hung
W-8	3'-4" by 5'-8", nine over two, double hung, ropes broken
W-9	3'-4" by 5'-8", nine over two, double hung, ropes broken
W-10	3'-0" by 4'-4", six over two, double hung
W-11	3'-0" by 4'-4", six over two, double hung
W-12	2'-10" by 4'-4", six over two, double hung
W-13	3'-0" by 4'-4", six over two, double hung, ropes broken
W-14	3'-0" by 4'-4", six over two, double hung, ropes broken
W-15	2'-10" by 4'-4", six over two, double hung
W-16	2'-6" by 2'-7", single sash, four light, top hinged, all glass missing

Condition: Some of the sash may have been replaced, and most are in good condition, although many of the counterweight ropes are broken and there are several panes of broken glass. The sash in the attic window, which are almost certainly original, are badly weathered, primarily because the interior side of the sash has not been maintained. At the northeast end of the boat room (Room 107), recent storms badly damaged both windows (w- 6 &

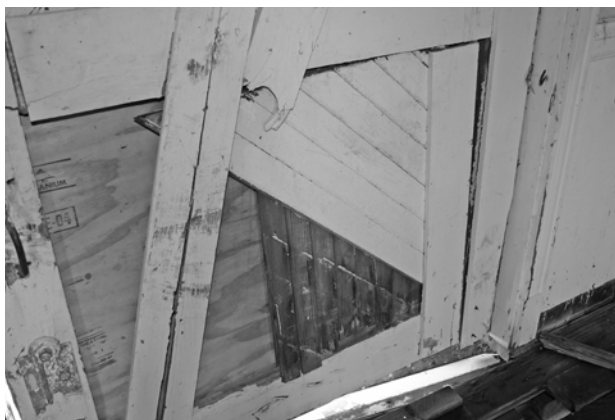
FIGURE 84. View of damage to lower panel of leaf of Boat Room door D-5. (T. Jones, NPS, 2005)

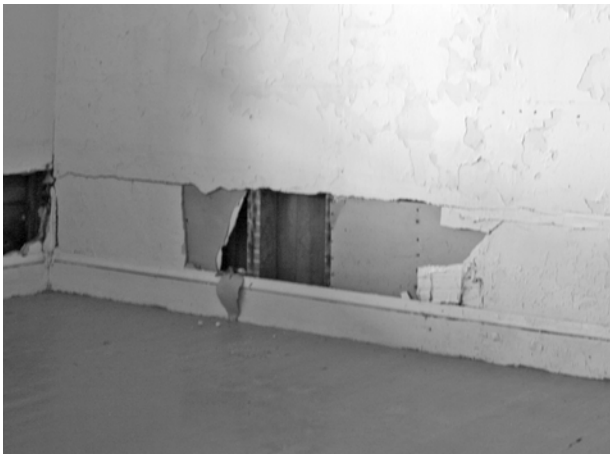
FIGURE 89. View of water-damaged plaster on rock lath in Room 106. (T. Jones, NPS, 2005)

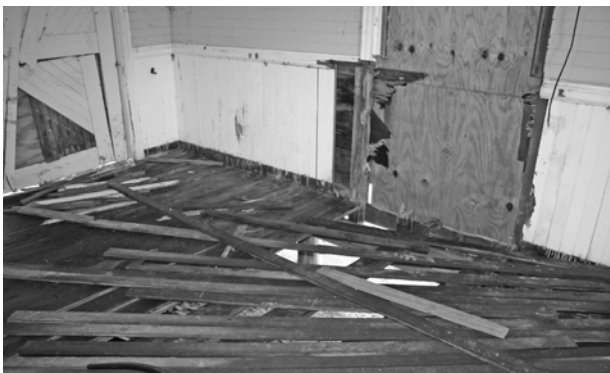
FIGURE 121. View of flooring damaged by storm surge in 1993. (T. Jones, NPS, 2005)

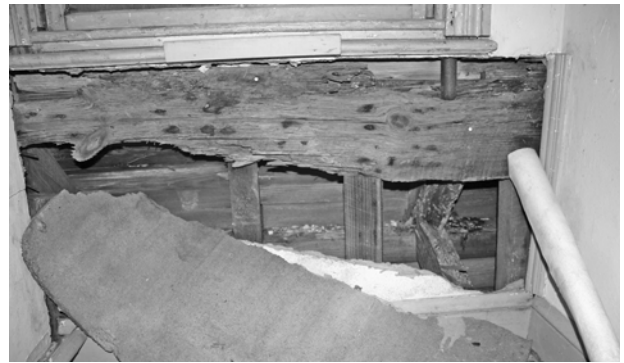
FIGURE 142. View damaged wall below window in Room 202. (T. Jones, NPS, 2005)
