Jean Lafitte National Historical Park and Preserve  
Chalmette National Cemetery  
Superintendent's Lodge

# Historic Structure Report

June 2006

National Park Service

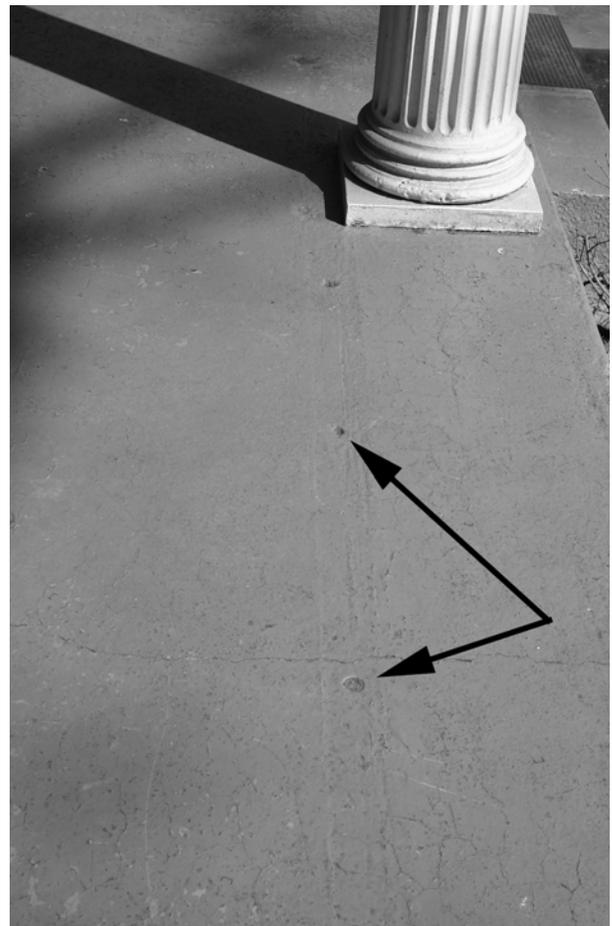
It must have been immediately clear that an unscreened porch was of limited utility in an environment like that at Chalmette, and in 1931, the front porch was screened at a cost of \$165. Framing for the screening was set behind the columns, following a line that is still evident on the floor of the present

FIGURE 13. View of front porch floor with arrows indicating where screen framing was attached to the floor.

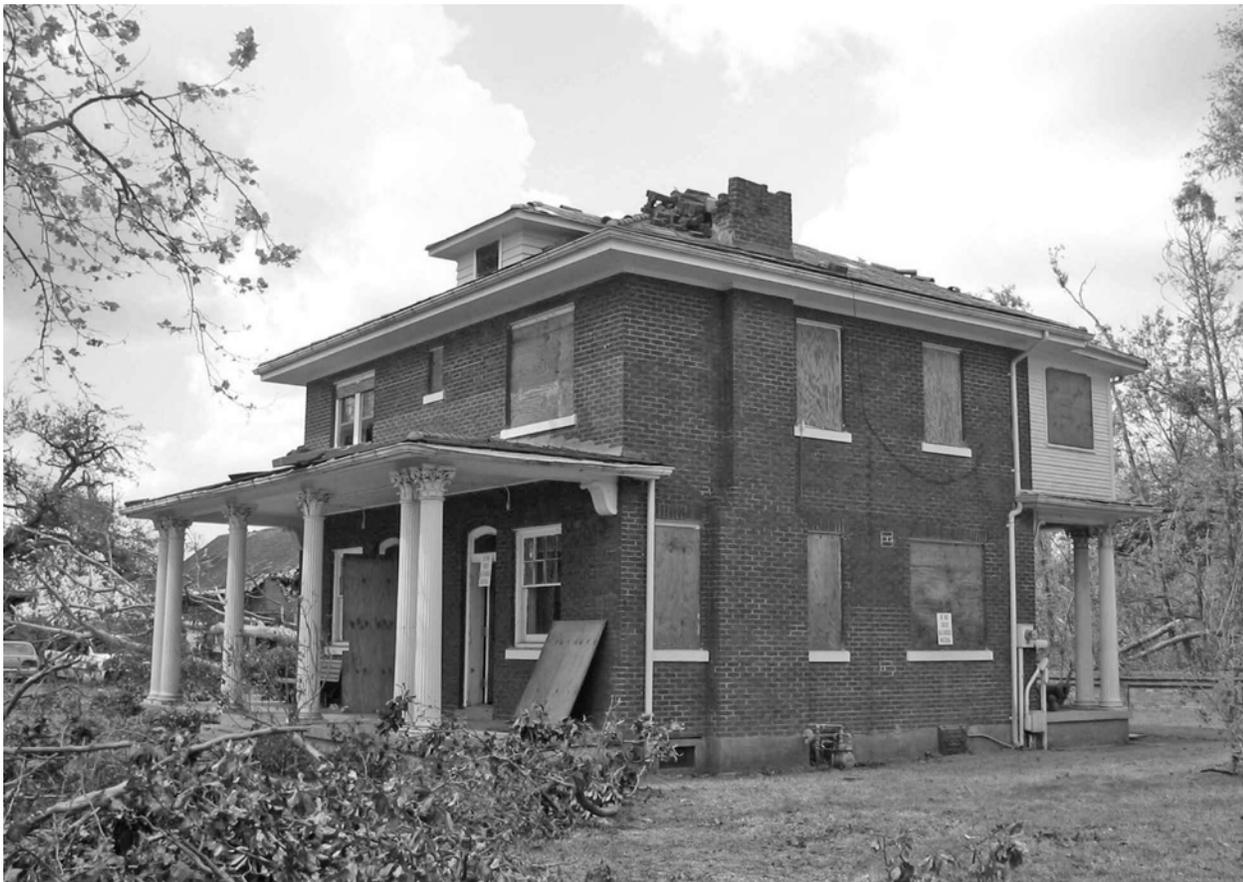
FIGURE 19. View of Lodge after Katrina, fall 2005. (NPS, SERO-CRD.)

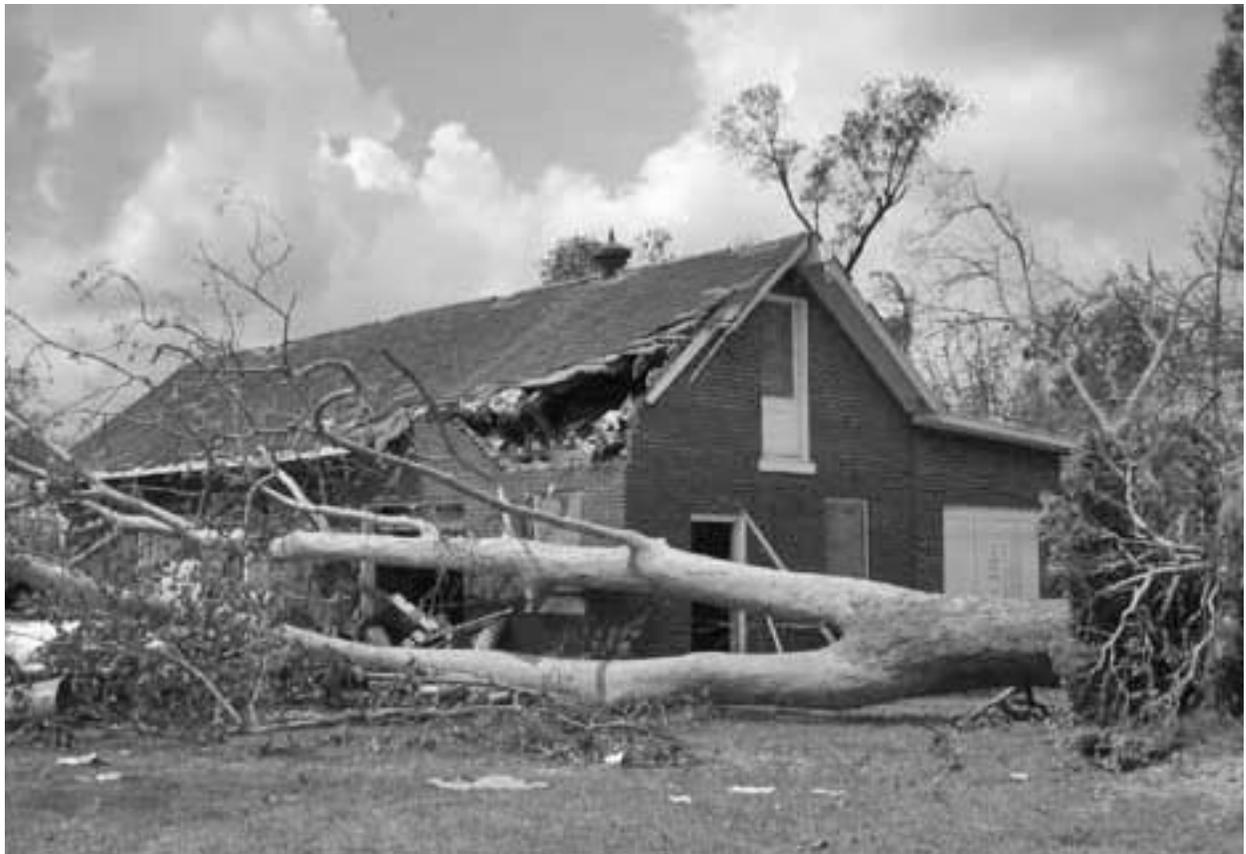
FIGURE 20. View of garage after Katrina. (JELA Coll.)

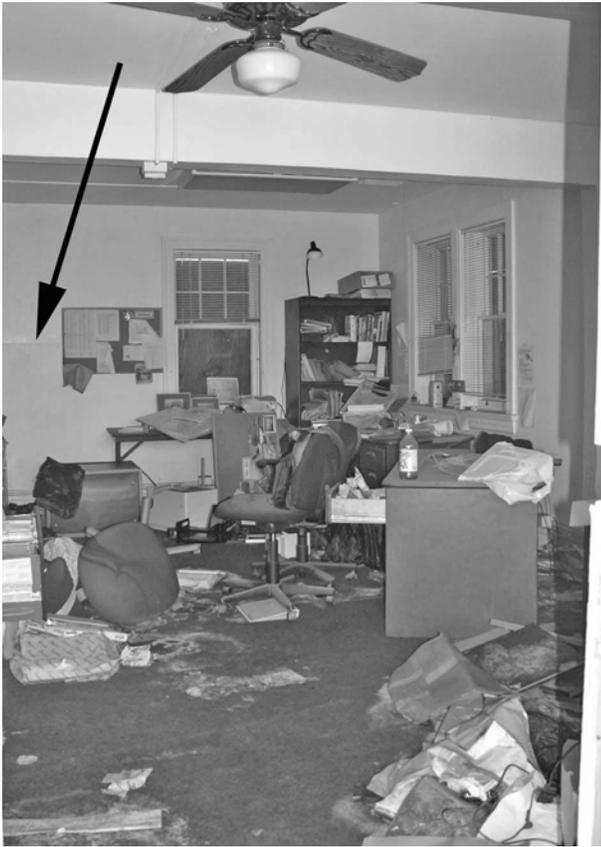
**FIGURE 21.** View of Rooms 101 and 104 in the Lodge after Katrina. Arrow denotes high-water line. (JELA Coll.)

as high as five feet inside the Lodge. In addition, the east chimney collapsed onto the roof. Stabilization of the building after the storm included removal of ruined mechanical equipment and all plumbing fixtures on the first floor. In limited areas, the plaster walls were removed to facilitate drying of wall cavities. Some sash were replaced with temporary louvers, also to facilitate drying.

- Reconstruct east chimney
- Repair roofing
- Replace gutters with 6” or larger gutters
- Install permanent drainage system from downspouts
- Reinstall original doors and windows

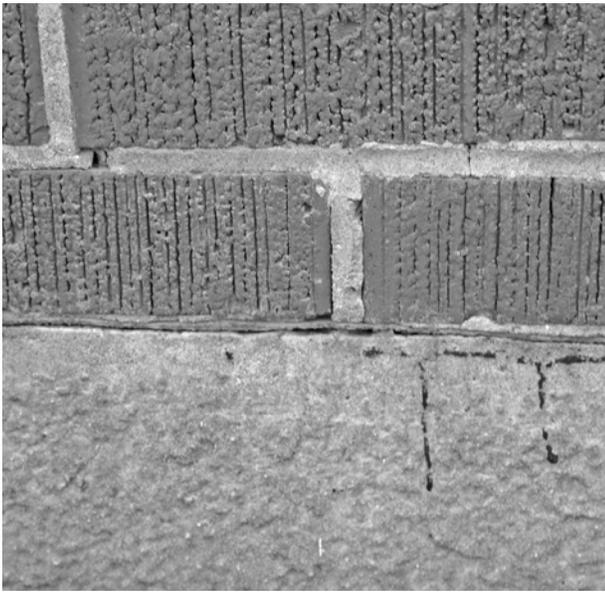
FIGURE 28. View of juncture of brick veneer wall and concrete foundation, with damp-proof course visible.

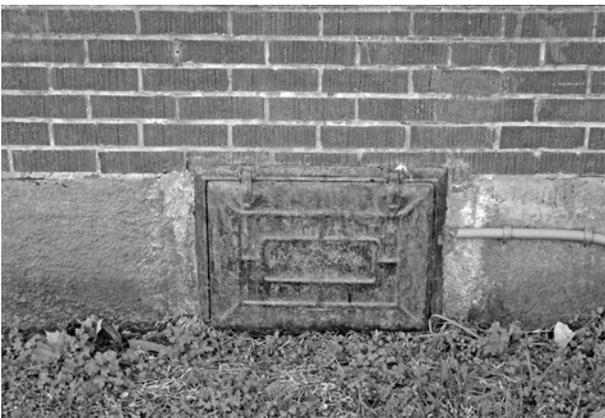
FIGURE 30. View of altered foundation opening on northeast side of house.

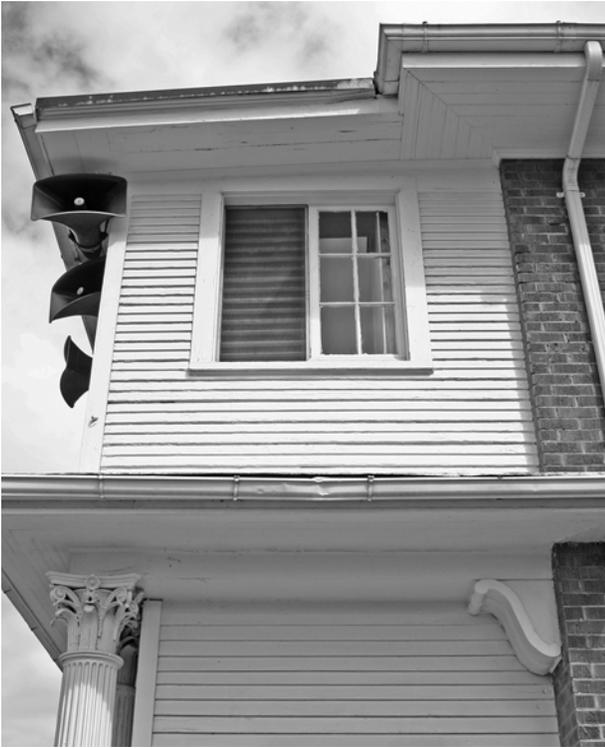
FIGURE 45. View of southwest end of sleeping porch..

- Remove additions on first floor of back porch
- Preserve sleeping porch, but remove added closets
- Replace aluminum windows with wood sash to match original

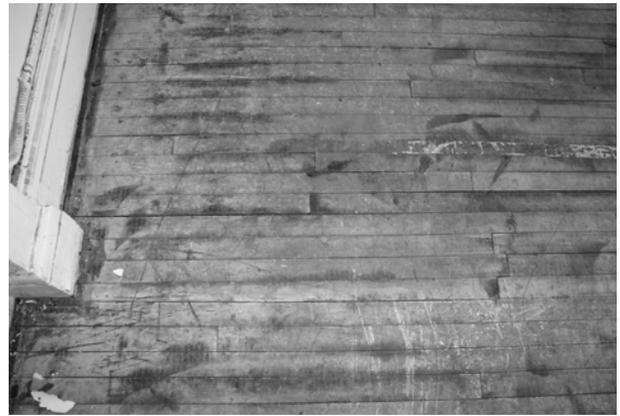
FIGURE 52. Oak flooring at location of former wall between Rooms 101 and 104.

- Reinstate wall between Rooms 101 and 104 if that would benefit the park's use of the building

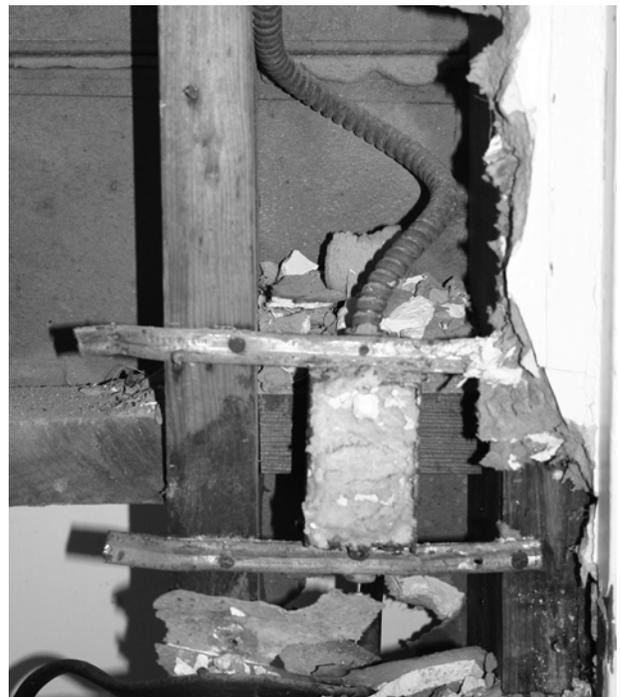
FIGURE 64. View of original switch box and BX electrical cable, abandoned in 1965.

- Replace all HVAC, electrical, and plumbing
- Repair plaster walls and ceilings

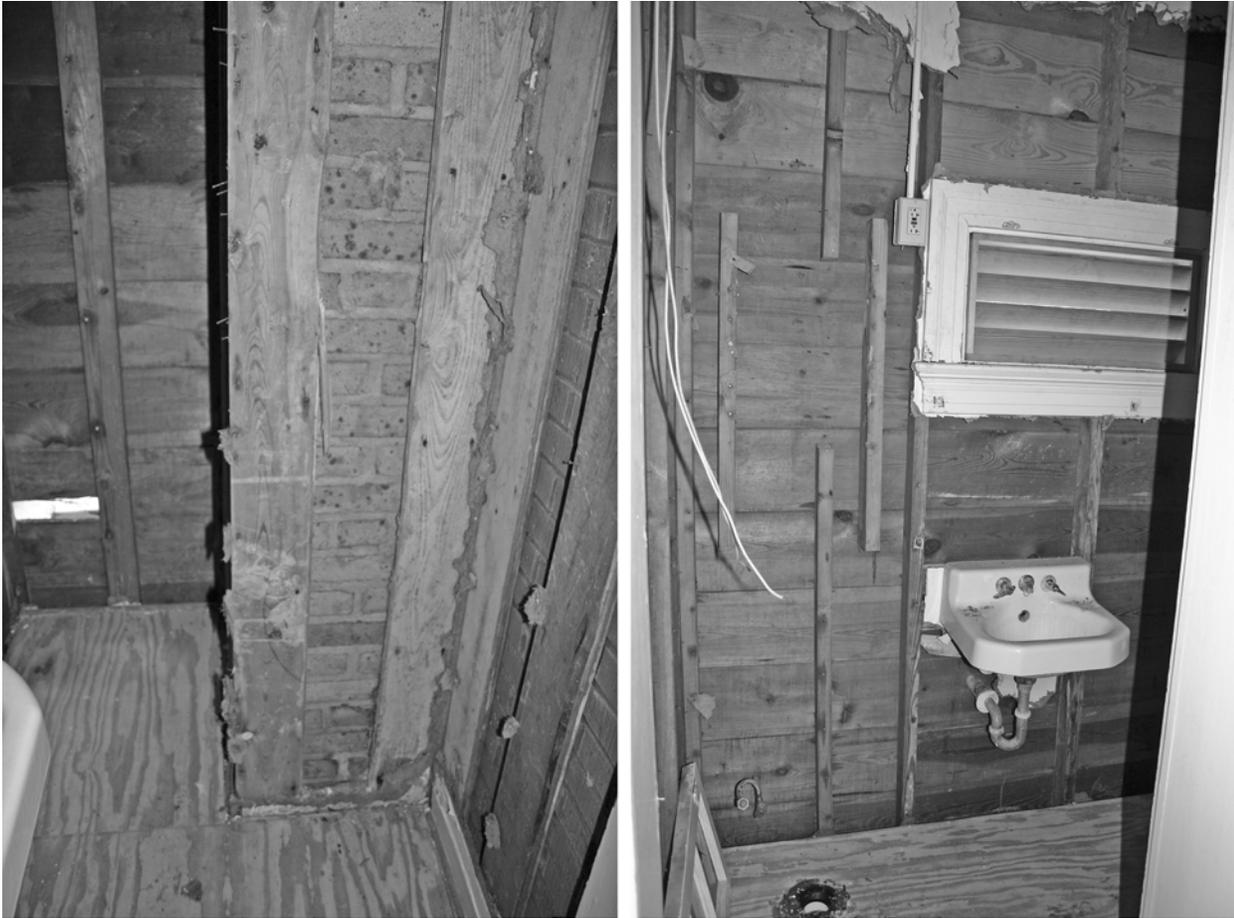
FIGURE 71. View northeast (left) and north (right) in Room 105. The odd framing visible in the right-hand image was probably to accommodate a wall-hung toilet tank.
