Ocmulgee National Monument
Dunlap House
Historic Structure Report

March 2011

2011
Historic Structure Report
Dunlap House
Ocmulgee National Monument

Management Summary

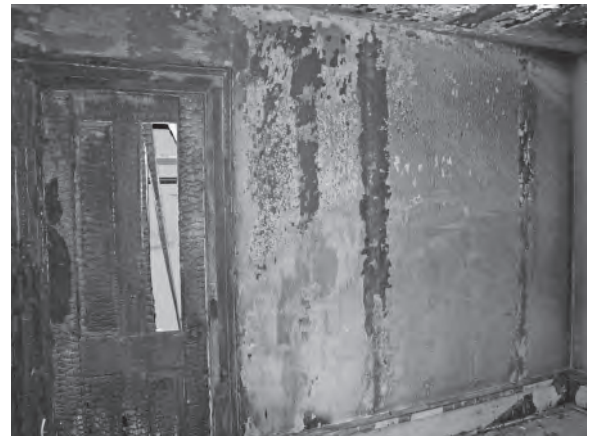
The arson fire in February 2011 heavily damaged the small bedroom (107) and the back hall (103) with lesser damage in the laundry room (108). The remainder of the house suffered smoke damage. Fast response from the local fire department limited the damage, so that the principal damage was the destruction of the two windows and doors, including most of the casing and trim, about 10' of baseboard in the southwest corner of the bedroom (107), the disappearing stairway in the rear hall (103), and one side of the door to the front hall, which was badly scorched by the flames. Firefighters also had to break the outside door to the master

Figure 14. View northeast in small bedroom (107) where the fire started.

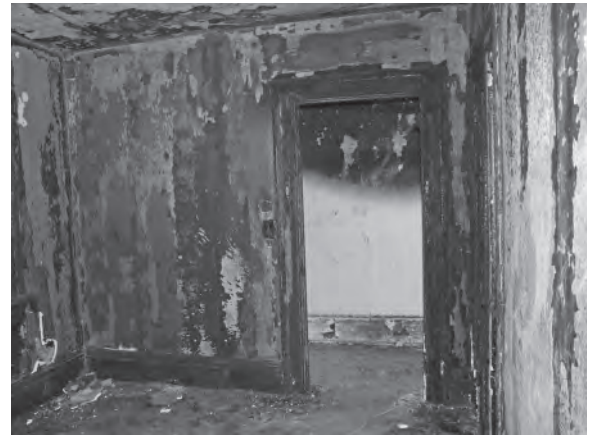
Figure 15. View west in small bedroom. All of the woodwork seen here, except for the baseboard in the hall, was charred beyond repair. The door in this opening was also destroyed.

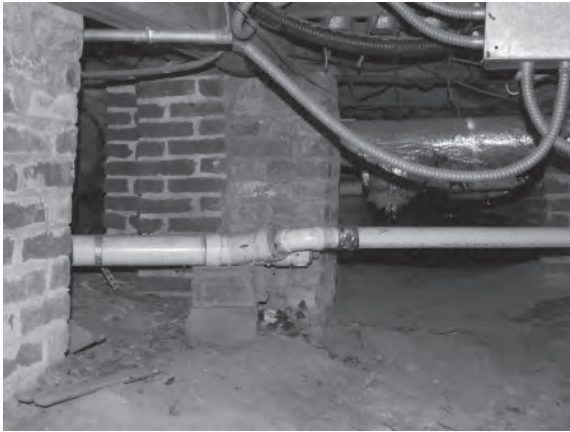
Figure 3. View west from beneath back porch. The gray mortar of mid-twentieth century alterations contrasts with the light mortar of one of the T-shaped piers, left of center, that were part of the original masonry.

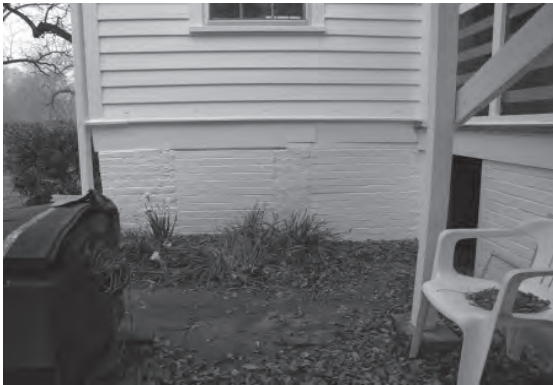
Figure 4. The anomalies in the foundation wall and skirt trim on the east side of the rear wing probably relate to the original configuration of the back porch. Beneath the present porch, a portion of the foundation is painted red, most likely after 1936 when part of the south foundation under the present kitchen was exposed.

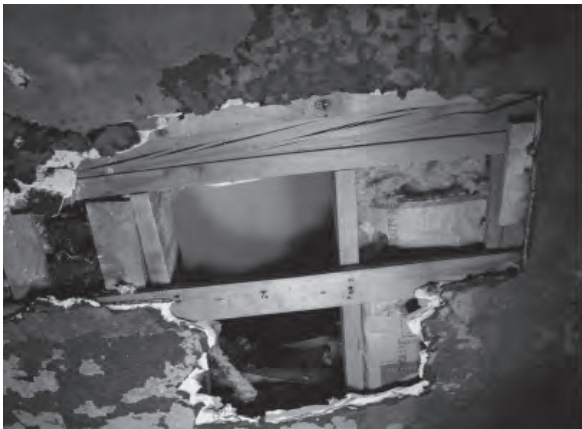
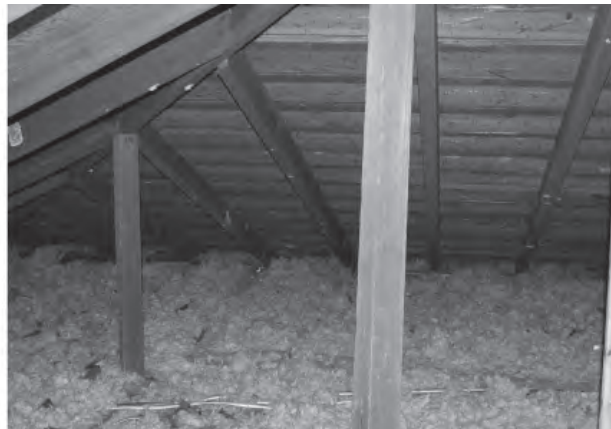
All observed framing appeared to be in excellent condition, including the framing of the ceilings in the two fire-damaged rooms, 107 and 108, except perhaps in the framing for the opening of the disappearing stairs.

Figure 7. View of framing for ceiling in Room 108 that was added in 1952-1953, left, and a view of typical roof framing in the attic, right.

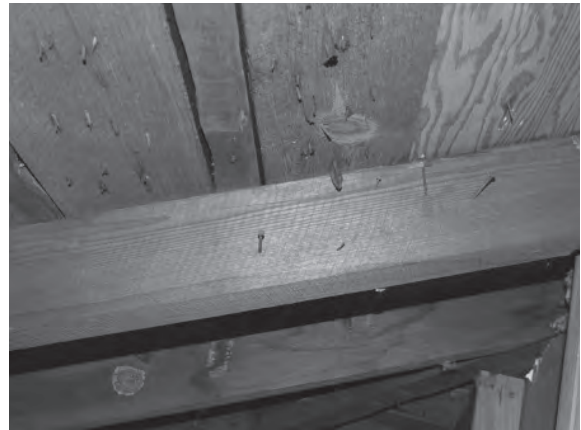
Figure 8. View of roof decking on west slope of roof, showing typical rafters and original 6" decking showing nails from original wood-shingled roofing. The narrow strips were used to create a solid wood deck for a standing-seam metal roof installed in 1938. At right is plywood decking used for repairs when the metal roofing was replaced with three-tab asphalt shingles in the last decade of the twentieth century.

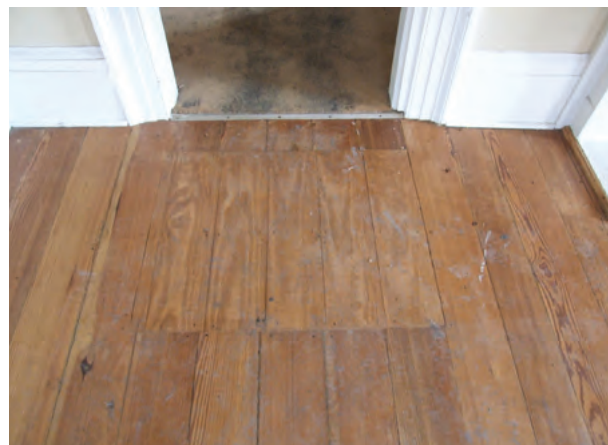
Figure 17. View of typical variation in the house's pine flooring. The wide, open grain of the square patched area is typical of lumber used in the 1950s.
