**WRIGHT BROTHERS NATIONAL MEMORIAL
VISITOR CENTER**

**HISTORIC STRUCTURE
REPORT**

2002
Historic Structure Report
Wright Brothers
National Memorial Visitor Center
Kill Devil Hills, North Carolina
LCS#: 91645

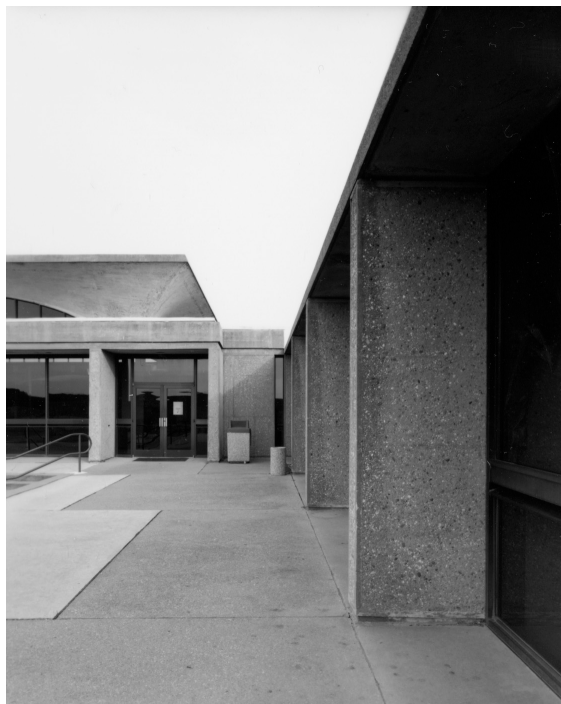
Figure 20 Above, view of concrete paving of Ceremonial Terrace, showing original exposed-large-aggregate panels to right, and the brush finish of modern repairs at left (National Park Service, 2000)

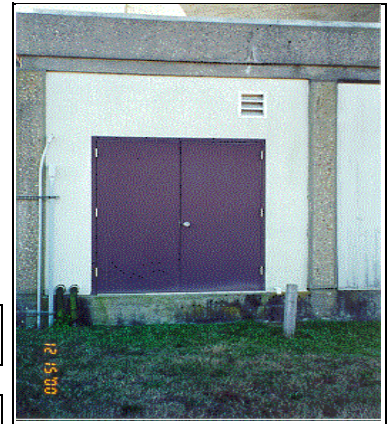
Deficiency: Original design plans have been significantly altered with this addition. However, it will not be possible to remedy if the HVAC systems are not revised.

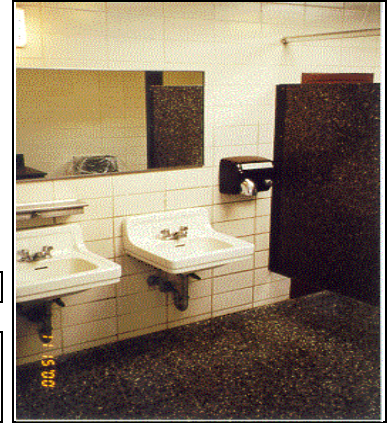
Deficiency: Penetrations for mounting non-original fixtures in the restroom.

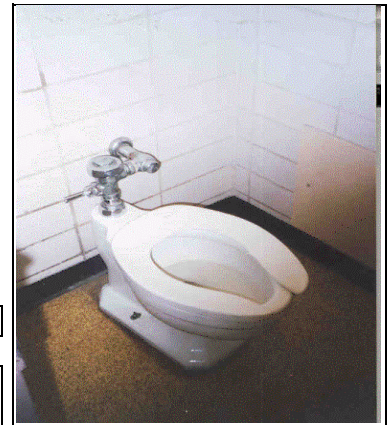
Deficiency:	Covered over by carpet.
--------------------	-------------------------

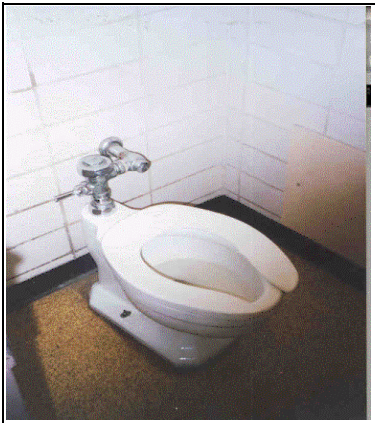
Deficiency: Not handicapped accessible proper height for handicapped accessibility.
--

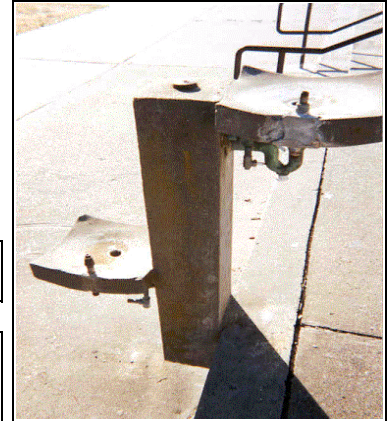
Deficiency: Working parts are missing, concrete parts are cracked and broken out.

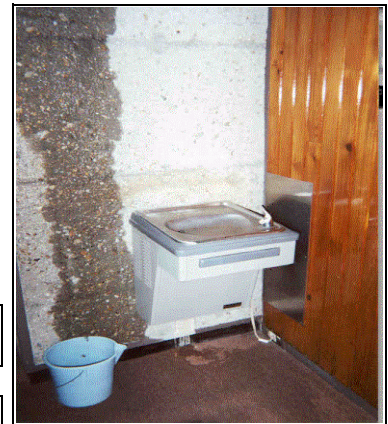
Deficiency: Too close to wall for handicapped access out,

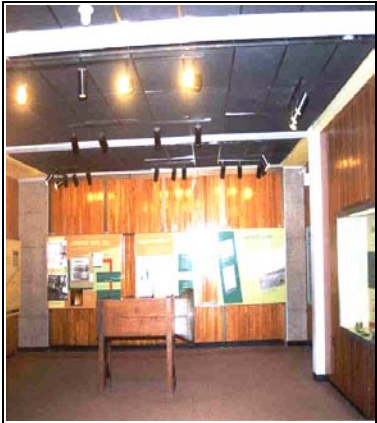
Deficiency: Non-contributing lay-in fixtures, missing flood lights and surface-mounted can lights.
