Blue Ridge Parkway
Saunders Farm
Historic Structures Report

June 2005

National Park Service

2005
Historic Structures Report
Saunders Farm
Blue Ridge Parkway
Peaks of Otter, VA
LCS#: Saunders House 006493
 Saunders Meat House 006495
 Saunders Chicken House 006496
 Saunders Hog House and Pen 006497

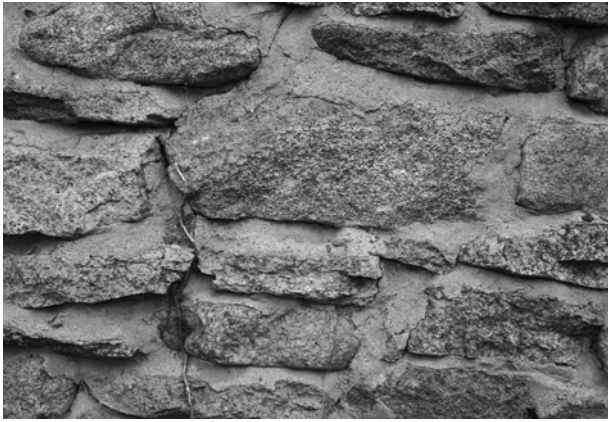
FIGURE 20. View of historic masonry near the southwest corner that has not been repointed. (NPS, 2005)

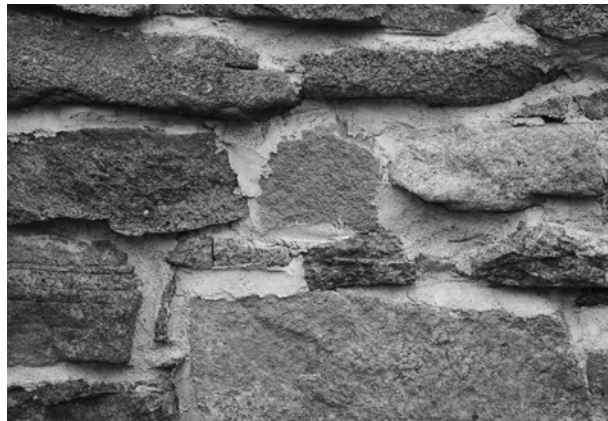
FIGURE 21. View of historic masonry that has been repointed with Portland cement. (NPS, 2005)

There has been no laboratory analysis of the mortars, but visual analysis distinguishes three separate mortars. The oldest that has not been repointed is that found on the west side of the cellar door and along the front of the house. This mortar is relatively

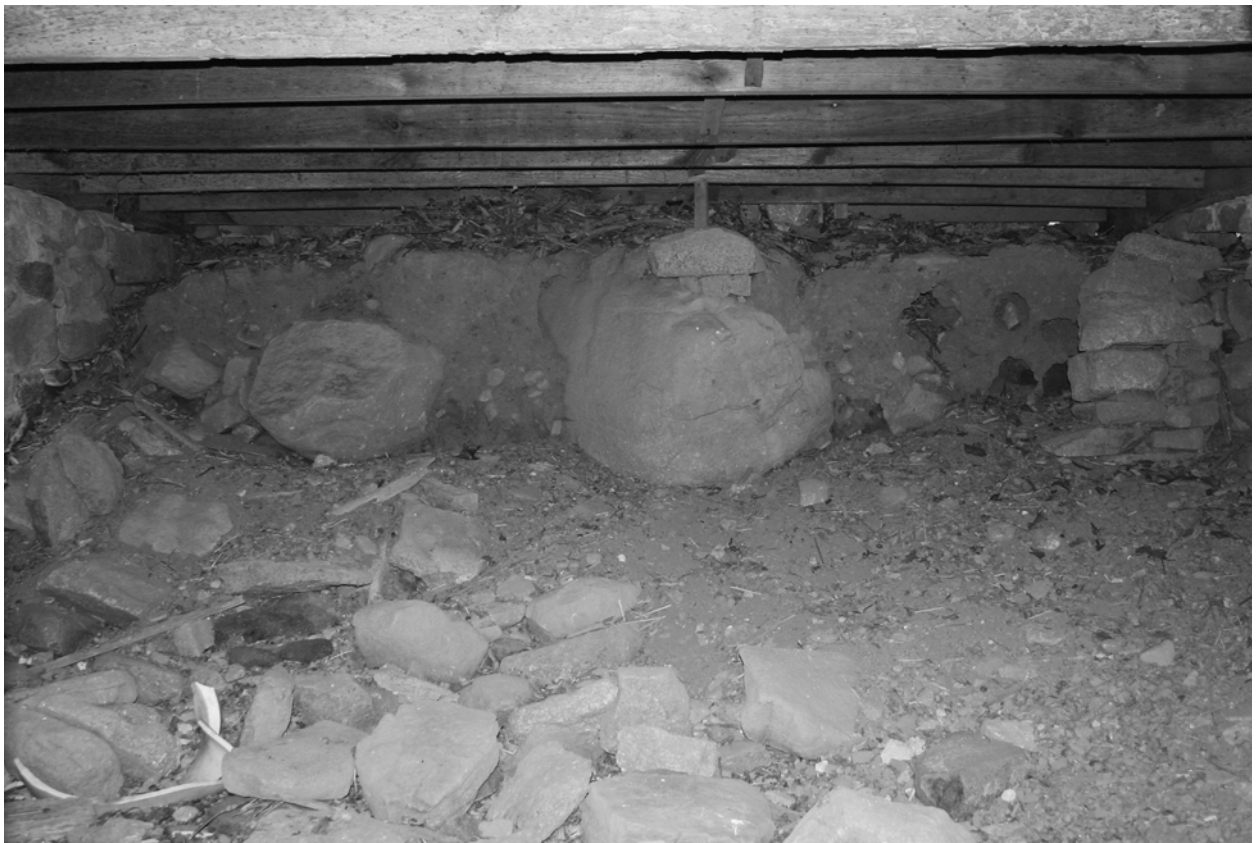
FIGURE 24. View north in cellar, with rocks from collapsed north wall in foreground. (NPS, 2005)

There appears to have been some excavation to create or enlarge the cellar, but it is not clear if the floor was ever level. It was probably never paved. The cellar extends about 13' under the log pen of the house and ends at some large boulders, some of which may form the foundation for the fireplace and chimney. The west, south, and east walls of the cellar are formed by the stone foundation under the log pen, and the north side of the cellar appears to have originally been closed by another stone wall that has now mostly collapsed.

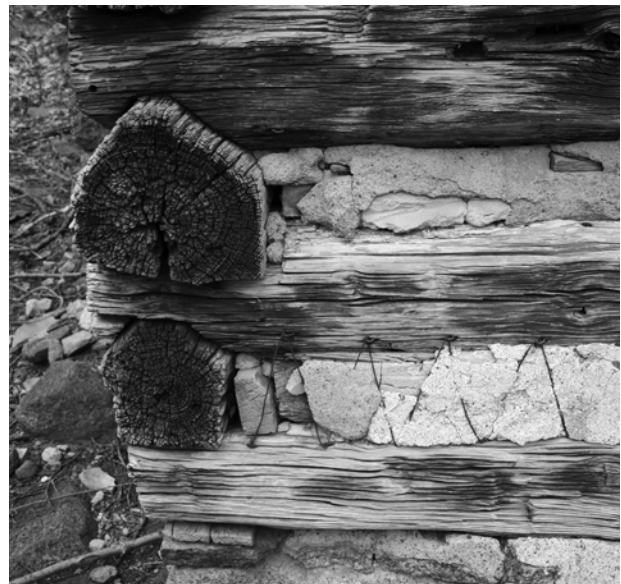
FIGURE 28. View of northwest corner of house, showing typical V-notch corners, all three generations of mortar chinking, and wire lath. (NPS, 2005)

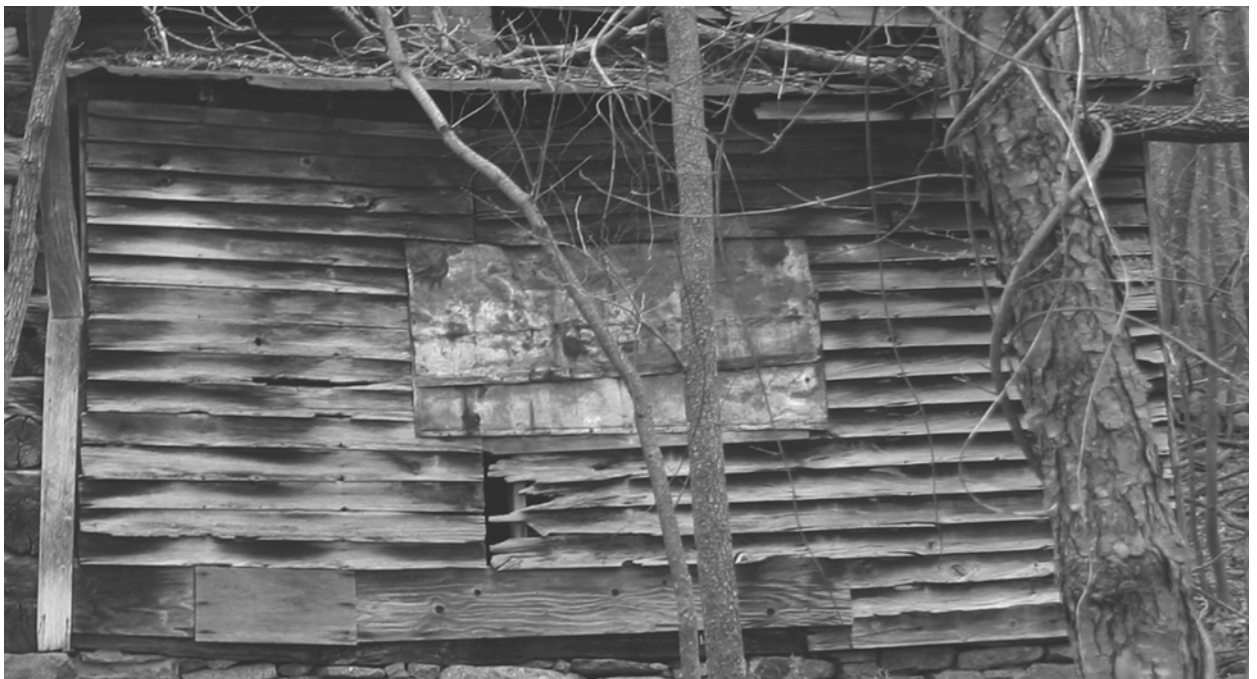
FIGURE 55. View of exterior of enclosed porch, showing two generations of siding. (NPS, 2005)

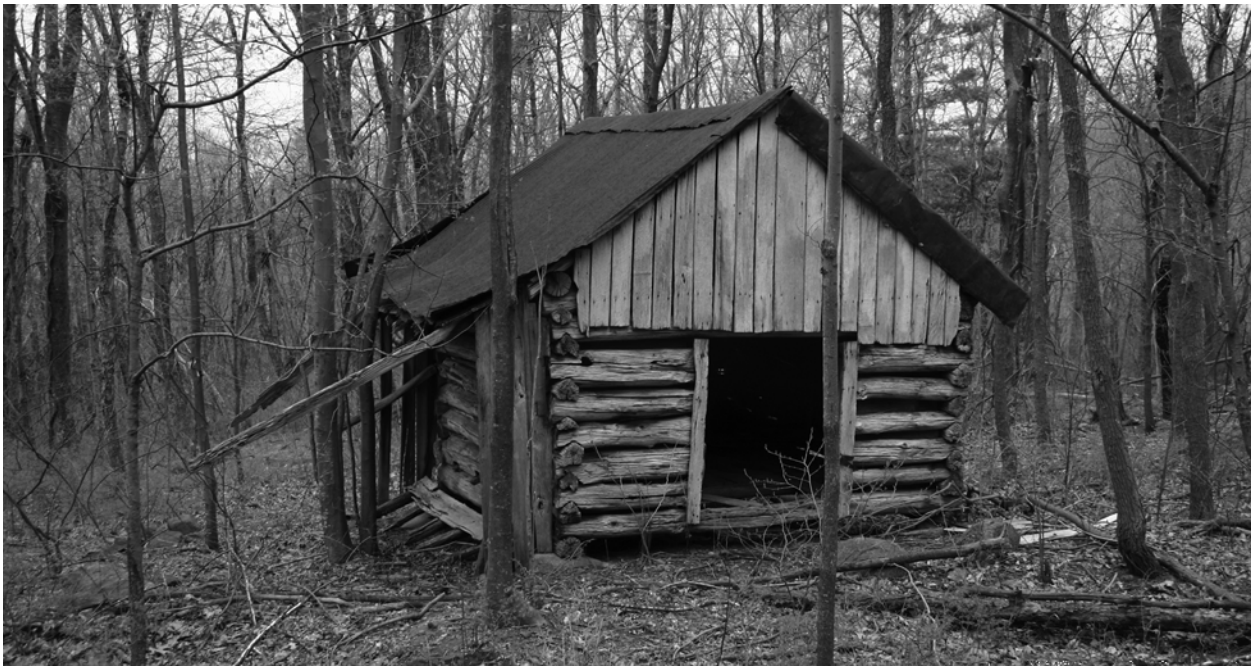
FIGURE 57. View of front and east side of meat house. (NPS, 2005)

The roof is covered with 24"-wide panels of corrugated steel, which are badly rusted but still without major leaks. The end gables are finished with vertically installed, circular-sawn boards, 6" to 8" wide and attached with wire nails. Floor boards are circular-sawn, 10"-14" wide, but several are missing or only loosely attached to the joists.

- Repair roofing on Meat House
- Reconstruct Meat House door
- Replace missing flooring in Meat House
- Reconstruct shed on Meat House
- Preserve stone foundations of ruins in place
- Reconstruct ruined buildings only if deemed necessary for interpretation

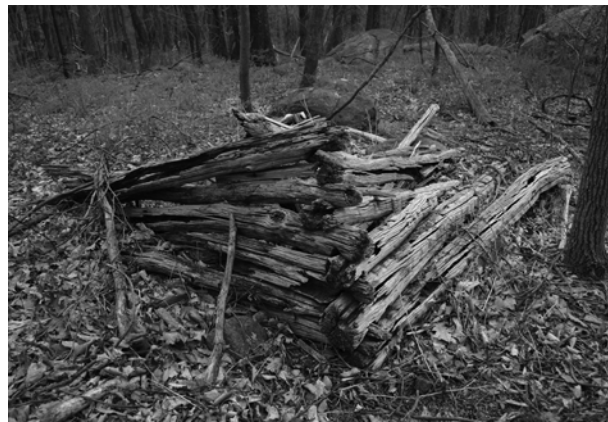
FIGURE 62. View southeast of chicken house ruin. (NPS, 2005)

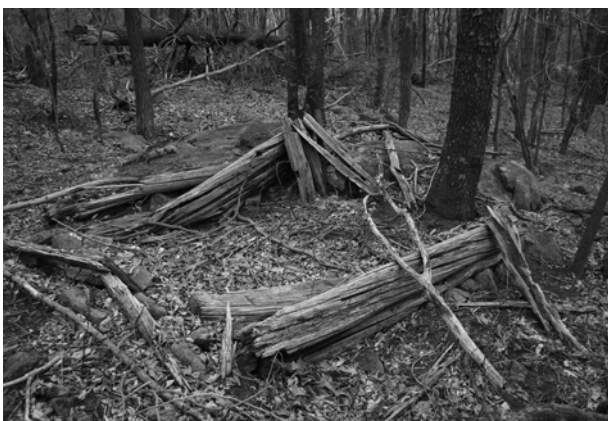
FIGURE 63. View southeast of ruins of hog house. (NPS, 2005)
