Cape Lookout National Seashore

Cape Lookout Life-Saving Station HISTORIC STRUCTURE REPORT

2004
Historic Structure Report
Life- Saving Station
Cape Lookout National Seashore
Cape Lookout Village
LCS#: 091835

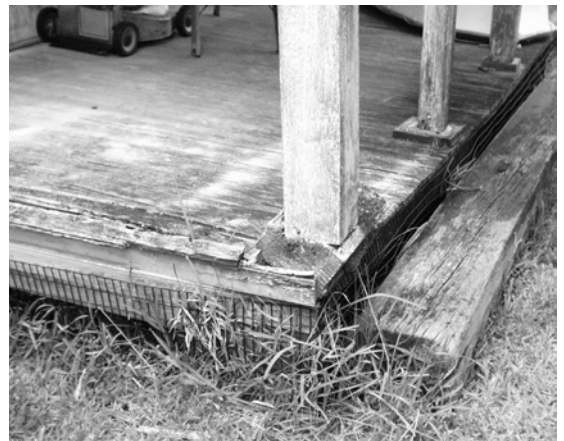
Figure 60 View of northeast corner of front porch, showing corner post seriously destabilized by deterioration of the sills at that location. (NPS-SERO-CRS, 2002)

- Inspect and repair sills and joists when building is relocated.
- Reconstruct floor system in Room 100.
- Repair porches.
- Reconstruct front porch stairs.
- Rescreen front porch if desired.
- Reconstruct missing balustrades at both porches.
