CANE RIVER CREOLE NATIONAL HISTORICAL PARK  
MAGNOLIA PLANTATION

~ GIN BARN ~  
HISTORIC STRUCTURE REPORT

**Cultural Resources, Southeast Region  
National Park Service**

**2004**

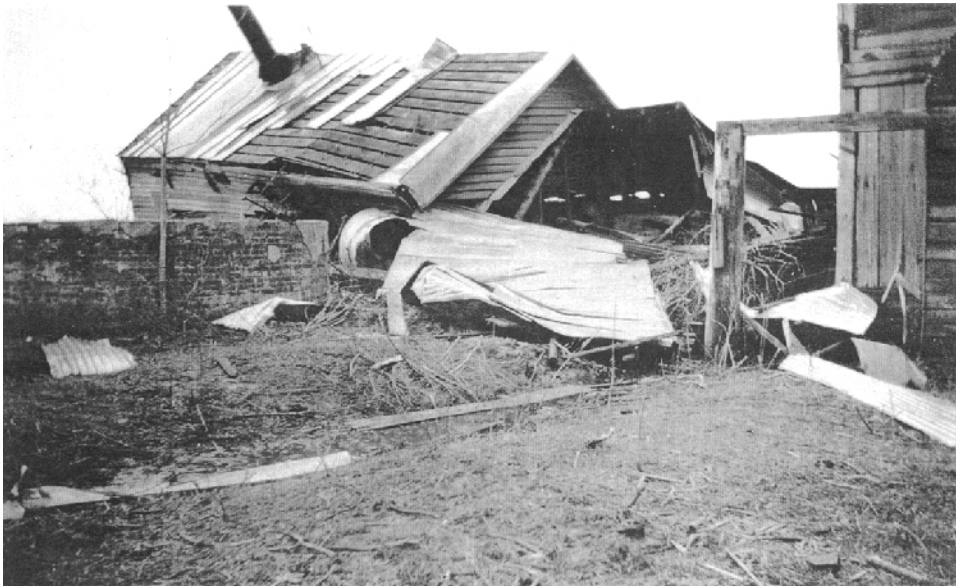
In 1939, the building was damaged by a tornado which also destroyed the adjacent engine house. In making repairs, the building was significantly altered. After the building was acquired by Museum Contents, Inc., in 1977, there were other repairs and alterations. Finally, the NPS replaced the entire roof system in 1996, significantly altering the building's historic character again.

**Figure 6** View of destroyed engine house at Gin Barn after 1939 tornado. The barn is partially visible at right. (Hertzog Family Collection, Magnolia Plantation)

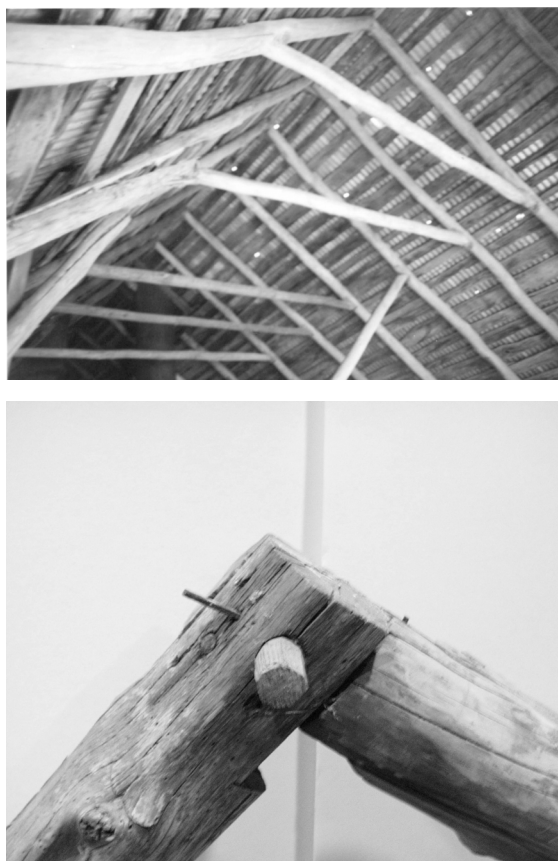
**Figure 8** Top, view of original roof prior to its removal in 1995; bottom, detail of salvaged rafters showing lapped and pegged ridge connection. (Upper image, Architectural Division, NPS-SERO, 1994; lower image, NPS-SERO-CRS, 2001)

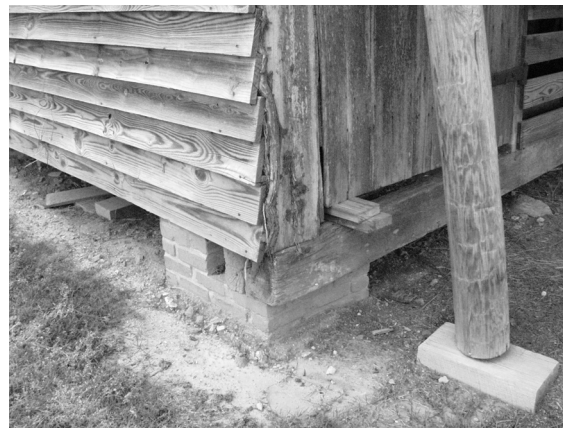
**Figure 18** View of northeast corner of barn, showing brick pier rebuilt in 1996. (NPS-SERO-CRS, 2001)

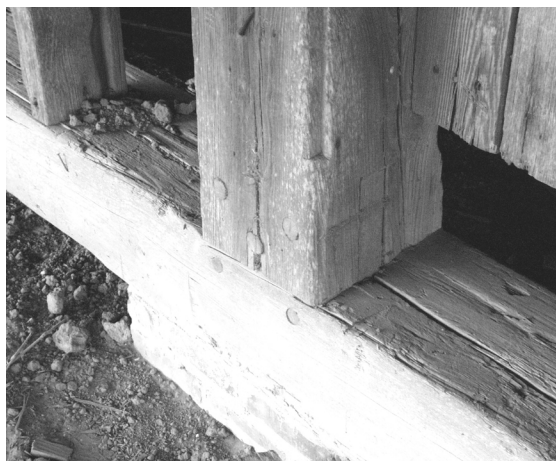
**Figure 19** View of typical sill and post with historic splined connection intact. (NPS-SERO-CRS, 2001)

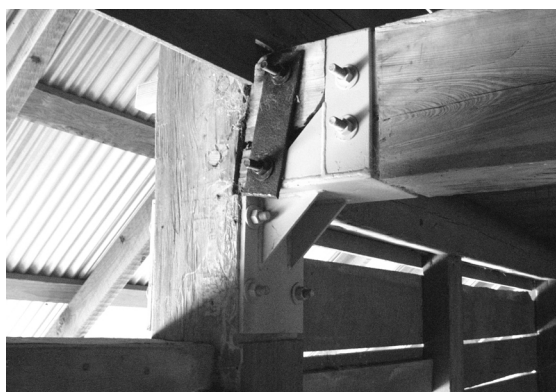
**Figure 20** View of typical beam/post connection, reinforced with metal brackets in 1996. (NPS-SERO-CRS, 2001)

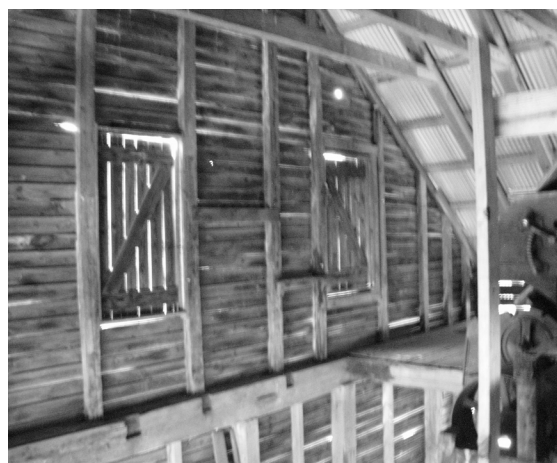
**Figure 26** View to southeast showing part of east end of barn; note empty mortises for framing around missing stairway. (NPS-SERO-CRS, 2001)

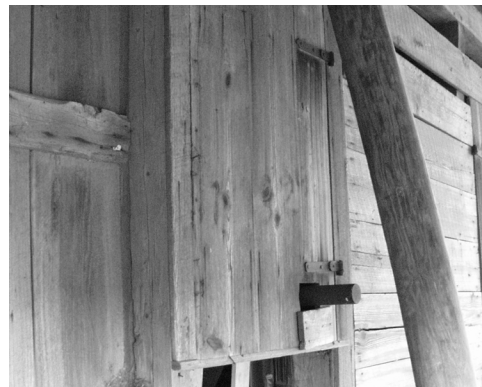
**Figure 36** View of window H, which originally had sash but was closed when existing gin machinery was installed c. 1900. (NPS-SERO-CRS, 2001)

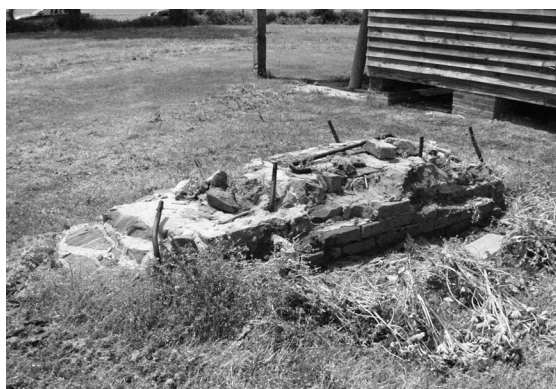
**Figure 37** View to southwest of brick foundation for steam engine. (NPS-SERO-CRS, 2001)

- Conduct complete archeological investigation around and within footprint of present building.
- Repair and repoint cistern; preserve engine base.
- Define appropriate routing of visitors around building.
- Keep perimeter of building free of vegetation.

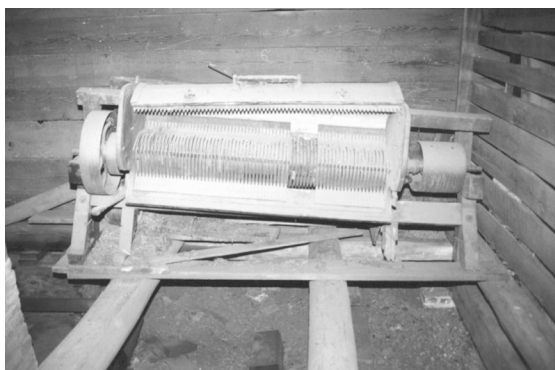
**Figure 39** View of disassembled Eagle gin stand in northwest corner of first floor. (NPS-SERO-CRS, 2001)

- Engage conservators and specialist in early twentieth century gins to guide conservation, re-assembly, and display of existing gin machinery, including the old Eagle gin.
- As part of overall exhibit design for the building, determine how much recreation of missing ductwork, drive shaft belts, and other missing components is necessary for good interpretation of the ginning and pressing operation.

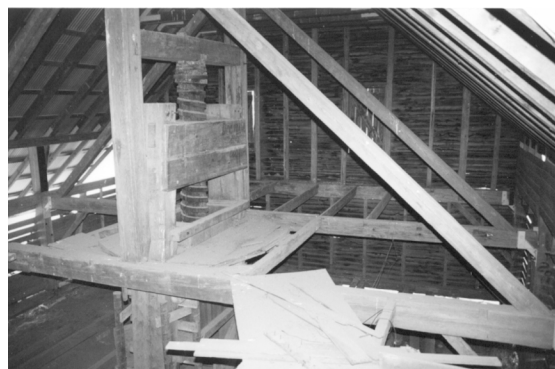
**Figure 45** View of top frame of wood-screw cotton press, which would have originally been surrounded by flooring. (NPS-SERO-CRS, 2001)

- Determine character and condition of press footing through archaeological investigation.
- Brace press with modern materials if necessary to insure structural stability.
- Avoid any disassembly or replacement of historic materials.
- Do not operate historic press; construct working scale model to demonstrate its operation to visitors.

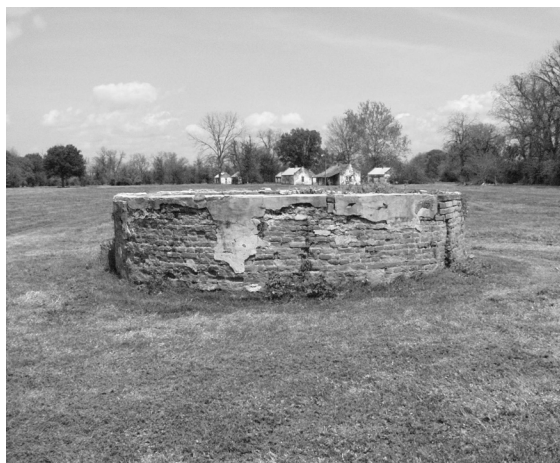
**Figure 47** View to northeast of cistern at Gin Barn. (NPS-SERO-CRS, 2001)
