Fort Pulaski National Monument
Quarantine Attendants' Quarters
Historic Structure Report

Historical Architecture, Cultural Resources Division

National Park Service

2004
Historic Structure Report
Quarantine Attendants' Residence
Fort Pulaski National Monument
Savannah, GA
LCS#: 12172

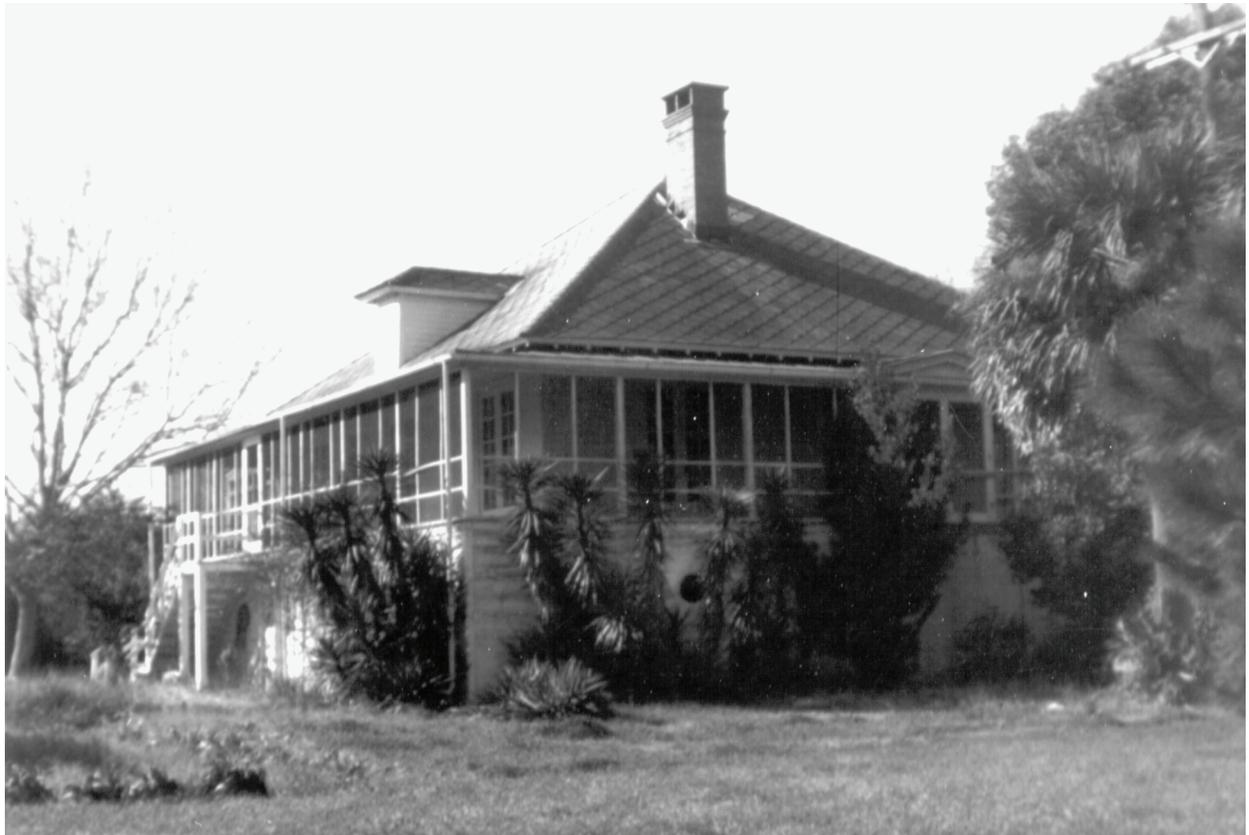
FIGURE 18. View of house from northeast, January 1960. Note unusual porthole windows and missing front stairs. (FOPU Coll.)

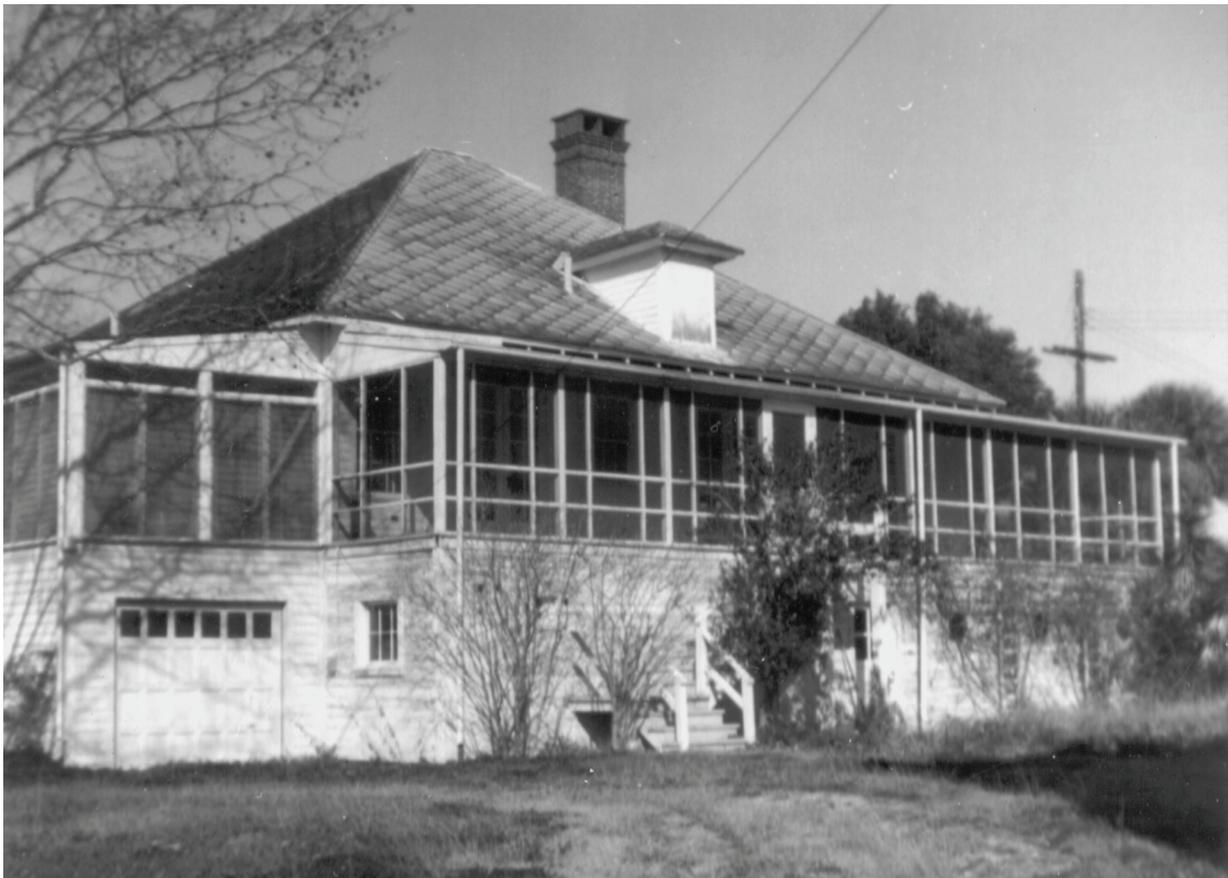
FIGURE 19. View of house from southeast, January 1960. Note jalousie windows installed in 1953 and the closed dormer window. (FOPU Coll.)

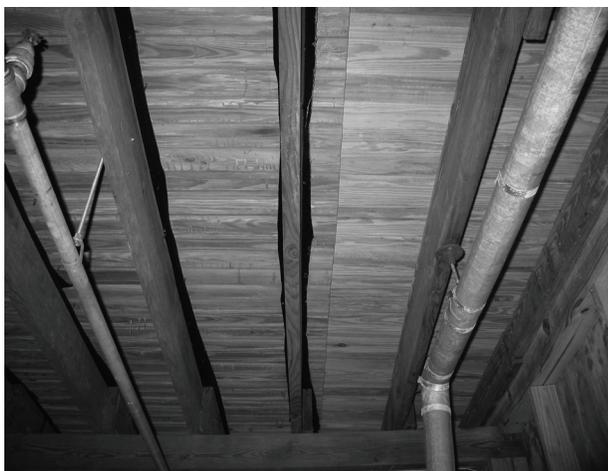
FIGURE 30. View of underside of east porch, with new flooring visible at right where older flooring has been removed. (NPS-SERO-CR, 2003)

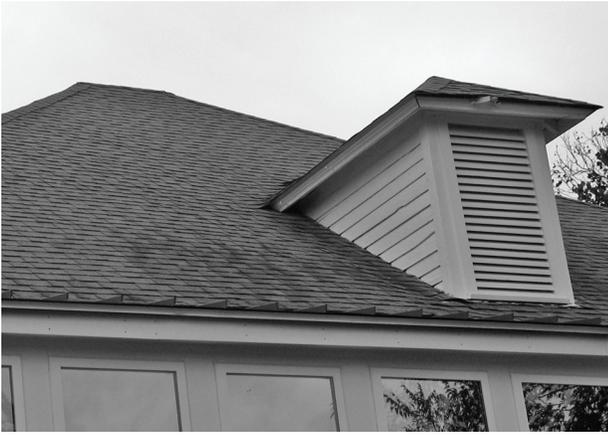
FIGURE 34. View east, showing original dormer. Note that modern fascia replaces original crown molding. (NPS-SERO-CR, 2003)

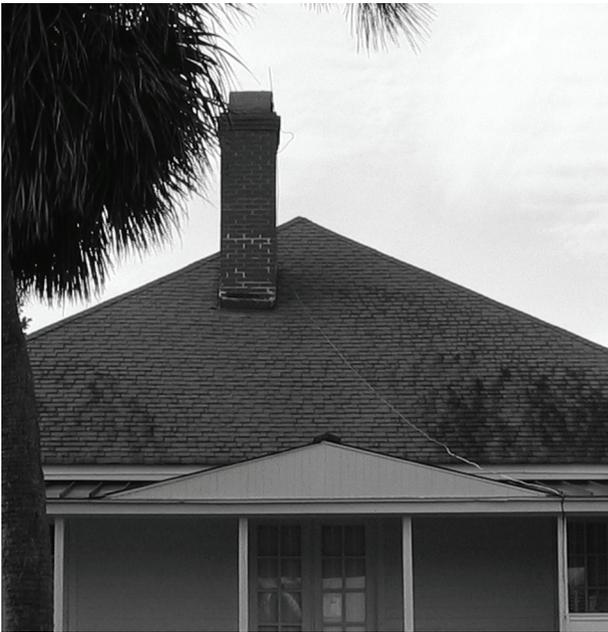
FIGURE 35. View south, showing modern gable over porch entrance. Note that modern fascia replaces original crown molding. (NPS-SERO-CR, 2003)

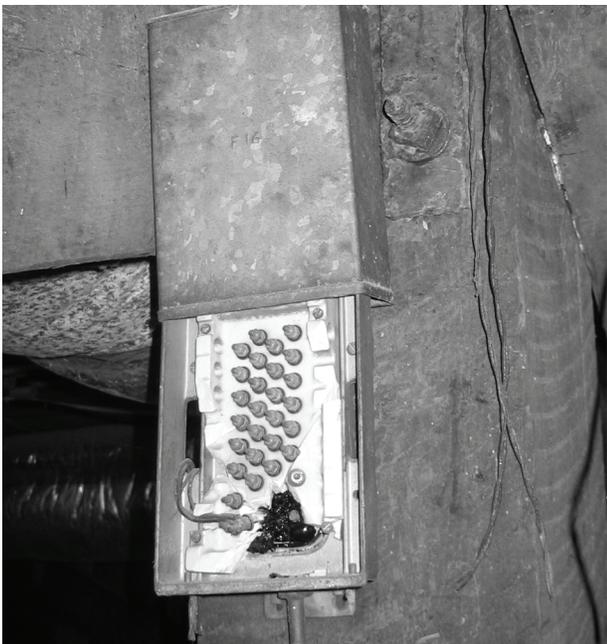
FIGURE 73. View of abandoned telephone junction box in basement. (NPS-SERO-CR, 2003)
