Ocmulgee National Monument

The Earth Lodge

# Historic Structure Report

Historic Architecture, Cultural Resources Division

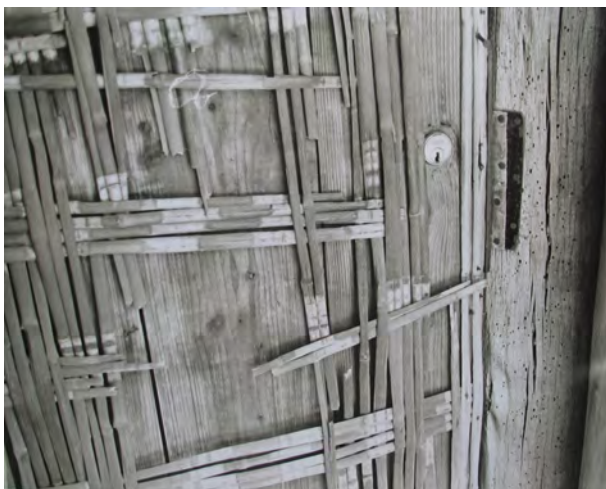
FIGURE 60. View of deteriorated door to Earth Lodge, c. 1965. (OCMU Coll.)

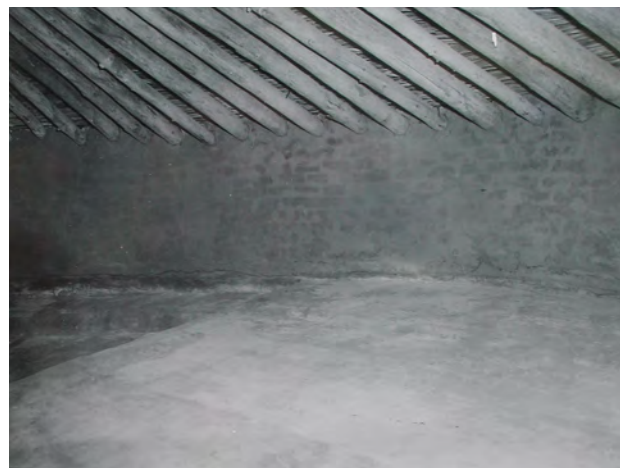
FIGURE 63. View west in Earth Lodge, showing discoloration of reconstructed wall due to uneven moisture penetration, 1965. (OCMU Coll.)

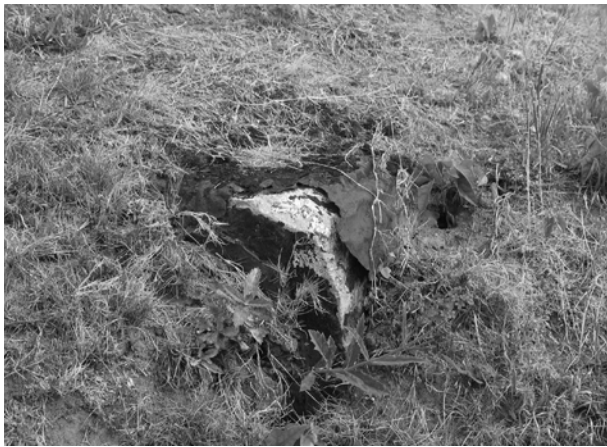
**FIGURE 90.** View of exposed corner of concrete shell for passageway, showing rusting corrugated metal that apparently covers the roof. (NPS-SERO-CR, 2004)

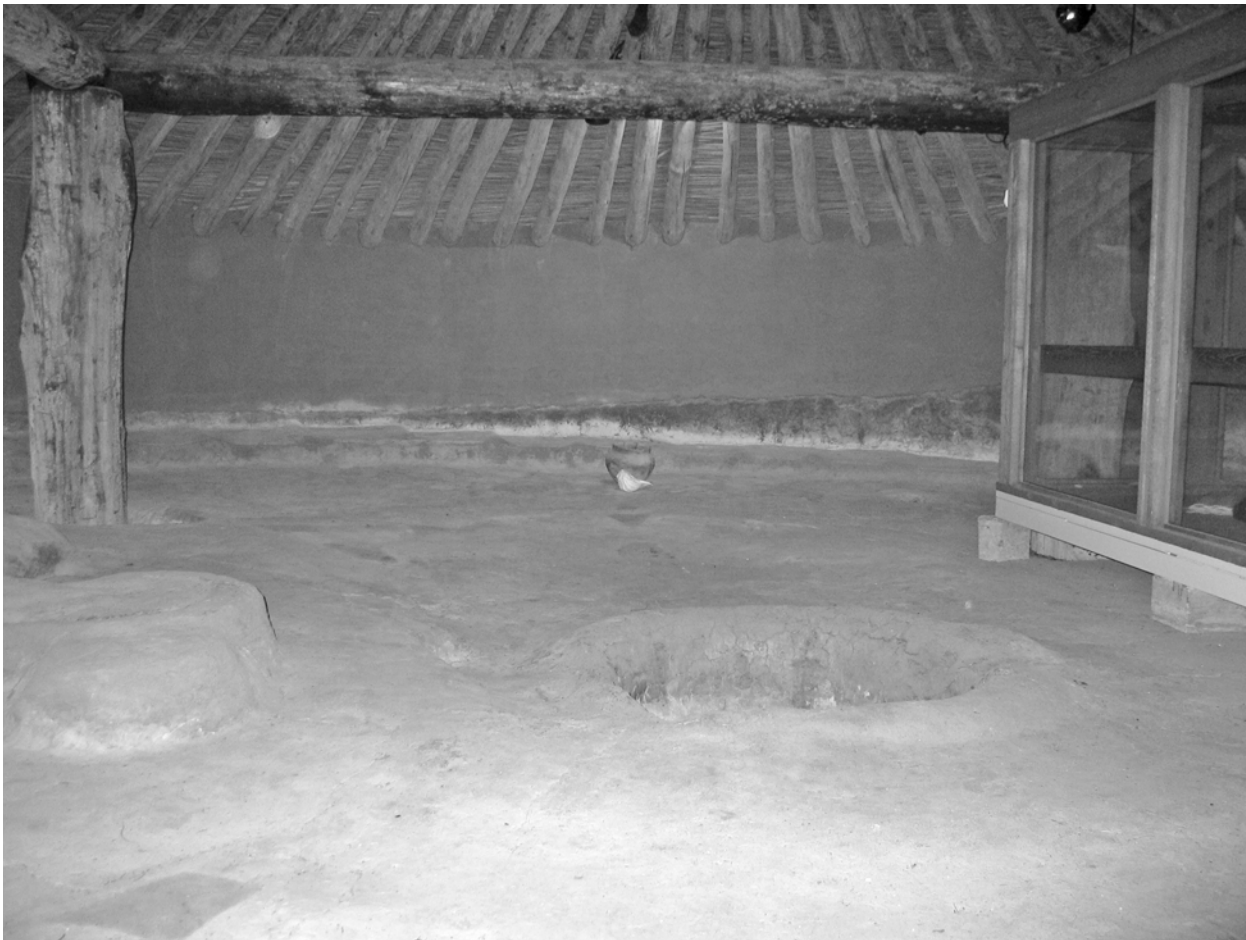
**FIGURE 94.** View northeast in Earth Lodge, with fire basin right of center and viewing platform at upper right. Reddish material around fire basin is clay that has fallen from the reconstructed roof. Dark trapezoidal shape at lower left marks location of one of the supports for the metal walkway installed in 1952 and removed in 1975. (NPS-SERO-CR, 2004)

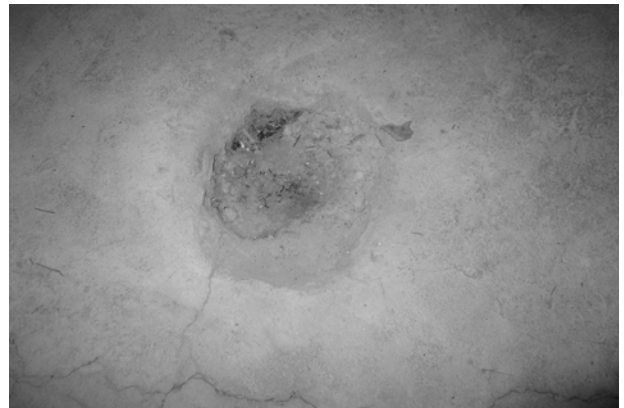
**FIGURE 103.** View of pre-Columbian posthole and charred wood on east side of lodge, one of the features interpreted as being indicative of pre-Columbian repairs to the structure. (NPS-SERO-CR, 2004)

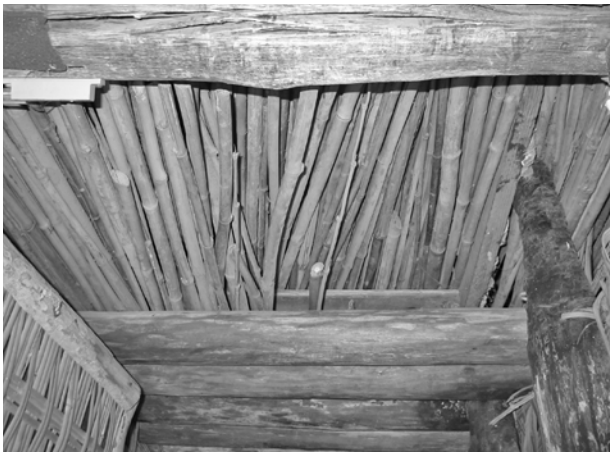
**FIGURE 104.** View of ceiling just inside entrance. Absence of cross logs is atypical. (NPS-SERO-CR, 2004)

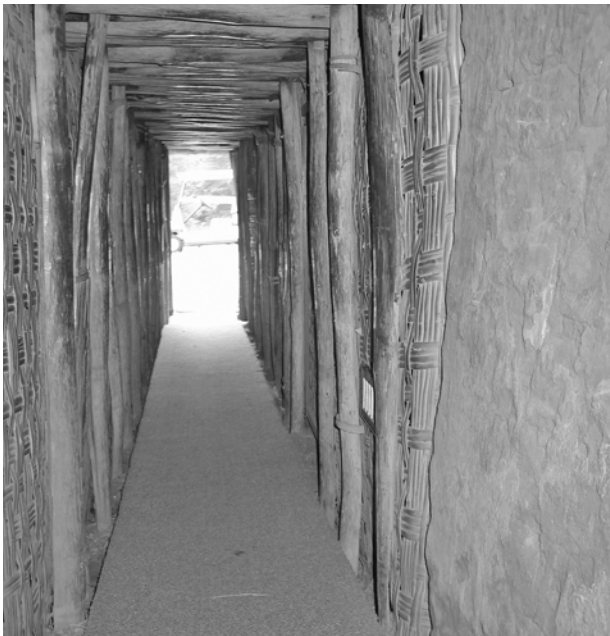
**FIGURE 105.** View of passageway, looking toward entrance. Note where visitors' hands (or heads) have worn the ceiling logs. (NPS-SERO-CR, 2004)
