Cape Lookout National Seashore

Washington Roberts House

Historic Structure Report

Developmental History

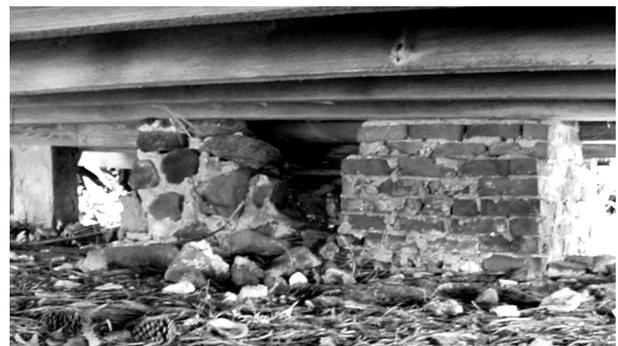
FIGURE 20. View of chimney base, with original stone chimney base at left, existing brick chimney at right. (NPS-SERO-CR, 2003)

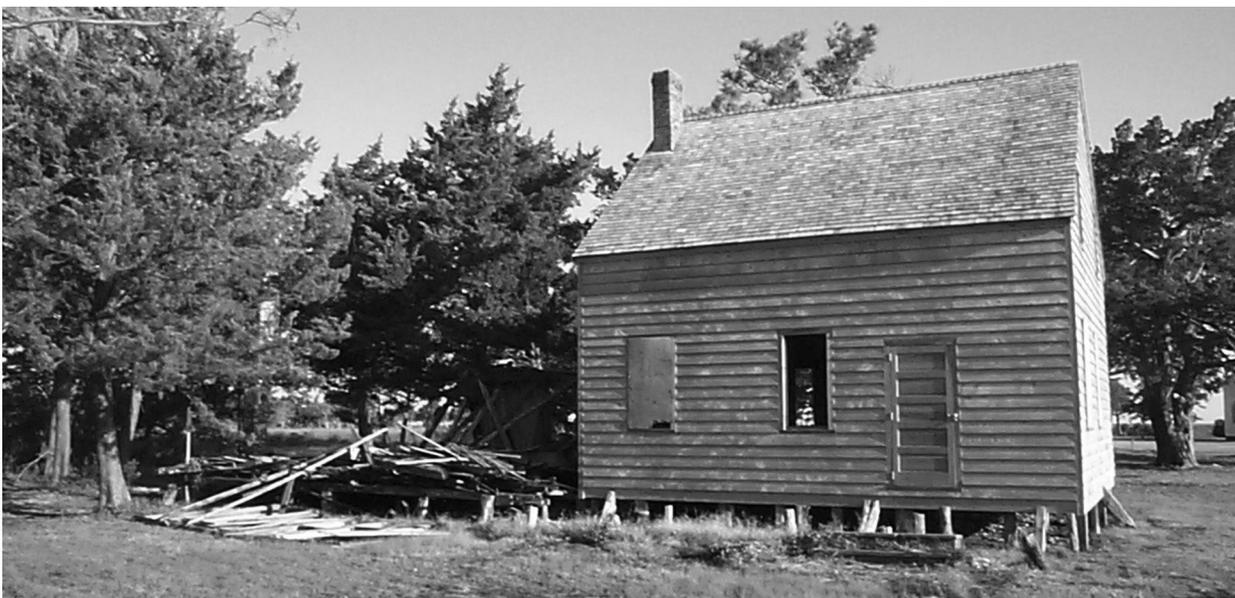
In September 2003, as this report was being completed, Hurricane Isabel swept the Outer Banks with the eye coming ashore around Drum Inlet a few miles south of Portsmouth. Although only a Category 2 hurricane, the storm's surge inundated the entire island and a number of structures sustained significant damage. The nearby George Dixon House was severely damaged, but little, if any, damage was sustained by the main block of the Roberts House. Unfortunately, wind and water completed destruction of the house's ruined kitchen wing. It was partially reconstructed in 2006.

FIGURE 29. View of Roberts House after exterior rehabilitation and after destruction of kitchen by Hurricane Isabel. (NPS-SERO-CR, 2003)

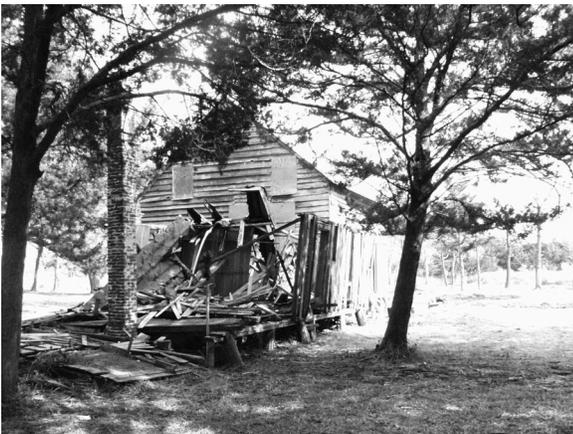
FIGURE 33. View to east, showing ruined kitchen wing in foreground. (NPS-SERO-CR, 2002)

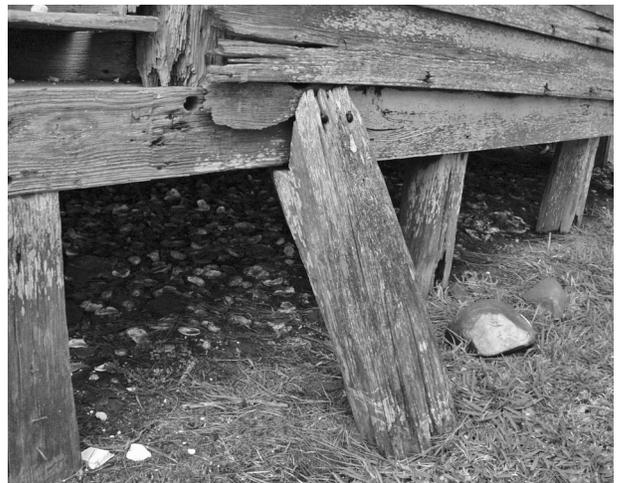
There are three braces each on the south, east, and north sides of the main block of the house, but there is only one brace on the west side. A 90-degree notch has been cut into the sloping face of that brace, probably to support the framing of the wooden, "coffin-like" cistern that once stood in that area. Part of the sill on the west side is covered by the kitchen wing and could not be examined, but with the original chimney in that location, additional bracing may have been unnecessary. Some of the original braces may have been replaced over the years, with the ones on the north and west

FIGURE 35. View of a typical "bird's-mouth" hurricane brace on north side of house. (NPS-SERO-CR, 2002)

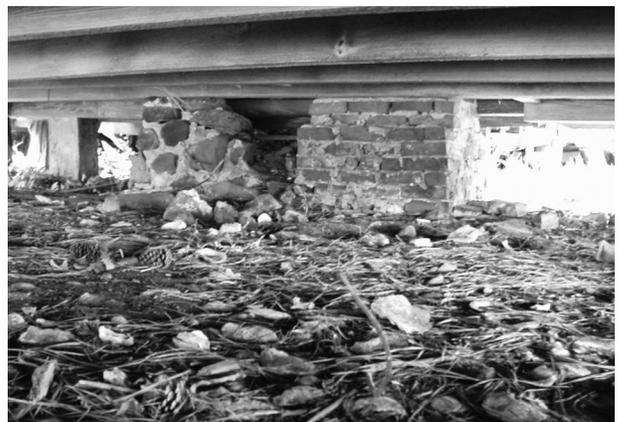
FIGURE 36. View of chimney foundation, with brick at right marking existing chimney base and stone at left marking larger extent of original chimney. (NPS-SERO-CR, 2002)

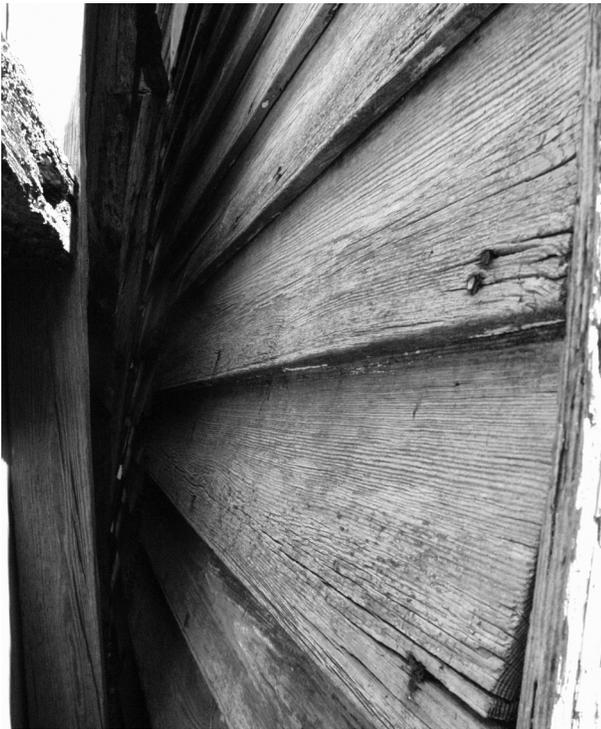
All of the siding is badly eroded, and the beading of the siding on the main block of the house has disappeared from all but a few of the boards that were protected by the kitchen addition. Nearly all of the siding on the north, east, and west sides of the

FIGURE 52. View of original beaded siding remaining on north west side of main block at kitchen addition. All of this siding was replaced in 2003. (NPS-SERO-CR, 2002)

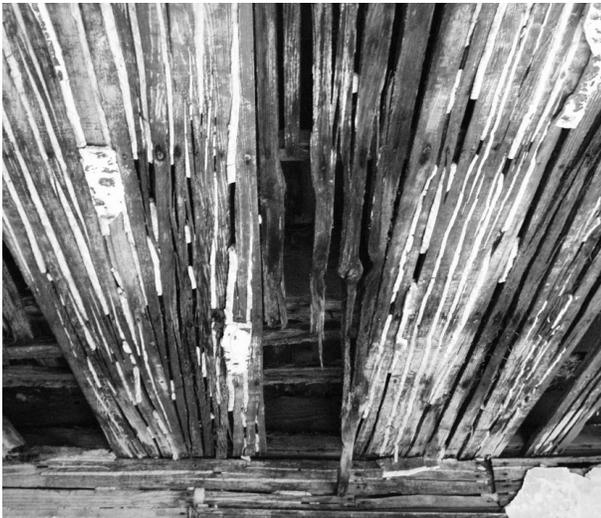
FIGURE 56. View of ceiling in Room 101, showing typical split-board plaster lath. (NPS-SERO-CR, 2002)

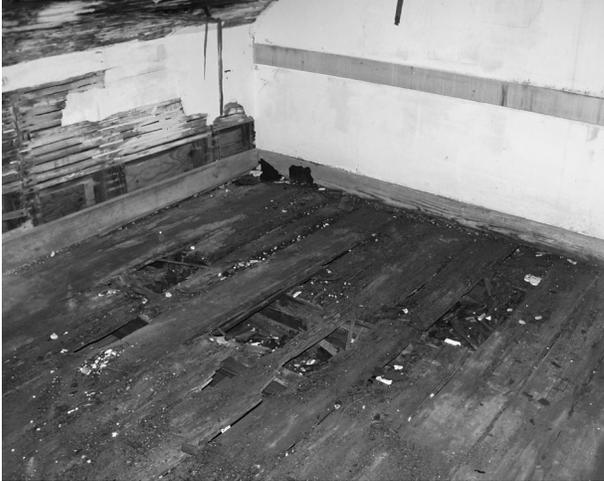
FIGURE 73. View of damaged floor in Room 203. (NPS-SERO-CR, 2002)

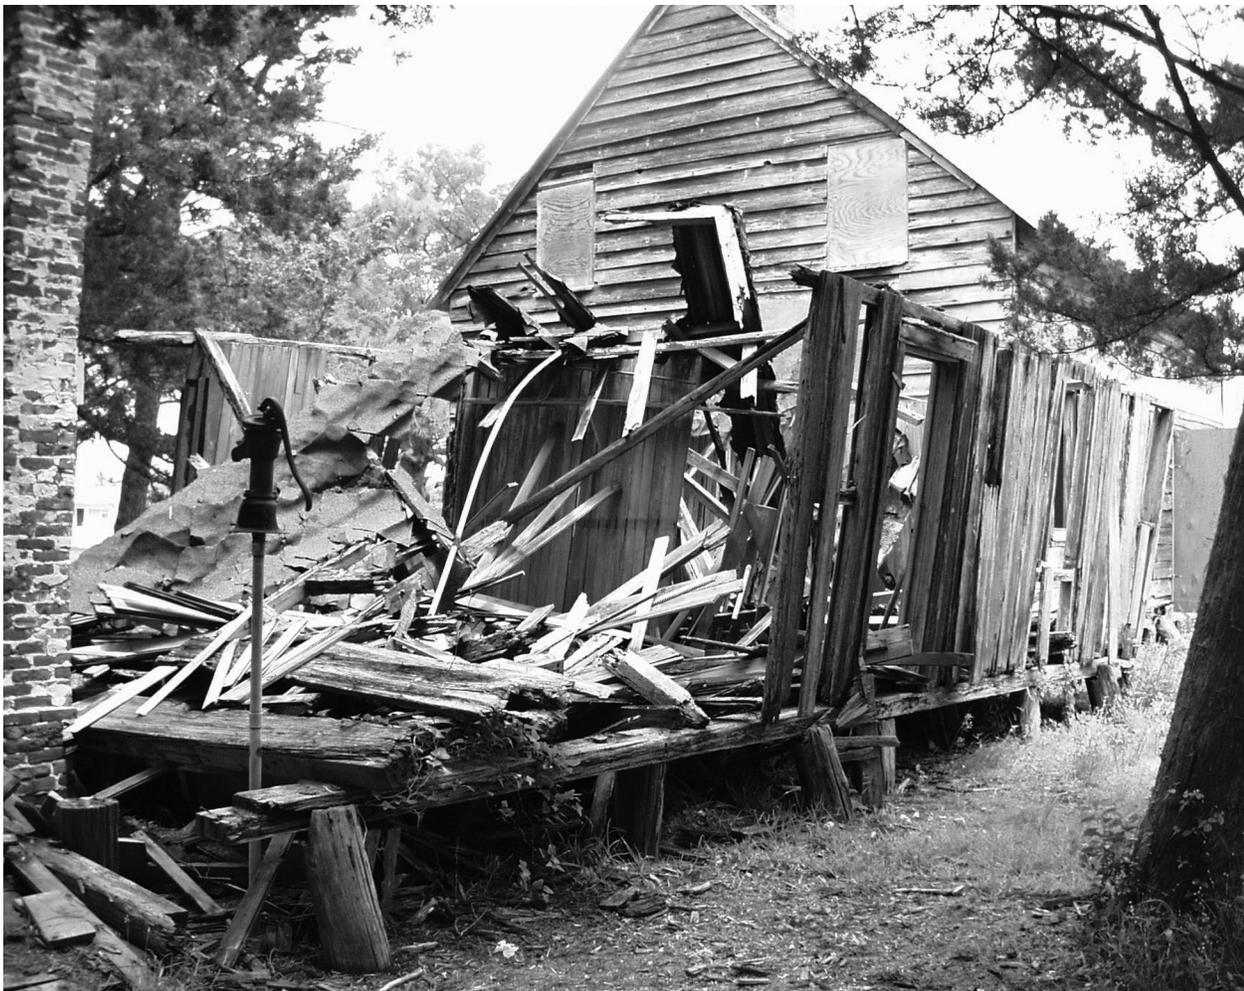
FIGURE 75. View east of kitchen wing, showing remains of Rooms 105 and 106. (NPS-SERO-CR, 2002)
