CANE RIVER CREOLE NATIONAL HISTORICAL PARK
OAKLAND PLANTATION

~ PRUD'HOMME'S STORE ~
HISTORIC STRUCTURE REPORT

2004
Historic Structure Report
Prud'homme's Store
Cane River National Historical Park
Natchitoches Parish, Louisiana
LCS#: 91617

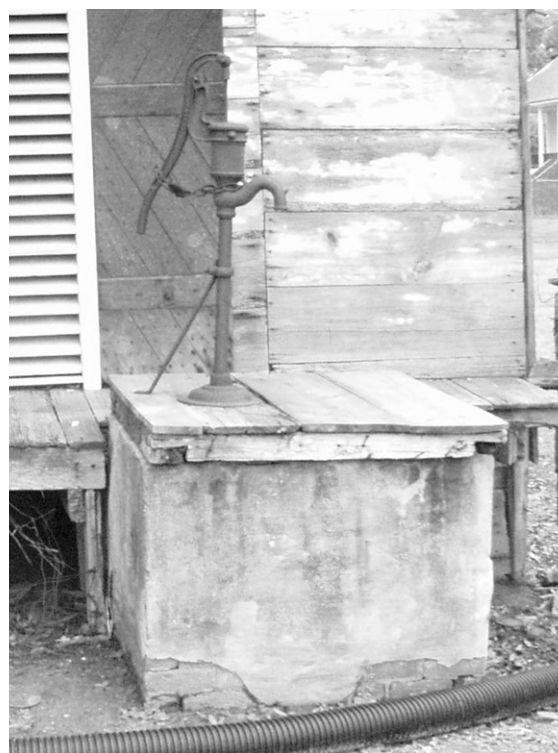
Cistern: The cistern is approximately 40½ inches square, constructed of brick, and rises 29 to 32 inches above grade. The exterior faces are stuccoed and there is a small overflow (approximately 8" by 7" and covered by an iron grill) near the base on the north side. An iron pump, which is historic but whose date of installation has not been established, is still in place on top of the cistern's wooden cover. "Mast. Foos & Co., Springfield, O., 191 [sic]" is imprinted on the iron body of the pump.

Figure 15 Cistern at northeast corner of Store, built by J. C. Keyser in 1877. (NPS-SERO-CRS, 2001)

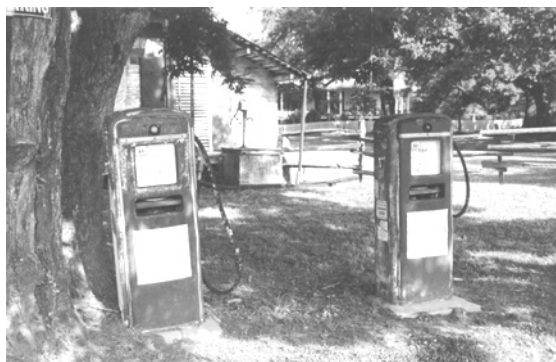
Figure 16 Gas pumps, installed c. 1950 in front of the store. (NPS-SERO-CRS, 2000)

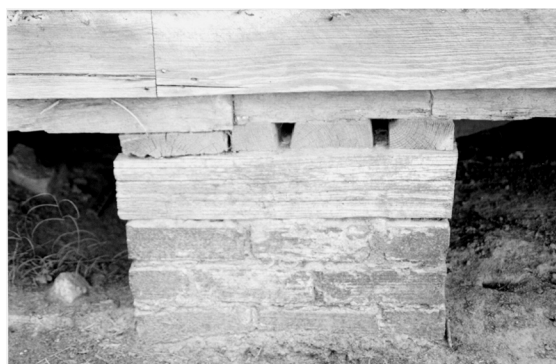
Figure 17 Typical brick foundation pier with original wood blocking. (NPS-SERO-CRS, 2001)

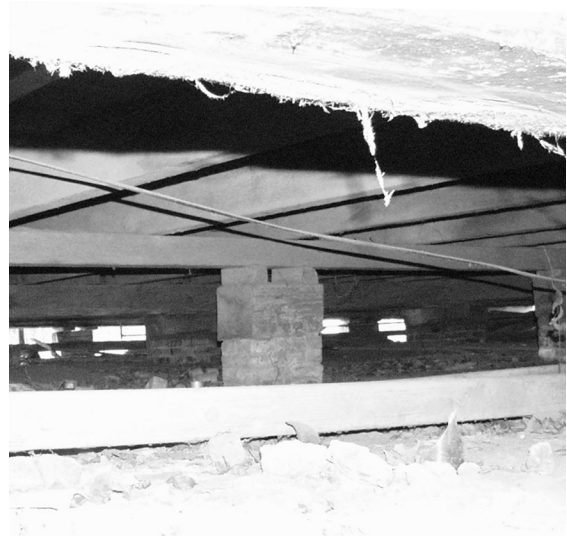
Figure 18 View of floor framing beneath original building. (NPS-SERO-CRS, 2001)

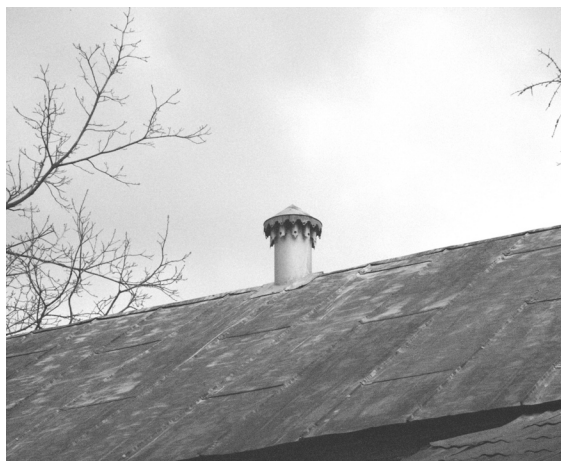
shingles, presumably cypress, laid in typical fashion over rough-sawn, widely-spaced roof lath (i.e., sheathing). The original wood-shingled roofs have now been replaced with standing-seam, galvanized roofing, except over 003 and 004, which are both covered with corrugated sheet metal roofing. The original wood-shingled roofing remains intact over 003.

Figure 20 View of south shed of roof with original ventilator (c. 1900). (NPS-SERO-CRS, 2001)

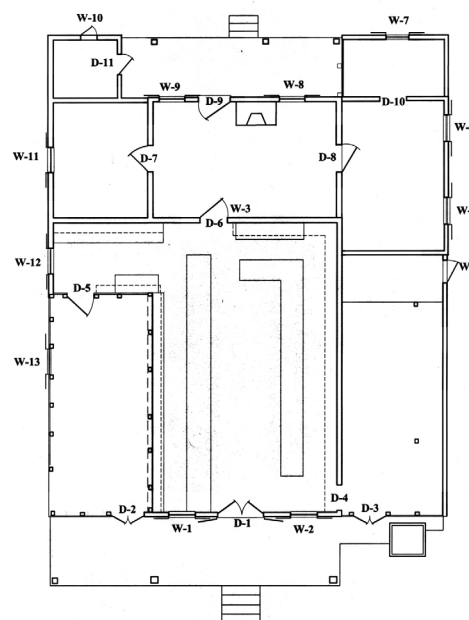
D- 9: Opening is 3'- 0" by 7'- 6"; interior door is 7'- 0" with the gap at the top filled by leather; nine lights over two vertical panels; moldings similar to front doors; some broken lights have been repaired using multiple pieces of glass. The existing metal latch on the door may not be original, given what appears to be the "ghost" of an earlier latch; the existing latch (at right) is similar to gravity latches found in the Big House and was probably salvaged from another building. A thin metal rod is mounted on the hinge side of the door by two small brackets on the interior face of the door and one on the interior casing. The mechanism appears to

Figure 21 Doors and Windows, Prud'homme's Store. (NPS-SERO-CRS, 2001)

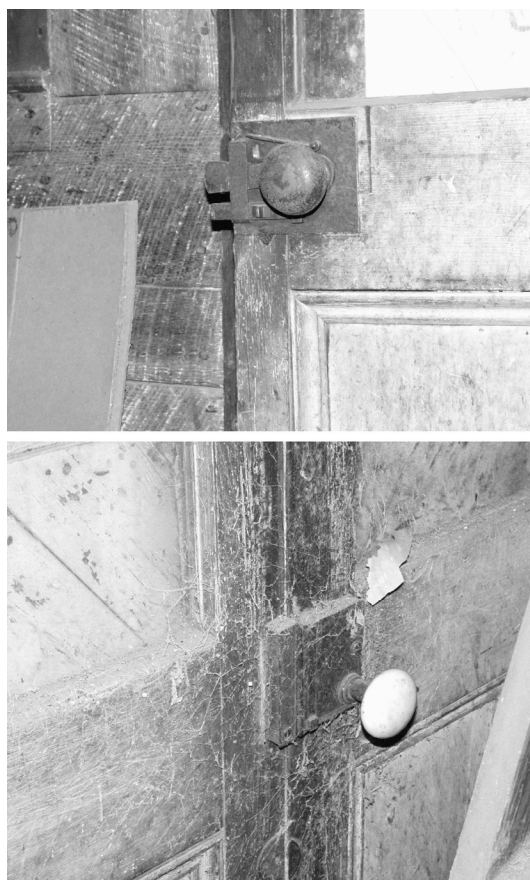
Figure 23 Top, view of spring latch at back door; bottom, view of rim lock with porcelain knob at front door. (NPS-SERO-CRS, 2001)

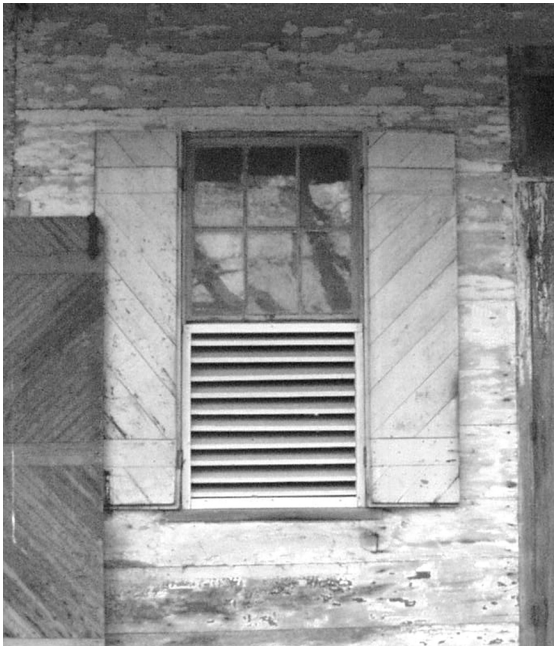
W- 2: Sash is 2'- 8" by 5'- 6", 6/6; shutters and other details like W- 1.

Figure 24 View of front window, W-2, with temporary ventilator. (NPS-SERO-CRS, 2001)

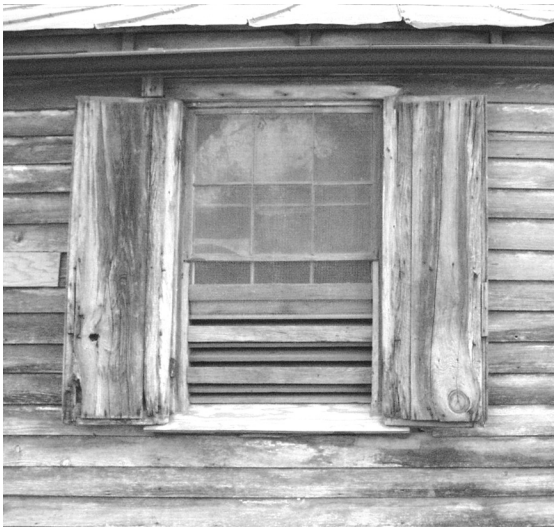
Figure 25 View of window W-12 in south addition. (NPS-SERO-CRS, 2001)

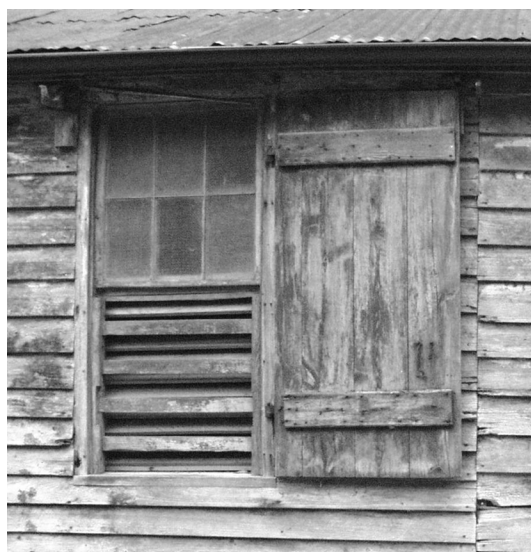
Figure 26 View of W-6 on north side of building. (NPS-SERO-CRS, 2001)

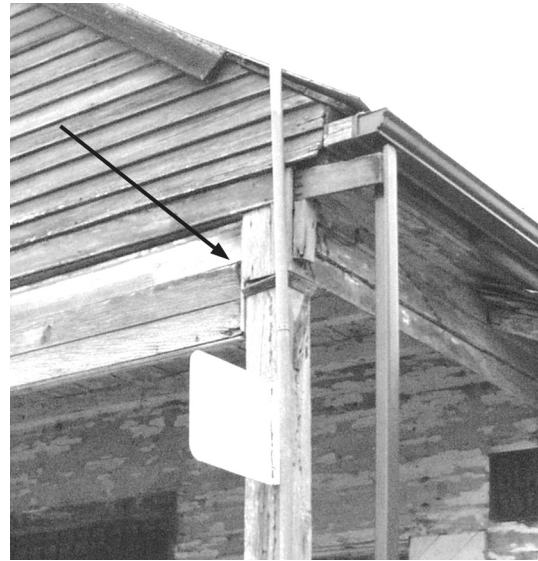
The 7" by 7" posts that support each corner of the gabled portion of the porch appear to be original. Some of the original drip cap and trim at the top of each post is missing. A plain 4" by

Figure 27 View of northeast corner of building, showing mixture of exterior finishes. Arrow notes original detail of post top. (NPS-SERO-CRS, 2001)

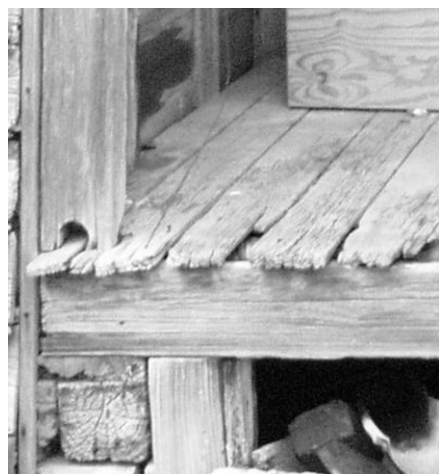
Figure 30 View of original column base on back porch. (NPS-SERO-CRS, 2001)

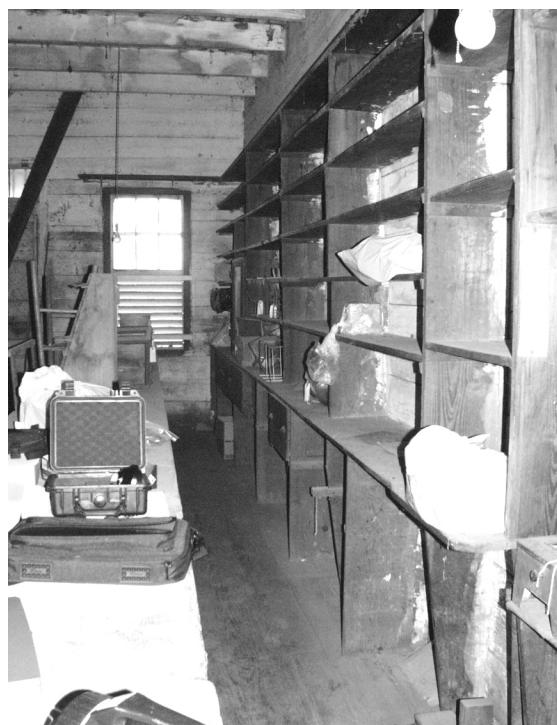
Figure 32 View of shelving for dry goods on south wall. (NPS-SERO-CRS, 2001)

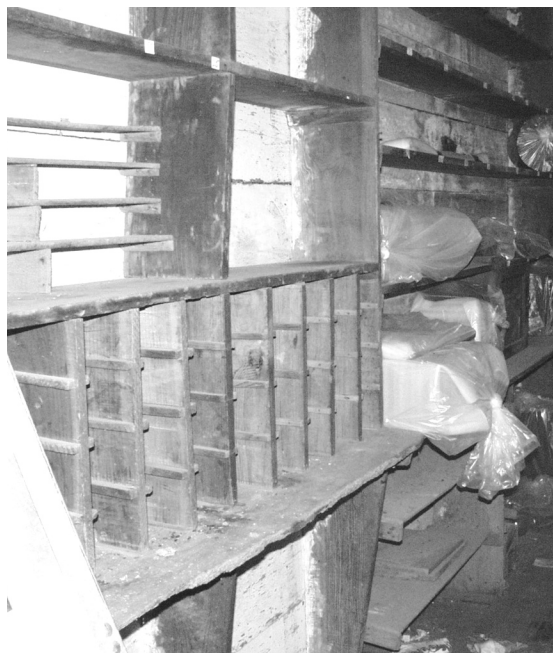
The range of shelving on the north wall is of similar construction to that on the south wall, but paint "ghosts" and relocated cleats indicate that the north range has undergone more alterations. At its east end, construction of the door to the north shed (003) necessitated removal of

Figure 33 View of frame on north wall; missing drawers held nuts, bolts, and other hardware. (NPS-SERO-CRS, 2001)

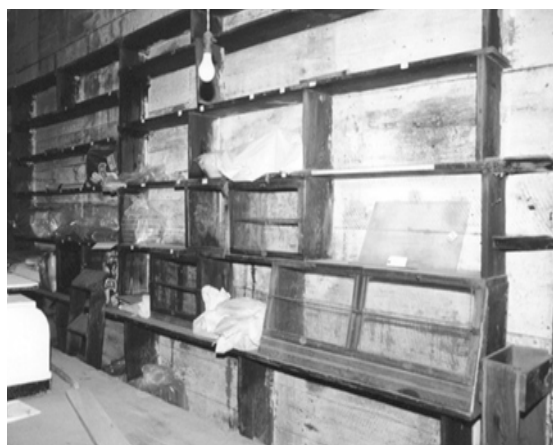
Figure 34 View of north wall, showing shelves for groceries and covered bins for bread (NPS-SERO-CRS, 2001)

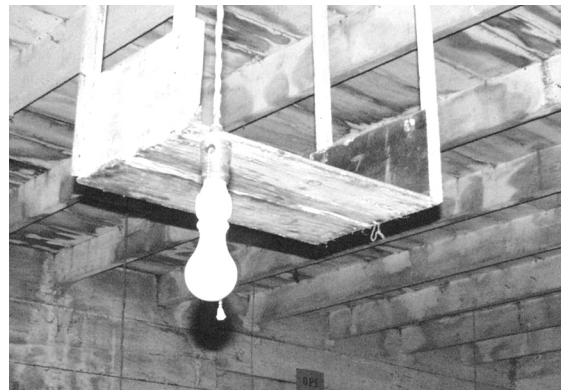
Figure 36 View of ceiling-hung rack used for match storage. (NPS-SERO-CRS, 2001)
