Carl Sandburg Home National Historic Site

The Swedish House  
Historic Structure Report

September 2005

Historical Architecture, Cultural Resources Division

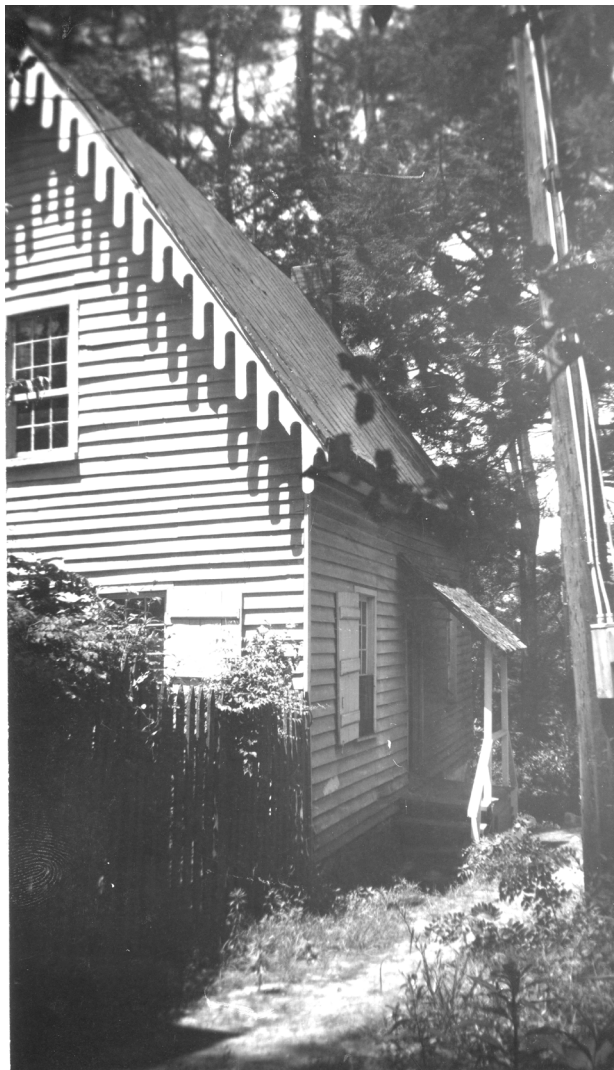
FIGURE 25. Earliest image of Swedish House, 1946, with early wooden steps and porch still intact. (CARL3000/17/1P Coll.)

The photograph of the house in 1946 (Figure 26) shows a standing seam metal roof covering, which might have been the original. Historic photographs show that roof covering having been replaced prior

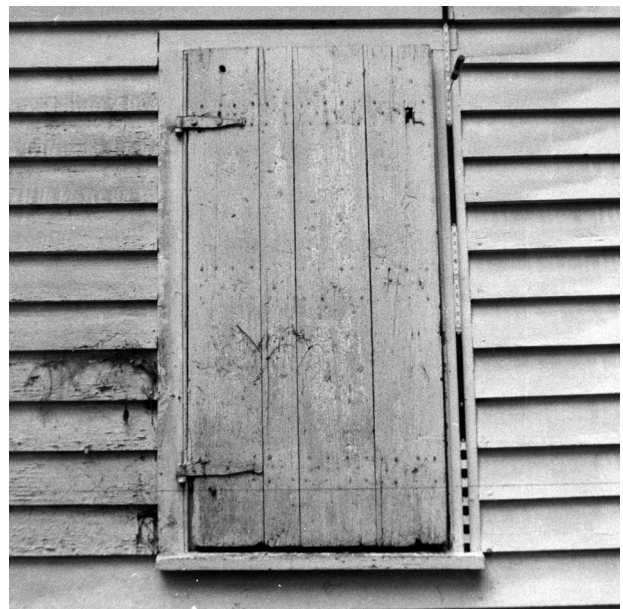
FIGURE 32. View of typical shutter, c. 1970. (CARL5026/2/3P)

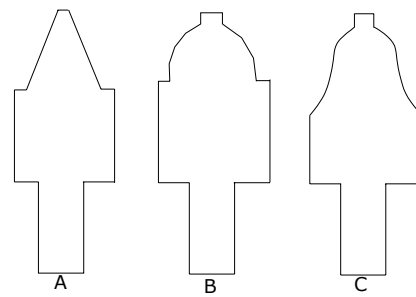
FIGURE 34. Muntin profiles in Swedish House, with Type A representing muntins in original sash and B and C muntins in later replacement sash.

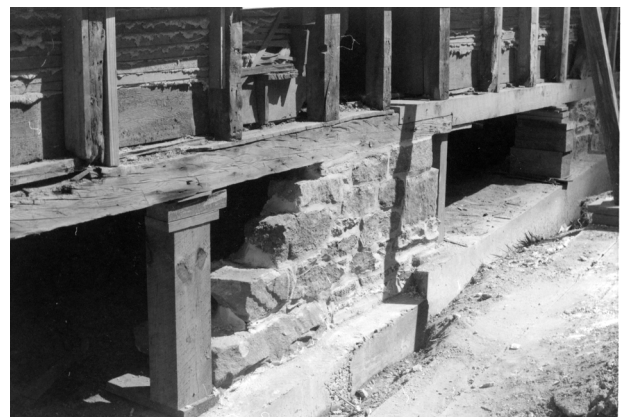
FIGURE 36. View of south foundation during repairs, 1977. (CARL4008/03/25P)

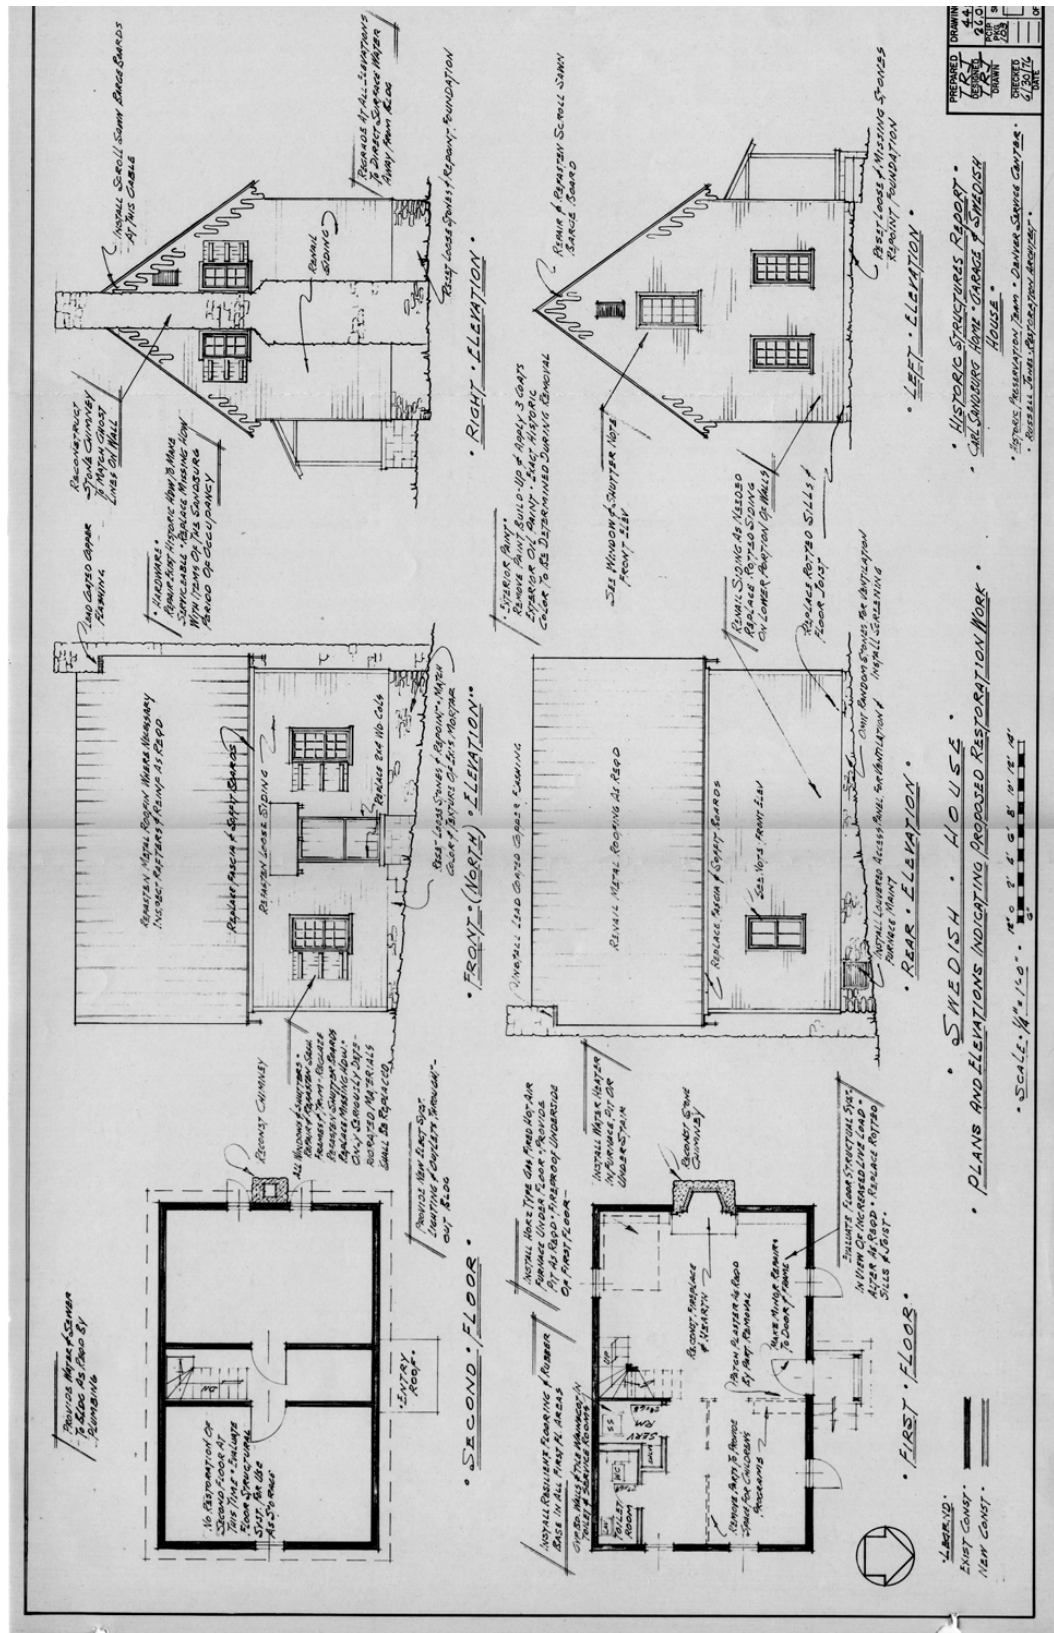
**FIGURE 38.** "Plans and Elevations Indicating Proposed Restoration Work," from Russell Jones' historic structure report on the Swedish House, 1976.

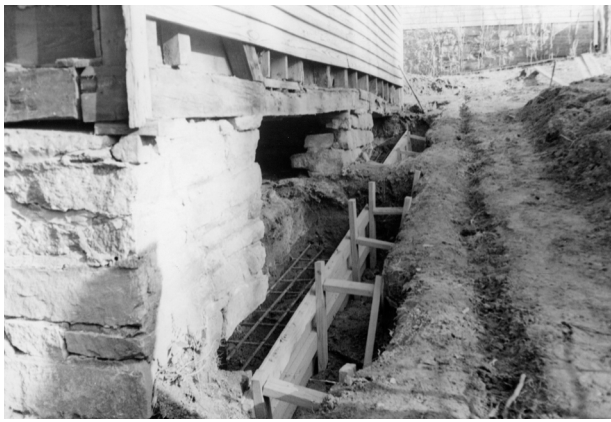
FIGURE 39. View of new footings, 1977. (CARL4008/03/15P)

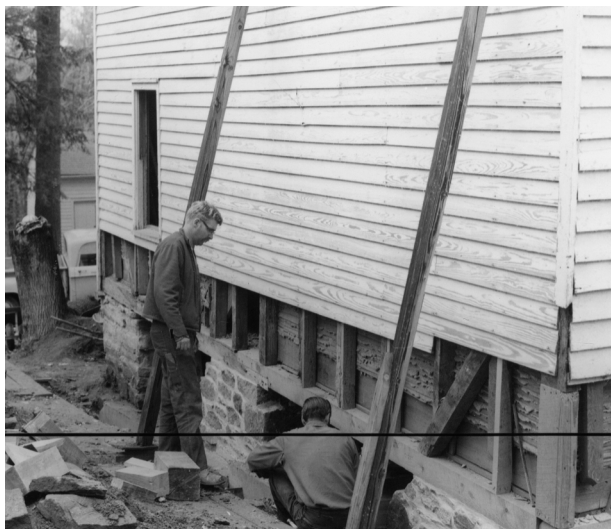
FIGURE 40. Glenn Barnwell, former maintenance employee, standing, inspecting foundation repairs at rear of house, 1977. (CARL4008/03/27P)

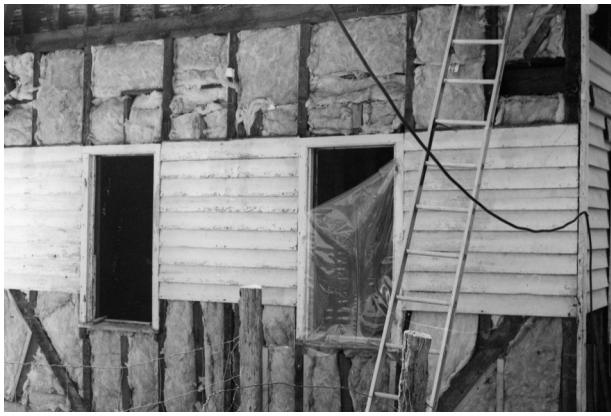
FIGURE 44. View of east end of house after installation of insulation. (CARL4008/03/39P)

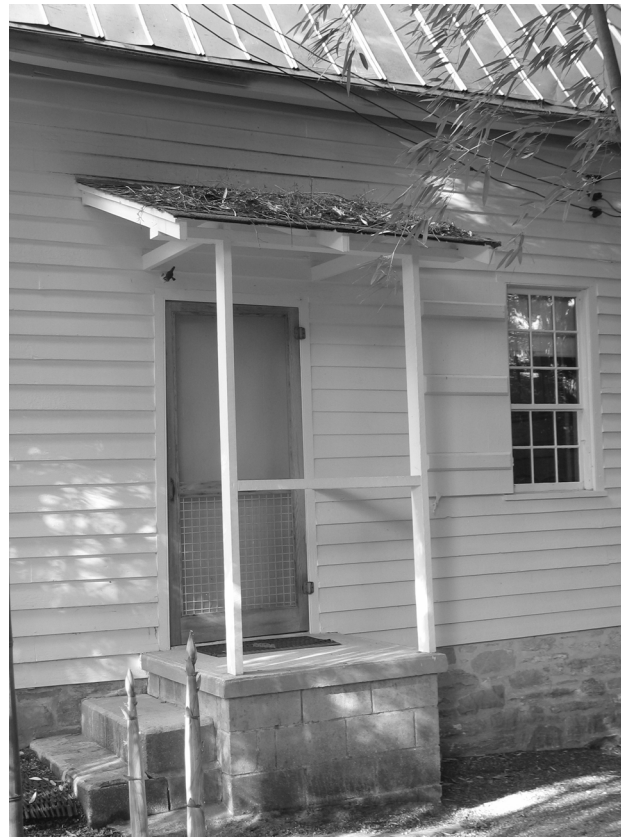
FIGURE 54. View of twentieth-century stoop and shed roof at front door. (T. Jones, NPS, 2004)

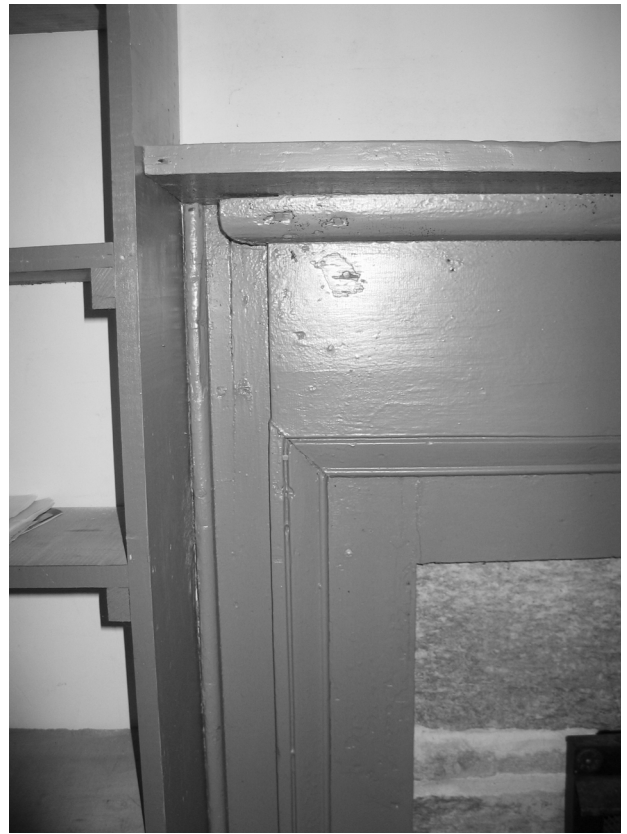
FIGURE 59. Detail view of mantel in Room 100. (T. Jones, NPS, 2004)

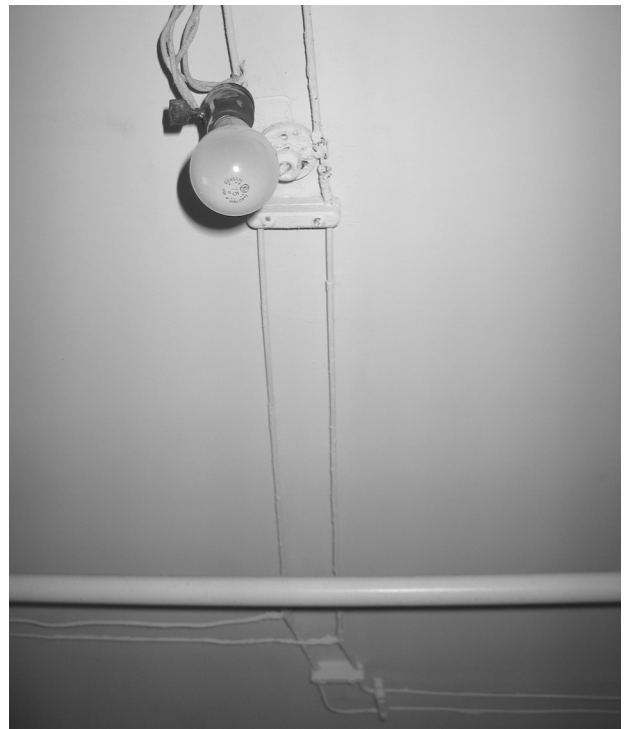
FIGURE 69. View of a portion of the knob-and-tube wiring system, which is no longer active. (T. Jones, NPS, 2004)
