Cape Lookout National Seashore  
O'BOYLE - BRYANT HOUSE  
**HISTORIC STRUCTURE  
REPORT**

**Historical Architecture, Cultural Resources Division  
Southeast Regional Office  
National Park Service**

**2004**

2004  
Historic Structure Report  
O'Boyle- Bryant House  
CAPE LOOKOUT NATIONAL SEASHORE  
Cape Lookout Village  
LCS#: 271581

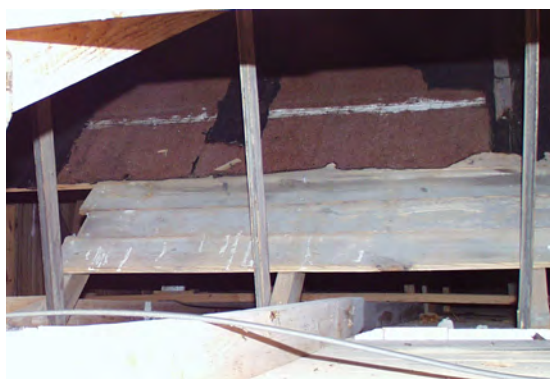
**Figure 29** View of original (1939) asphalt roll roofing in attic. (NPS-SERO-CR, 2003)

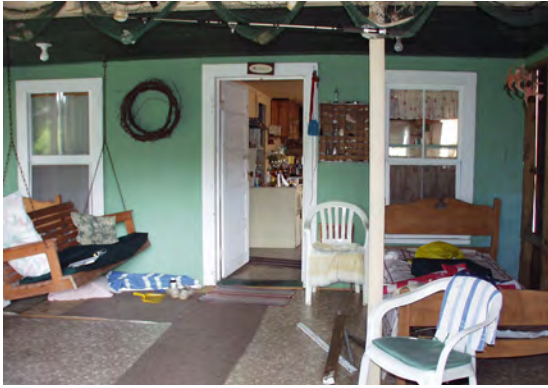
**Figure 32** View of front porch.  
(NPS-SERO-CR, 2002)

*Floor:* The entire floor framing system was replaced when the porch was expanded. Plywood flooring is now covered with a modern vinyl floor covering.

*Ceiling:* The historic porch ceiling is finished with 3- 1/2", V- joint, tongue- and groove boards, painted green and in excellent condition. This ceiling dates to the first expansion of the house in the early 1940s.

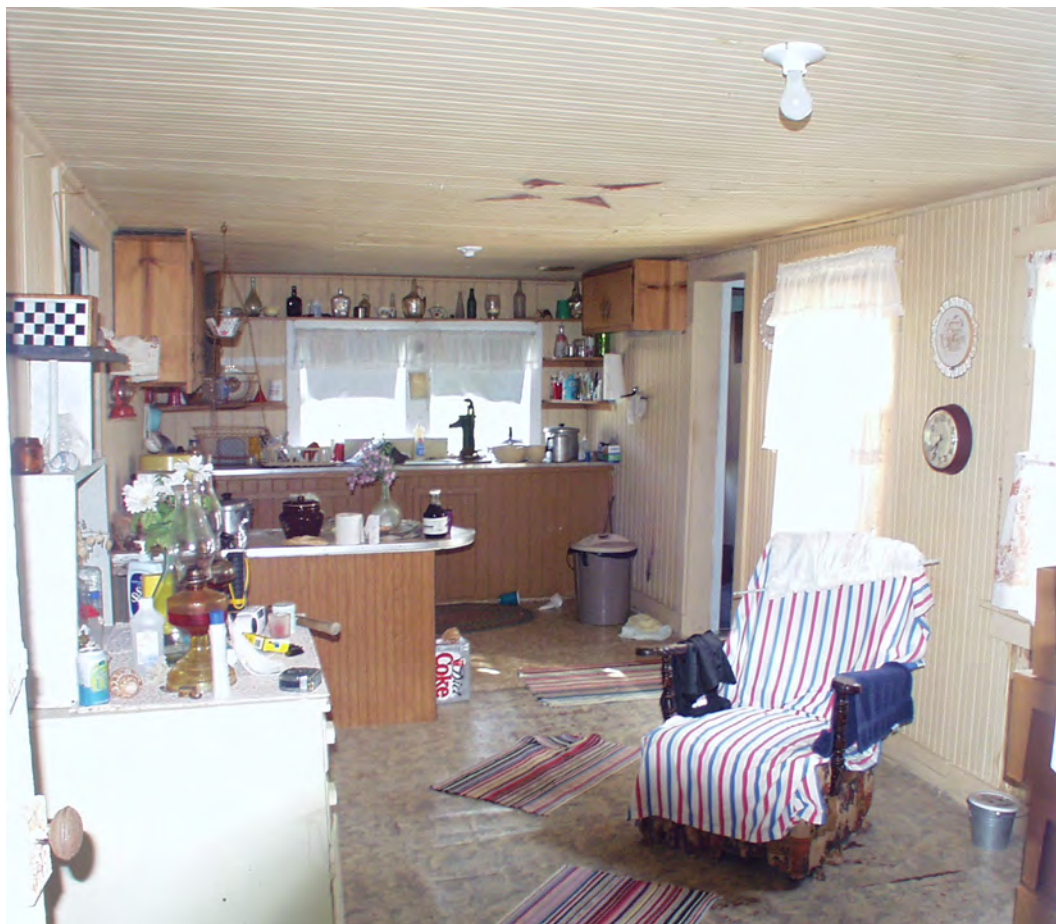
**Figure 33** View to northwest in main room. (NPS-SERO-CRS, 2002)

in the house. When the present space was created by removal of the original wall that separated the two rooms is not known, but it may have occurred as early as the 1950s. The original front room was nearly square, about 9'-6" in each direction. The original back room measured about 6'-6" by 9'-6". The present room is about 23'-5" long by about 9'-6" wide.

It is covered with two or three layers of linoleum and, at the rear, with a modern vinyl floor covering.

*Ceiling:* The ceiling is set at 6'-9". The original portion of the ceiling is finished with double V-joint, tongue-and-groove boards, 3-1/4" wide, typical of the material used on all walls and ceilings in the original house. The portion of the ceiling added with the first expansion of the house in the 1940s is finished with single-V-joint, tongue-and-groove boards, 3-1/2" wide. On the ceiling are painted points of the compass of unknown origin.

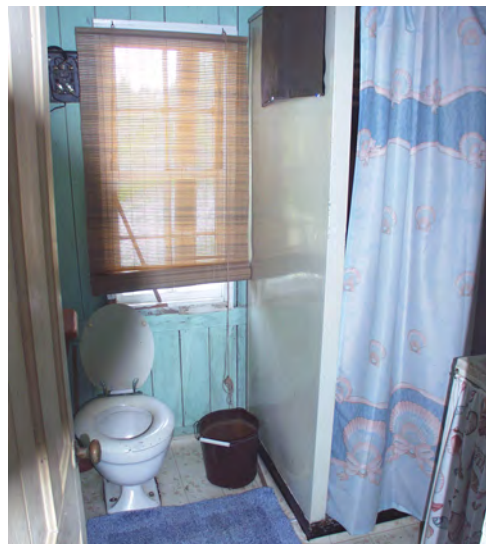
**Figure 38** View of bathroom.  
(NPS-SERO-CR, 2002)

*Fixtures:* In the north corner of the room is a metal shower enclosure, 32" by 32", apparently installed when the room was constructed. The toilet, which also appears to date to the room's original construction, is missing its tank and appears to be flushed using water from the metal water tank mounted on the wooden frame just outside the window. The original sink (if there was one) has been replaced by the present wooden cabinet with a modern, imitation marble sink.

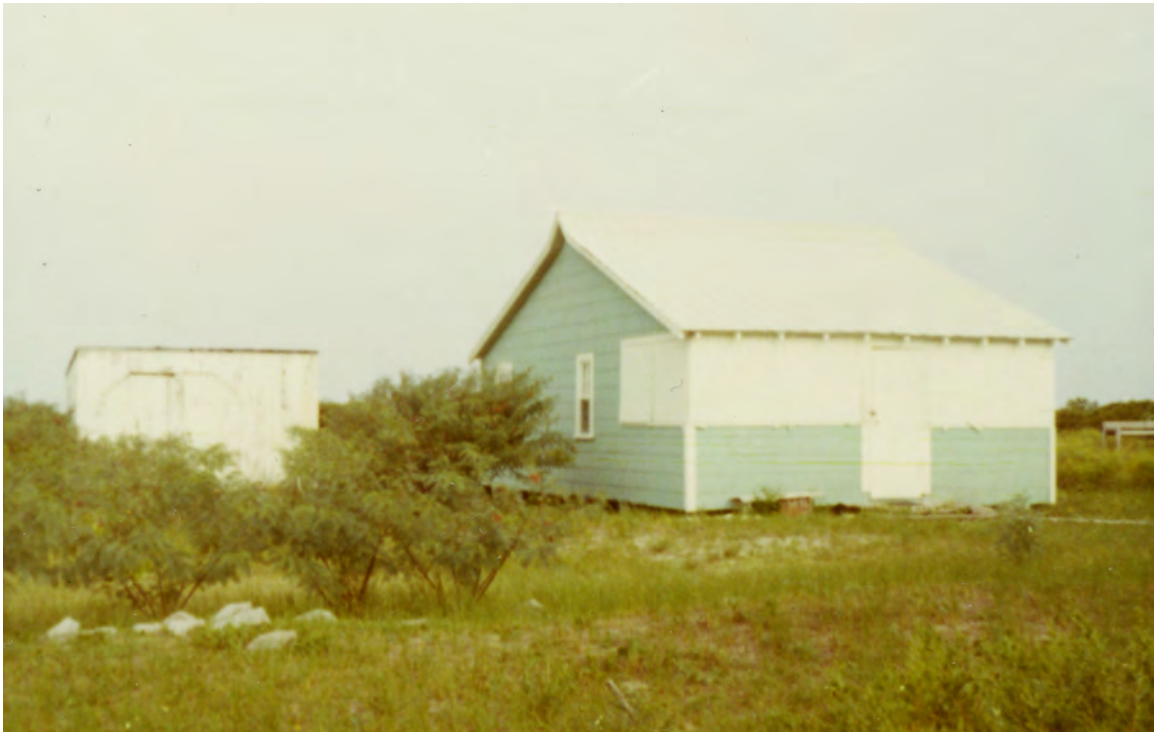
In many cases, sizing and spacing of historic and modern framing members do not meet modern code requirements, but the historic framing can be augmented without total replacement. In raising the building to replace foundation piles, additional beams can be installed to strengthen the floor system. Set on wooden piles, these should be run perpendicular to the joists in a manner similar to the support beam that already exists at mid-span of the original joists. Temporarily raising the building would also allow easier access for necessary repairs to termite or water damaged sills and, as noted above, to raise the grade

**Figure 40** The goal of the proposed plan is a return of the house to its general appearance in this image, c. 1970, minus the asbestos siding. (CALO Coll., Phelps#6)

beneath the building to insure good drainage. It may also make possible improvements to the connection of the wall framing to the perimeter sills. Augmentation of the wall framing is not recommended since that would necessitate total removal of interior and/or exterior finishes, something which cannot be accomplished without significant damage to and loss of historic materials.
