Cape Lookout National Seashore  
**LEWIS- DAVIS HOUSE**

# **HISTORIC STRUCTURE REPORT**

**2004**

2004  
Historic Structure Report  
Lewis- Davis House  
Cape Lookout National Seashore  
Cape Lookout Village  
LCS#: 09t828

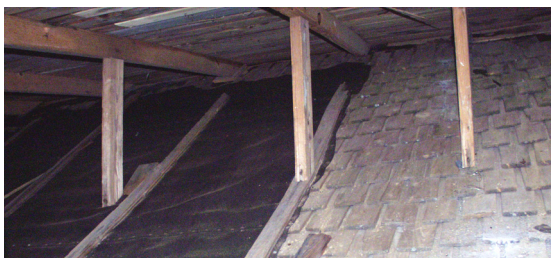
**Figure 27** View of wood shingle roof on original structure encompassing Rooms 100 and 101. (NPS-SERO-CR, 2002)

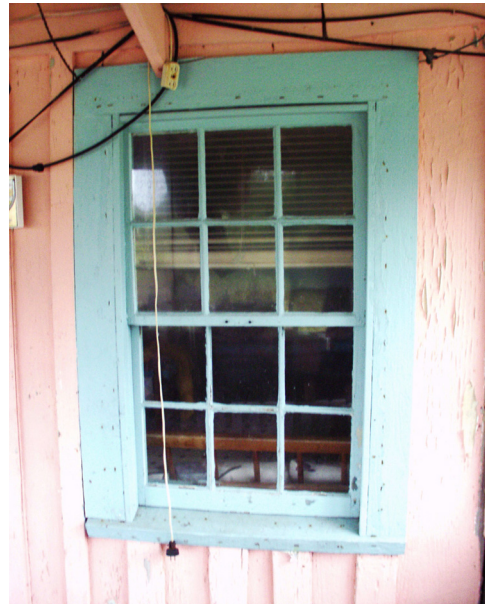
**Figure 29** View of window W-2 on southeast (front) side of house, with exterior siding and trim typical of the original building. (NPS-SERO-CR, 2002)

batten siding was left exposed. There are numerous broken shingles, and all of the siding, which is now painted pink, is stained and mildewed.

- Remove cement-asbestos siding.
- Repair underlying boards and install new battens to match the original.
- Repair and preserve historic board-and-batten siding and trim on front and side porches.
- Repair and preserve other exterior woodwork.

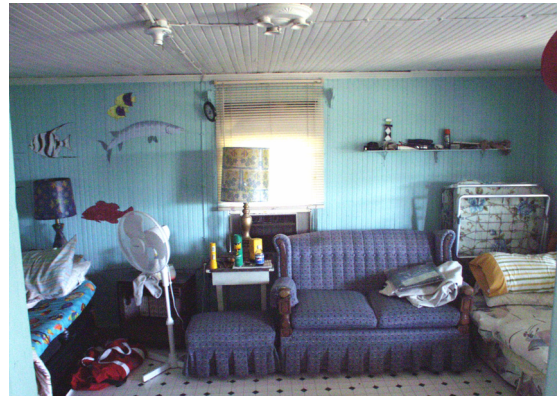
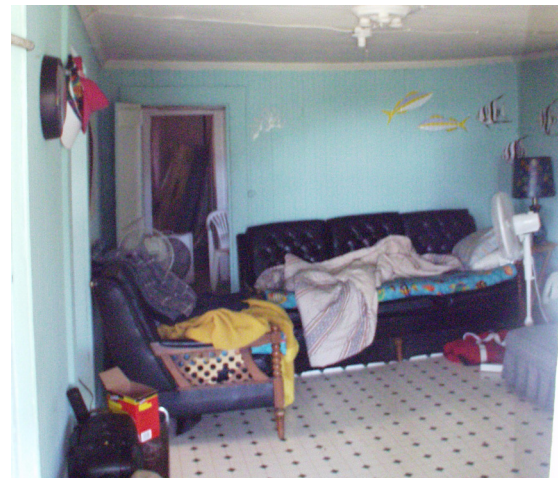
The front door opens into this room, which is about 11' by 15'- 3". Most of its historic features remain intact and in good condition.

**Figure 32** View to northeast in Room 100. (NPS-SERO-CR, 2002)

**Figure 33** View to northwest in Room 100. (NPS-SERO-CR, 2002)

*Floor:* Flooring is typical 3- 1/4" tongue- and-groove. The flooring was historically painted, but now is covered with a modern vinyl floor covering.

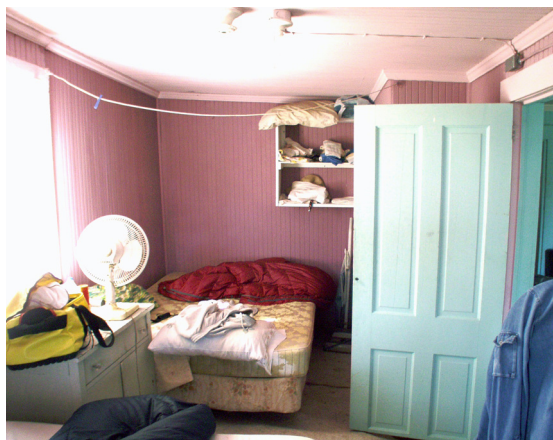
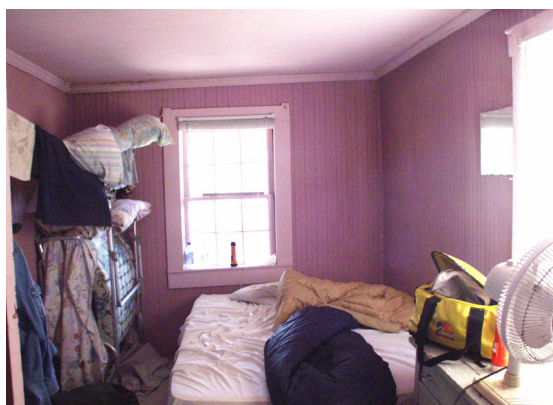
**Figure 34** View to west in Room 101. (NPS-SERO-CR, 2002)

**Figure 35** View to southeast in Room 101. (NPS-SERO-CR, 2002)

The floor is in dangerous condition and appears to be collapsing due to major deterioration of floor joists and/or piers under this part of the house.

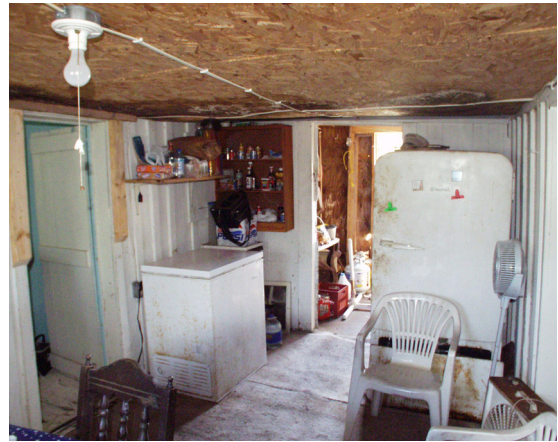
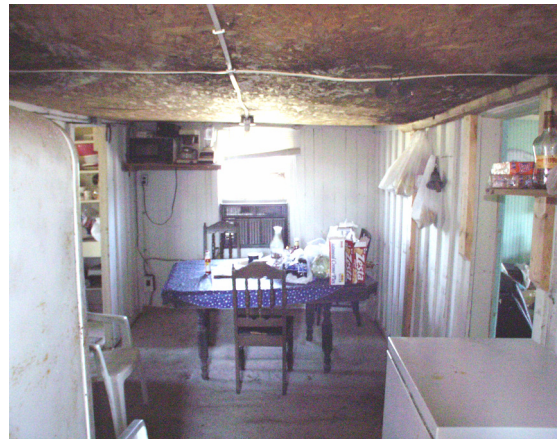
This room measures 8'-2" by about 15'. All of the rooms in the house except Room 101 open to this room. Major damage is ongoing where the roof is leaking along the wall adjoining Room 100.

*Ceiling:* The ceiling is set at about 7' and covered by sheets of wafer board. Original tongue- and-groove boards, 3-1/2" wide, probably V-joint, remain in place beneath the wafer board, but many are probably damaged or deteriorating due to water penetration. The ceiling has been braced along the middle of the

**Figure 36** View to south in Room 102. (NPS-SERO-CR, 2002)

**Figure 37** View to northeast in Room 102. (NPS-SERO-CR, 2002)

the east wall because water-damaged joists are collapsing in that area.

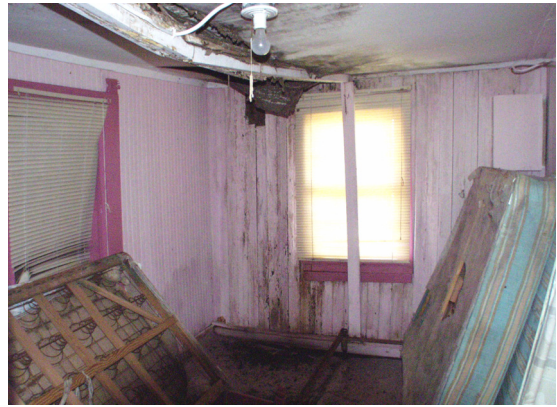
**Figure 40** View to west in Room 104. (NPS-SERO-CR, 2002)

Measuring 8'- 4" by 11'- 6", this room is in extremely poor condition.

*Floors:* The floor is carpeted over plywood, although there appears to be an underlying layer of historic tongue- and- groove material. Water penetration and termites have destroyed the connection between the joists and the rear sill, allowing the entire floor to collapse at that end of the room.

*Ceiling:* The ceiling, like the floor, is on the verge of total collapse due to severe termite and water damage. It was originally finished with double- V- joint, tongue- and- groove boards, 3- 1/2" wide.

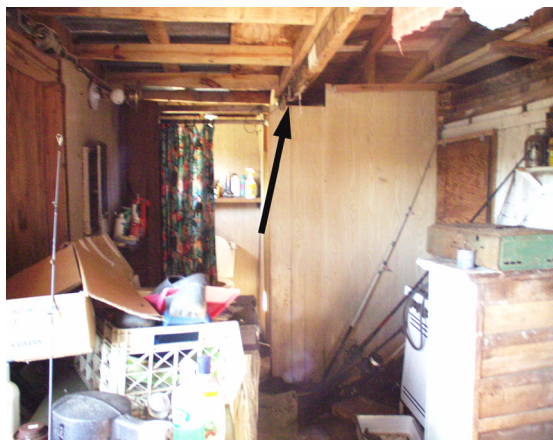
**Figure 42** View northwest in Room 105. Arrow marks header at outside of historic porch. (NPS-SERO-CR, 2002)

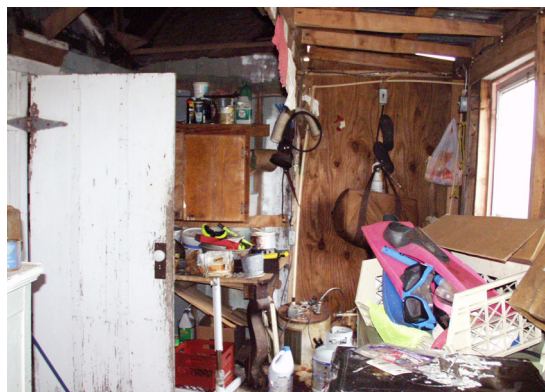
**Figure 43** View to southeast in Room 105. (NPS-SERO-CR, 2002)

*Floor:* The floor is modern plywood and is suffering from severe water damage near the entrance to the bathroom area.
