Cape Lookout National Seashore
Portsmouth
GEORGE DIXON HOUSE
HISTORIC STRUCTURE
REPORT

2004
Historic Structure Report
George Dixon House
Cape Lookout National Seashore (CALO)
Portsmouth, NC
LCS#: 12519

Historic Structure Report

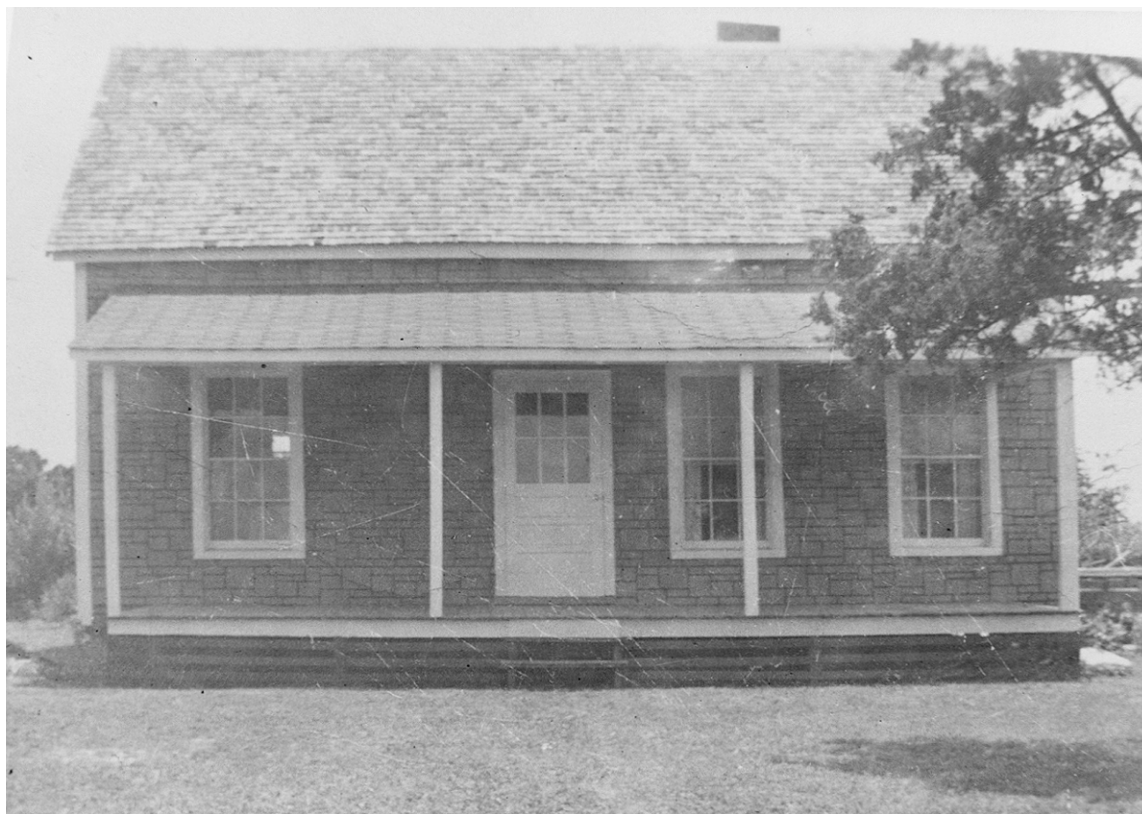
Figure 7 Earliest known photograph of George Dixon House, c. 1952, shortly after its remodeling by Philip Ball. Note wooden enclosure of foundation. (CALO Coll., #A-51)

The exterior of the house was also stripped of its original siding. Old siding and material removed from the interior appears to have been used to resheath the house with flush-laid boards that were then covered with the present asphalt composition panels. The old wood-shingled roof covering remained in place but within a few years had been replaced by green, asphalt-composition, "hurricane" shingles.²⁹

- Remove existing asphalt siding, preserving at least one complete panel in the park's permanent collection.
- Identify original 1" by 8" siding material, and re- install all sound material as lapped siding, replacing missing material as necessary.
- Paint siding and trim as dictated by careful analysis of surviving finishes.

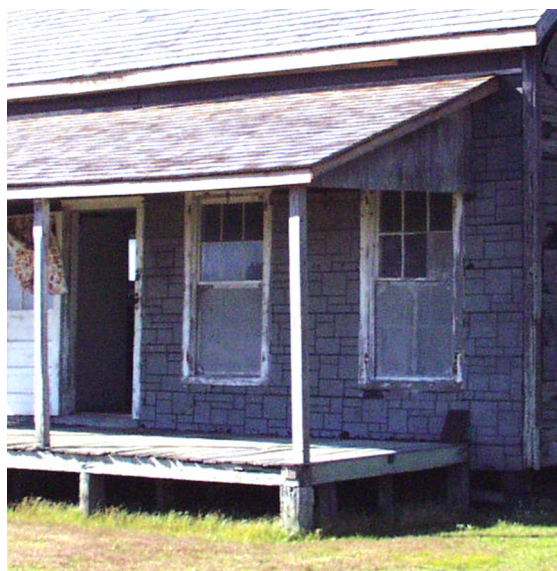
The windows on the front porch and one window on the back porch have wood-framed screens over the lower sash. These probably once existed at all of the windows, although

Figure 15 View of front porch; column at left is original. (NPS-SERO-CRS, 2002)

- Repair all existing sash, replacing those that are missing or too badly damaged to repair.
- Restore and reinstall louvered shutters.
- Close window on northeast side of Room 102 if kitchen wing is reinstated.
- Install aluminum- framed half screens.

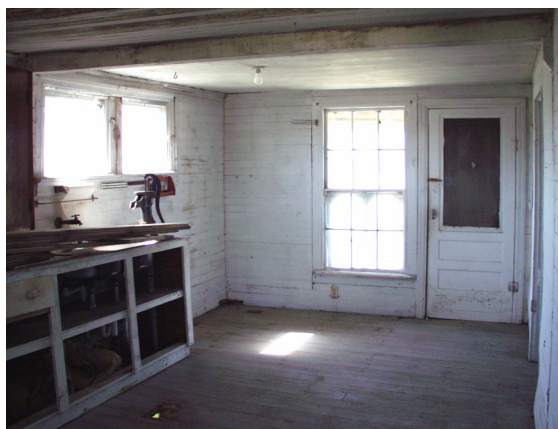
Figure 21 View west showing what was Room 103, now combined with Room 104. (NPS-SERO-CRS, 2002)

When the original porch door from this room was closed after World War II, the sash that had been part of the window on the south wall of Room 103 appears to have been recycled to fill this opening, since it matches the original sash in Room 101 and elsewhere.

- Remove existing windows in Room 103 and replace with original window now in Room 102.

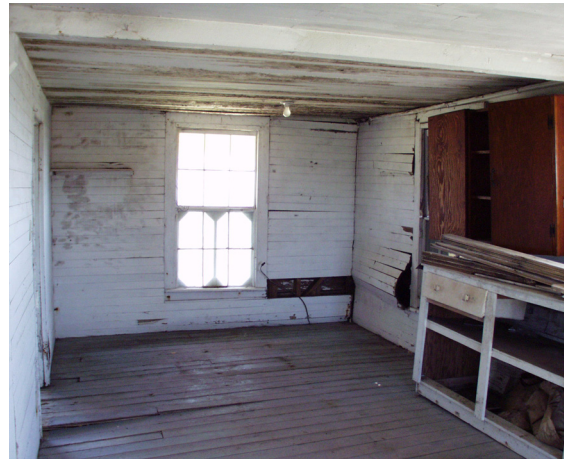
Walls: The wall that was constructed to partition this space from the central hall is composed of plain, 3- 1/4”- wide, tongue- and- groove boards attached at the floor and the ceiling without an internal frame.

Figure 22 View east showing Room 104, now combined with Room 103. (NPS-SERO-CRS, 2002)

- Install new bathroom in Room 202, avoiding alterations to the ceiling in Room 102.
- Install modern kitchen in Room 102.
- Rebuild wall between Rooms 103 and 104.
- Reconstruct ceiling in Room 202.
- Reconstruct missing walls and ceiling at front (east) end of center hall.
- Repair finishes in Room 201, preserving as much of the historic wallpaper as possible.
- Install modern electrical and plumbing systems.

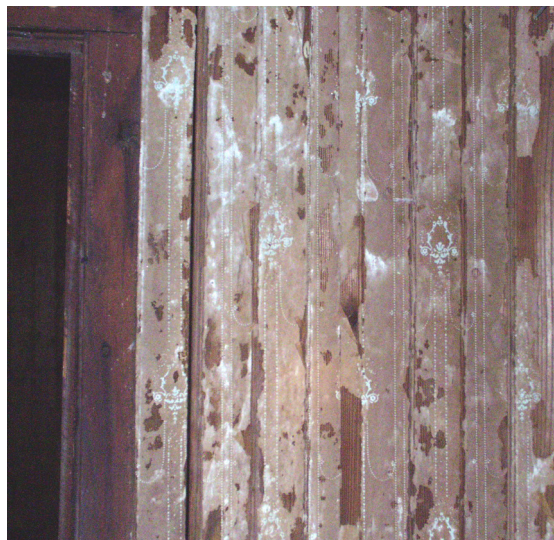
Figure 25 View of wallpaper-covered paneling on north wall of Room 201. (NPS-SERO-CRS, 2002)

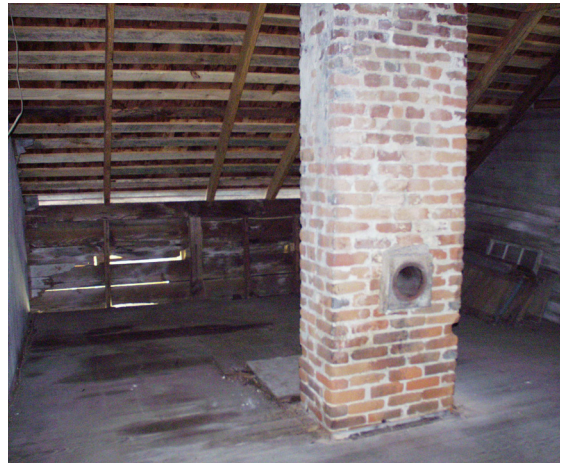
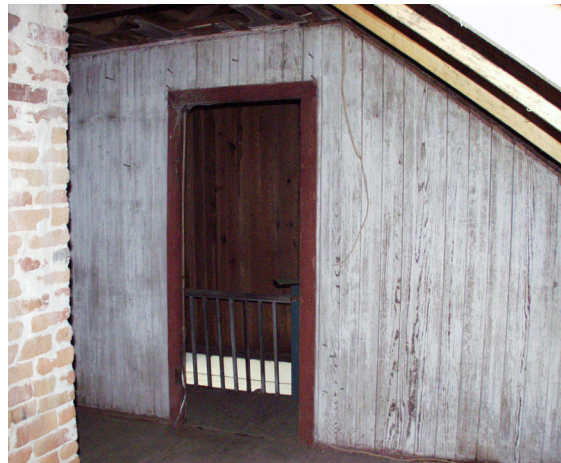
Room 202

Figure 26 View west in Room 202. (NPS-SERO-CRS, 2002)

Figure 27 View south in Room 202. (NPS-SERO-CRS, 2002)

Windows: There are two window openings on the south wall. Both are 2'- 4" by 3'- 10", originally fitted with six- over- six sash. The upper sash in the east window is missing.

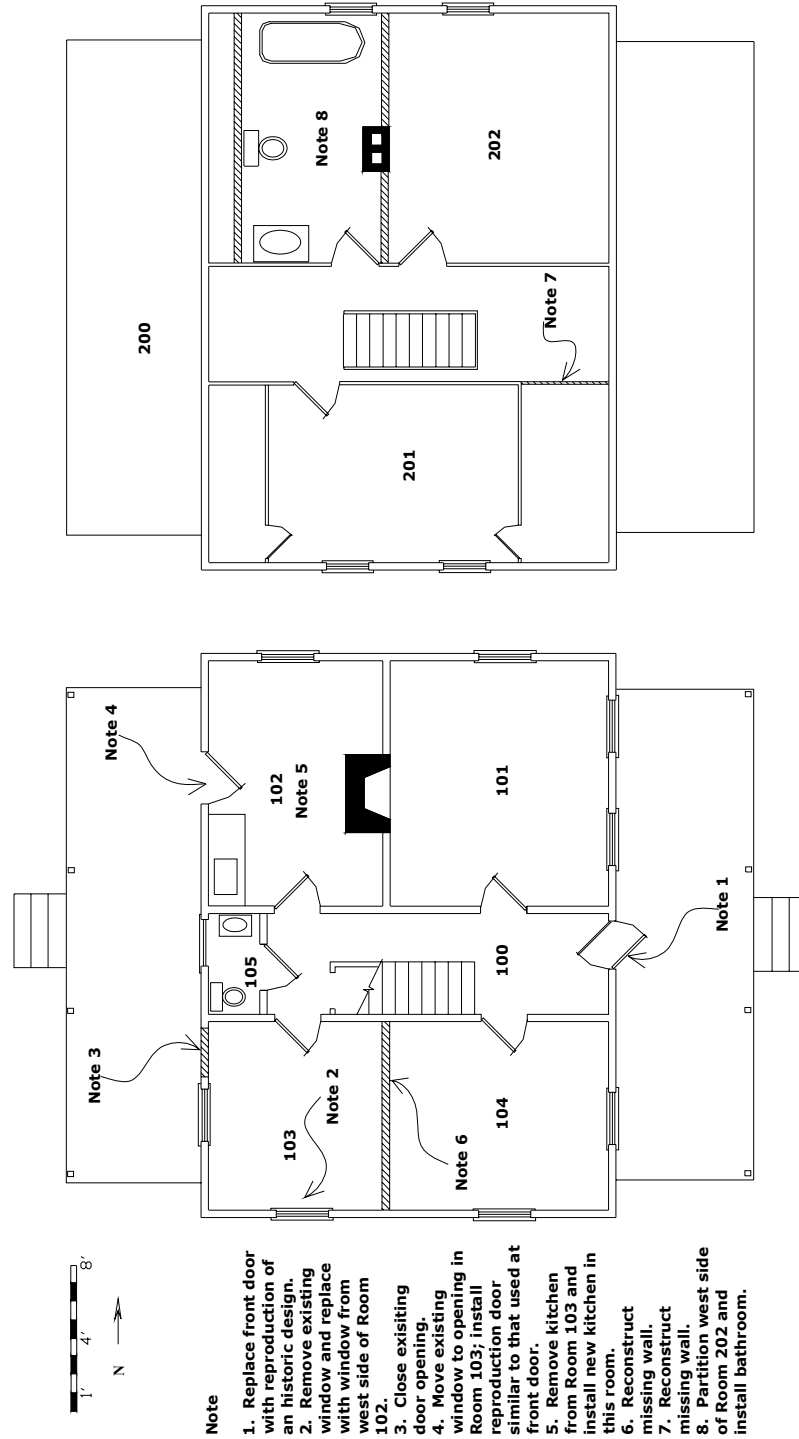
Figure 29 Proposed plan for treatment and use. (T. Jones, SERO-CR, 2003)

1. Replace front door with reproduction of historic design.
2. Remove existing window and replace with window from west side of Room 102.
3. Close existing door opening.
4. Move existing window to opening in Room 103; install reproduction door similar to that used at front door.
5. Remove kitchen from Room 103 and install new kitchen in this room.
6. Reconstruct missing wall.
7. Reconstruct missing wall.
8. Partition west side of Room 202 and install bathroom.
