Portsmouth Life- Saving Station

Historic Structure Report

2006

2005
Historic Structure Report
Portsmouth Life- Saving Station
Cape Lookout National Seashore
Portsmouth, NC
LCS#: 012512

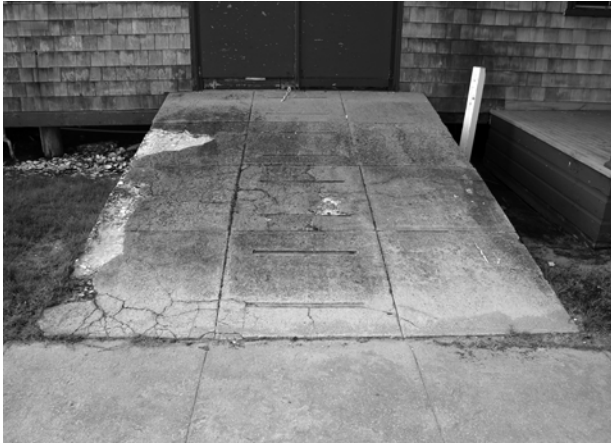
FIGURE 55. View of ramp to smaller boat room door on northwest side of building. (T. Jones, NPS, 2005)

Condition: The ramp from the easternmost door on the northwest side of the building is basically sound, but the finish layer of concrete on the other two ramps is spalling away from the base along part of the edges of the ramps.

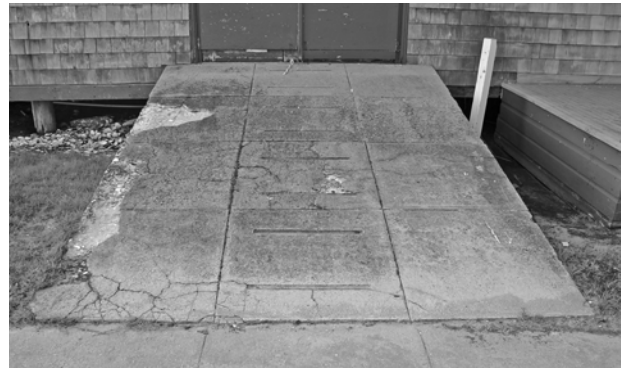
FIGURE 59. View of ramp to Boat Rooms doors D-5. (T. Jones, NPS, 2005)

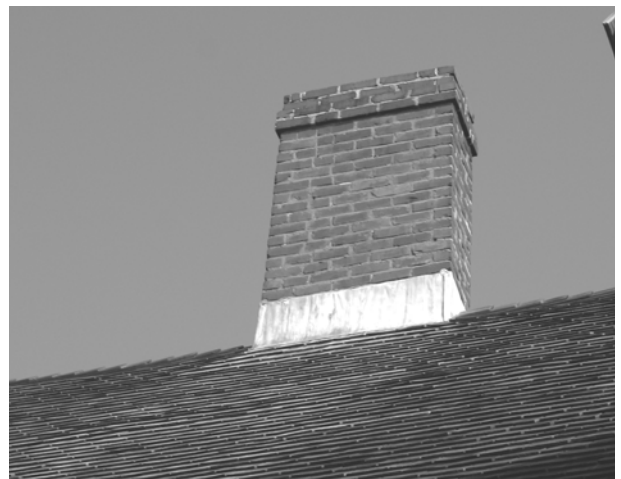
FIGURE 60. View of southeast side of chimney. (T. Jones, NPS, 2005)

Condition: The chimney stack is only visible in the attic and above the roof. In the attic, the brick has been stuccoed, and the stucco remains mostly intact and in good condition. Above the roof, the original chimney stack appears to remain intact, although the original stepped flashing has been replaced.

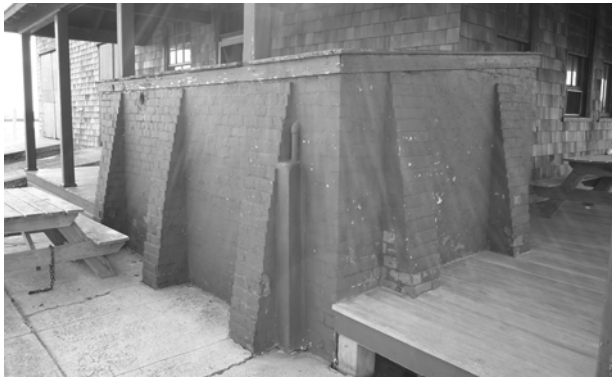
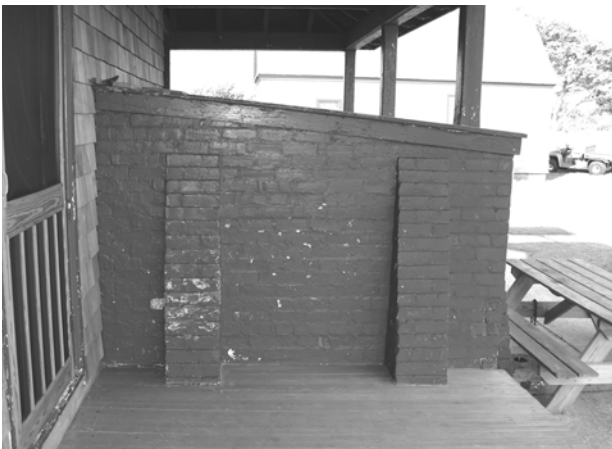
FIGURE 61. View east of cistern. (T. Jones, NPS,

FIGURE 62. View southwest of cistern. (T. Jones, NPS, 2005)

Condition: The cistern appears to be in sound condition, but downspouts from the gutters no longer

keep it filled. The wooden cover is in fair condition. The hatch that provides access to the interior of the cistern is nailed shut, and the condition of the interior of the cistern was not inspected.

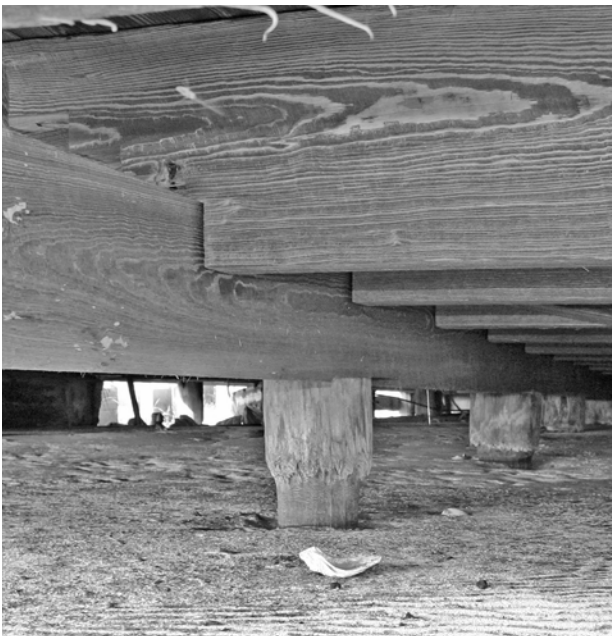
FIGURE 63. View west under boat room. (T. Jones, NPS, 2005)

Condition: There is no indication that the pilings are not original to the building, and many of them have lost a considerable amount of wood, mostly due to erosion from sand- laden water that periodically sweeps the site.

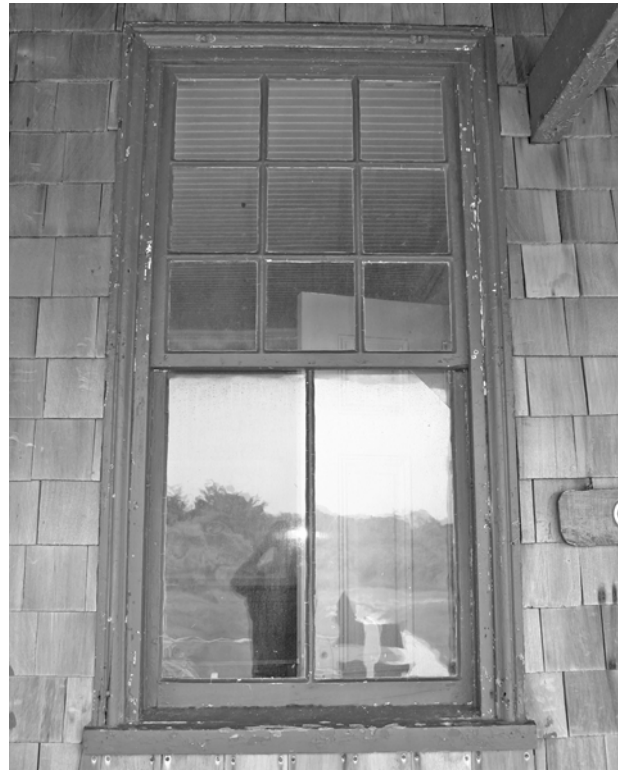
Condition: Some of the sash may have been replaced, and most are in good condition, although many of the counterweight ropes are broken and there are several panes of broken glass. The sash in the attic window, which are almost certainly original, are badly weathered, primarily because the interior side of the sash has not been maintained. At the northeast end of the boat room (Room 107), recent storms badly damaged both windows (w- 6 &

FIGURE 76. View of W-2, a typical nine-over-two window. (T. Jones, NPS, 2005)

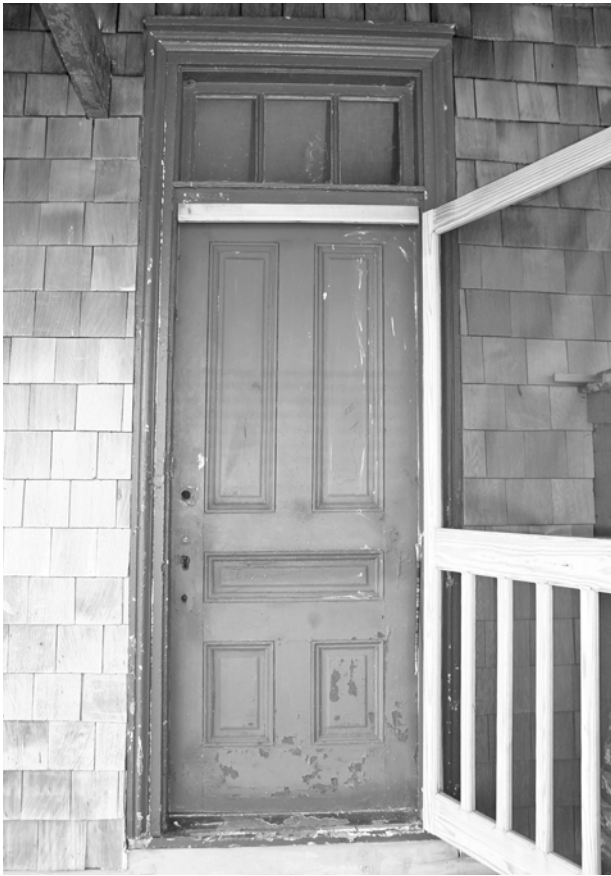
FIGURE 78. Door D-1 on northwest side of house. (T. Jones, NPS, 2005)

Condition: Although the doors themselves are in reasonably good condition, historic mortise locks are inoperative or missing. The historic lock set and escutcheon plates are entirely missing from the northwest door but remain on the southwest door, although the lock is missing its thumb latch so that it is essentially inoperable. An historic deadbolt lock is also missing from both doors, and one hinge is missing from door D-1. The sill to the southwest door has been replaced, but its installation damaged the door frame and the sill itself appears not to be attached to the building's framing.

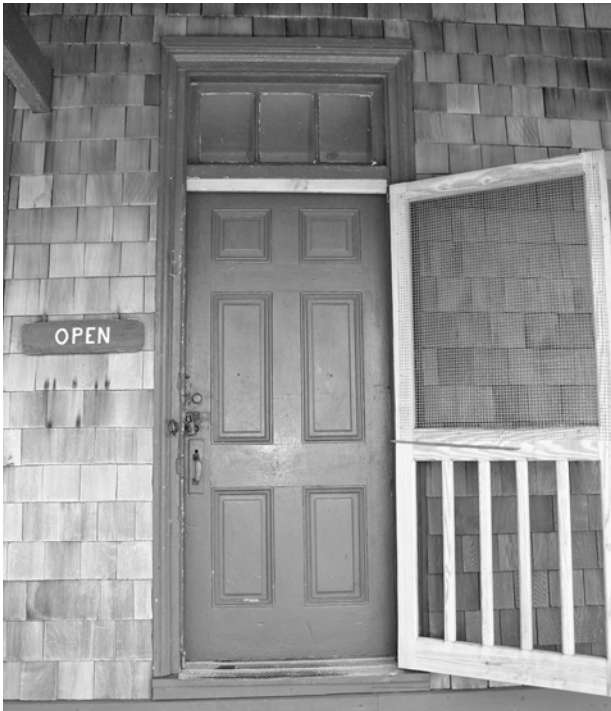
FIGURE 79. Door D-2 on southwest side of house. (T. Jones, NPS, 2005)

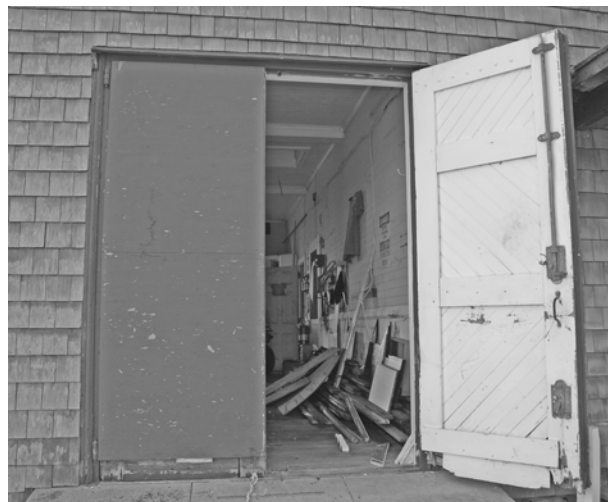
FIGURE 80. View of Door D-5. (T. Jones, NPS, 2005)

Condition: All three sets of boat room doors are deteriorated, and crossbraces have been added to strengthen the large doors. Deterioration is espe- cially pronounced along the doors' lower edges, but Door D- 4 was also severely damaged in the recent storms, with some of the paneling in the lower part of the door torn away. The historic hardware remains completely intact on only two of the six boat room doors. On the others, the lower bar guide is missing or broken and the interior pull is missing from two of those. Some or all of the drip caps appear to have been replaced, perhaps with some- what narrower material.

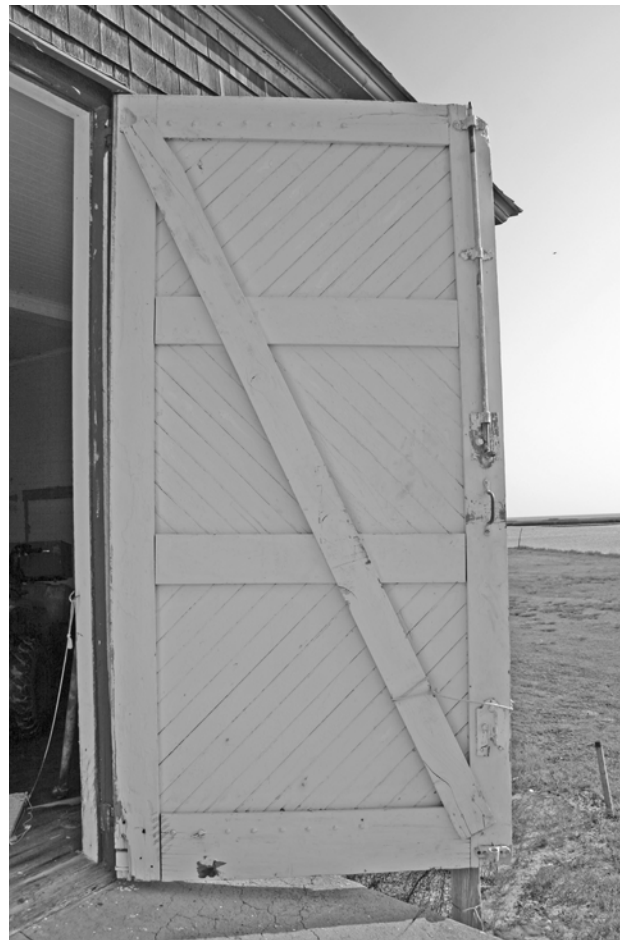
FIGURE 82. View of one leaf of Boat Room door D-3. The diagonal brace is not an historic feature. (T. Jones, NPS, 2005)

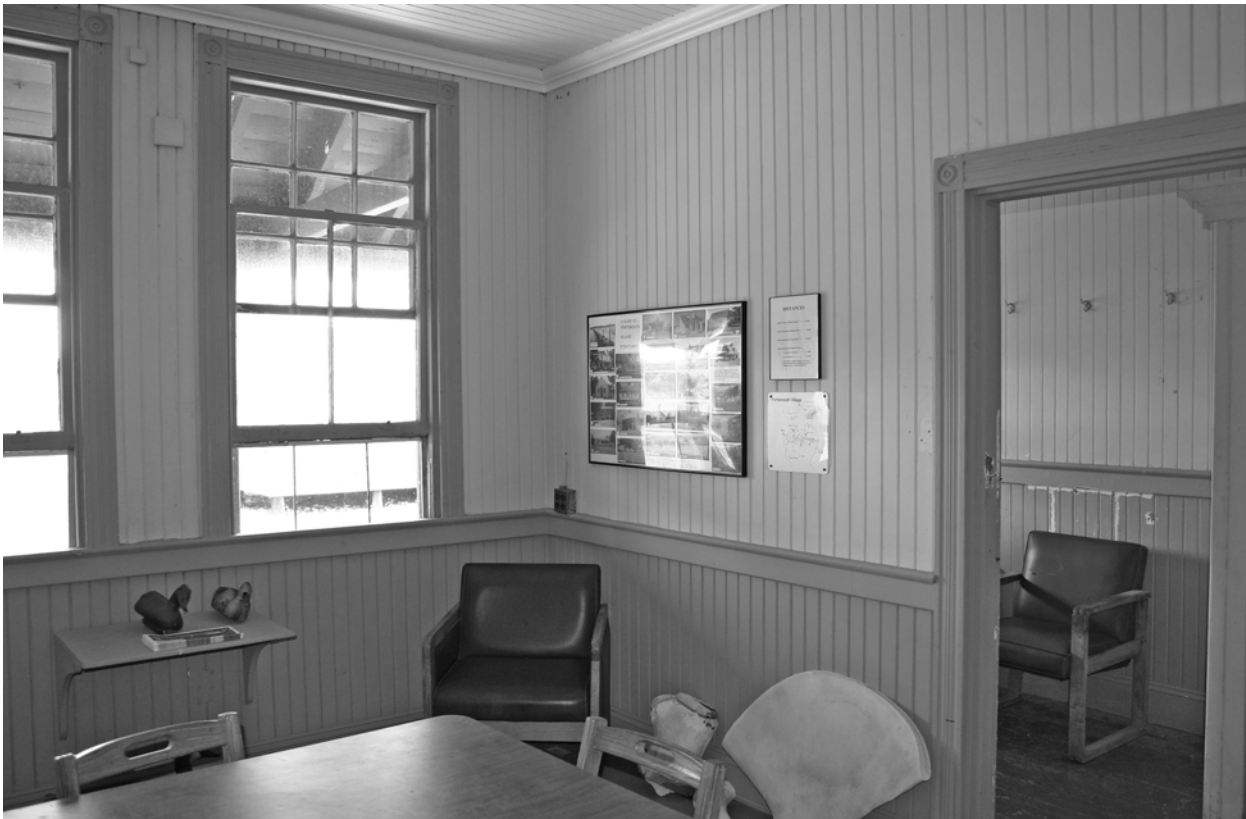
FIGURE 98. View west in Room 102. (T. Jones, NPS, 2005)

two, and are 2'-10" by 5'-8". One of the large panes in each of the lower sash is broken.

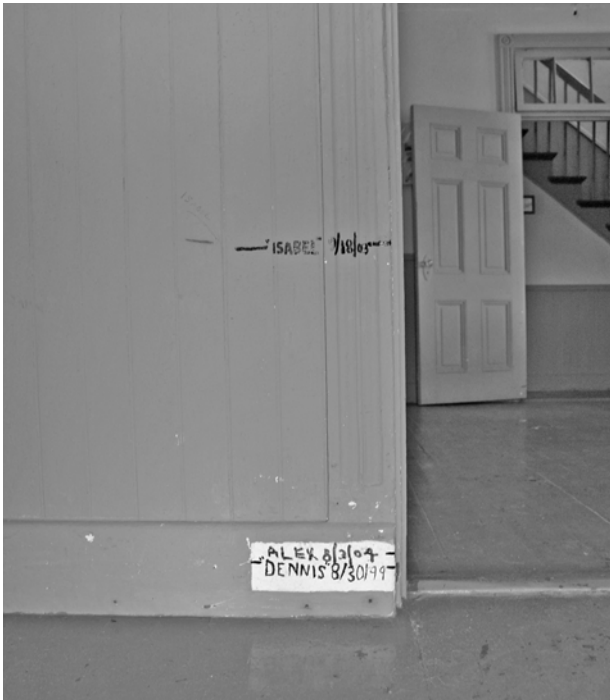
FIGURE 103. View of marks showing high-water marks for recent hurricanes. (T. Jones, NPS, 2005)

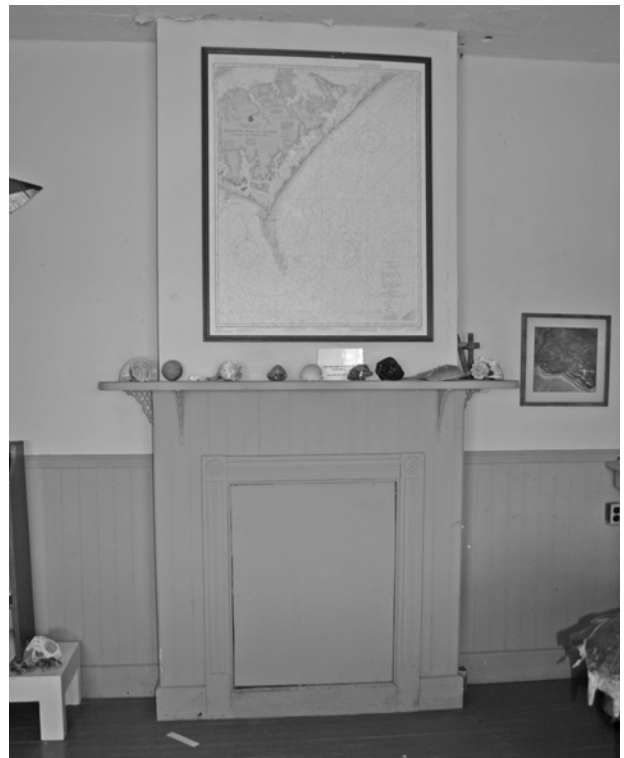
Flooring: The entire floor is laid with painted, 2- 1/2" wide, tongue- and- groove flooring, the only floor in the building laid entirely with the narrower flooring. As a result of storm flooding, flooring is severely buckled on the northwest side of the room.

FIGURE 105. View north in Room 104. (T. Jones, NPS, 2005)

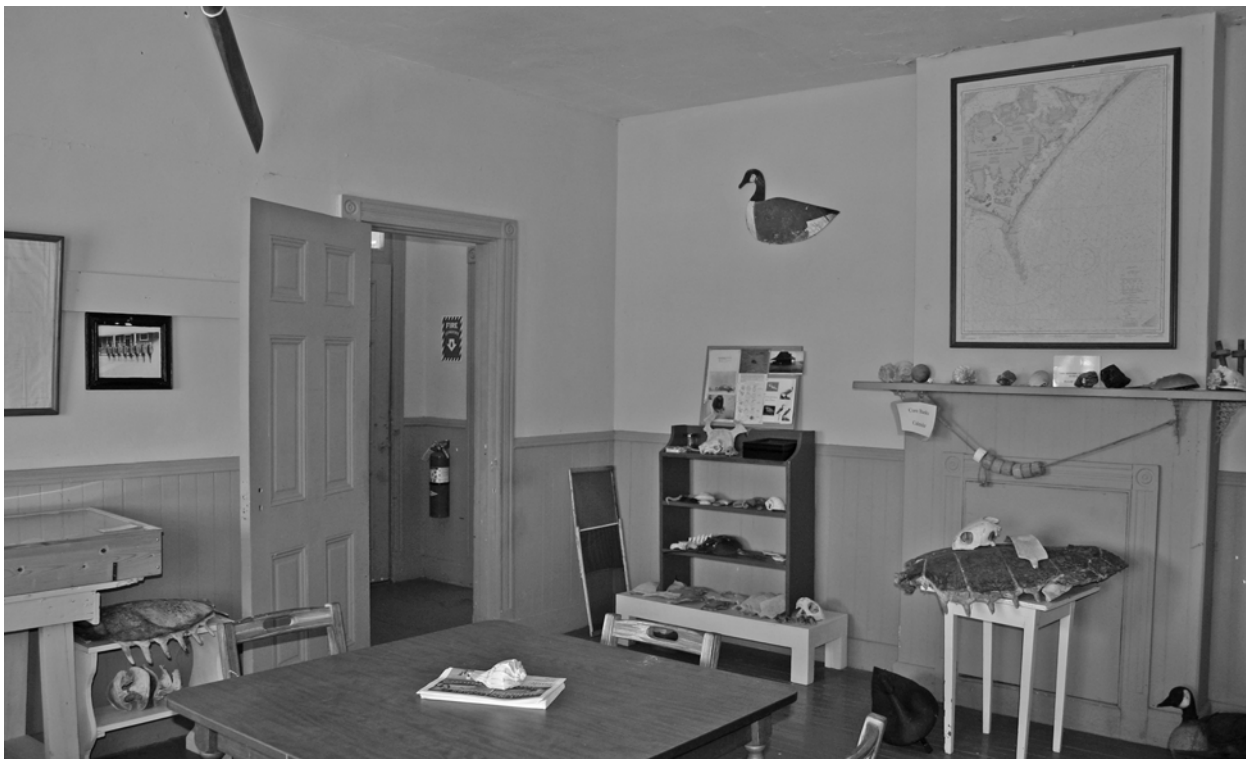
Windows The room has two windows on the south- west wall. Both are typical double- hung, nine- over- two, 3'- 4" by 5'- 8". Counterbalance ropes are broken on both windows.

FIGURE 108. View west in Room 104. (T. Jones, NPS, 2005)

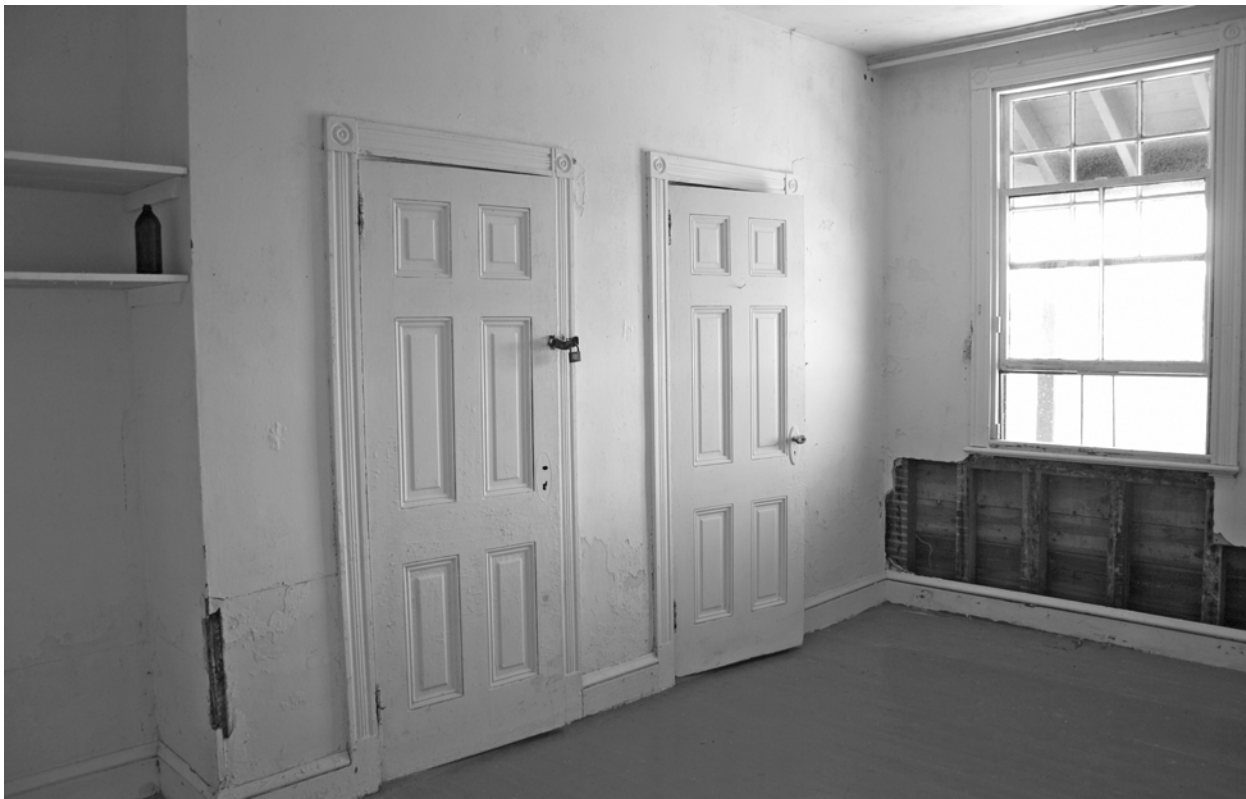
Walls and Ceilings: Walls and ceiling are finished with plaster on plaster board. Recent flooding badly damaged the lower portions of the walls, and some of the plaster board has been removed. Residue from the original plaster on wood-lath walls is visible on exposed studs.

FIGURE 117. View west in Room 106. (T. Jones, NPS, 2005)

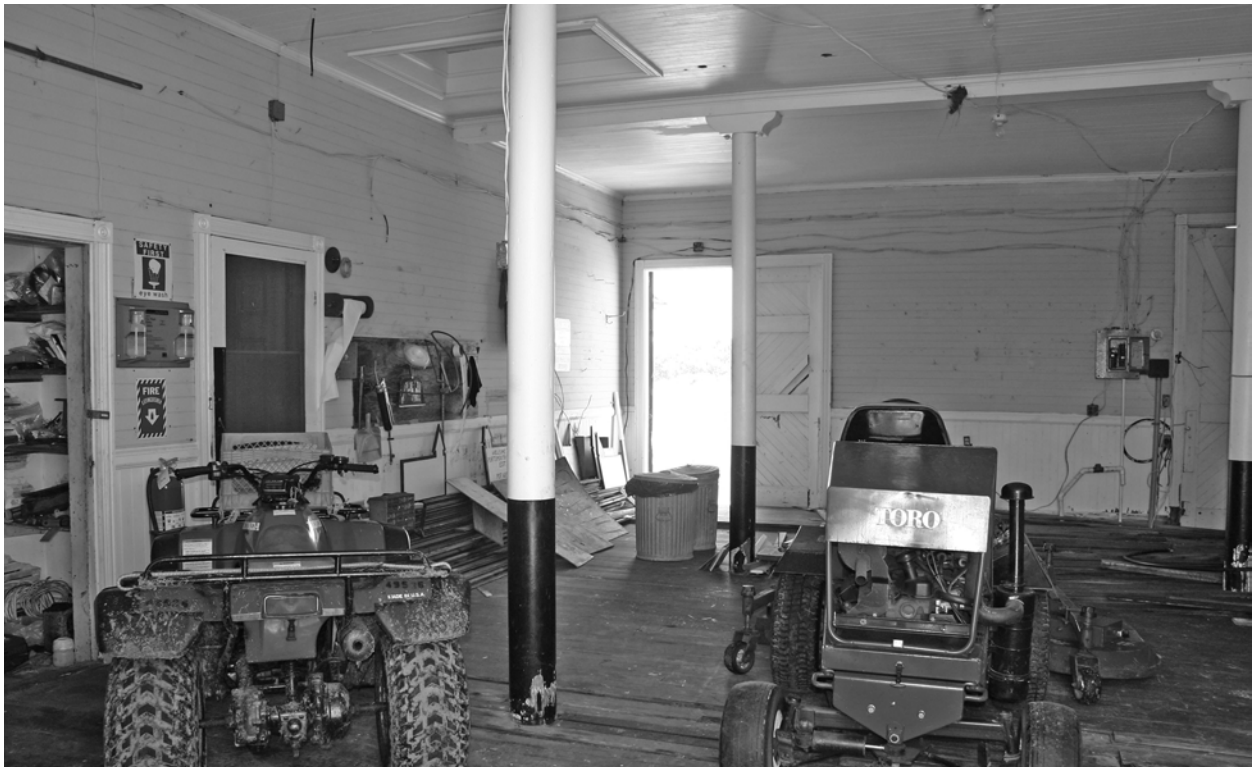
Flooring: Flooring is a typical mixture of 2- 1/2" and 3"- wide tongue- and- groove flooring. The storm surge that accompanied Hurricane Isabel in 1993 did severe damage to the north corner of the room, including dislodging sub- flooring and flooring from the floor joists, although the flooring itself was not destroyed.

FIGURE 123. View west in Room 107. (T. Jones, NPS, 2005)

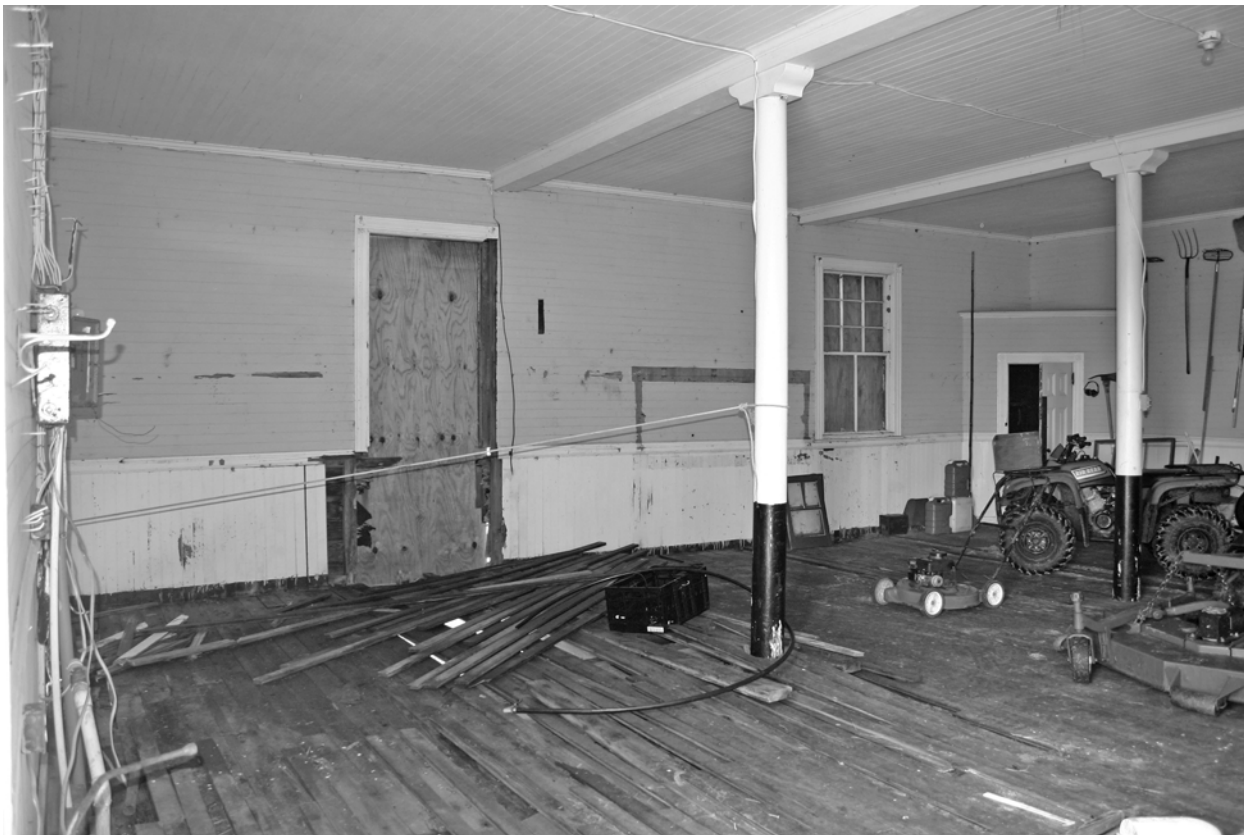
Windows: The room has two windows, both located on the room's northeast wall and typical nine-over-two windows, 3'-4" by 5'-10". The north window of the pair was badly damaged by the storm surge during Hurricane Isabel. The sash and most of the frame were knocked from the opening, but the sash were not destroyed.

FIGURE 127. View east in Room 107. (T. Jones, NPS, 2005)

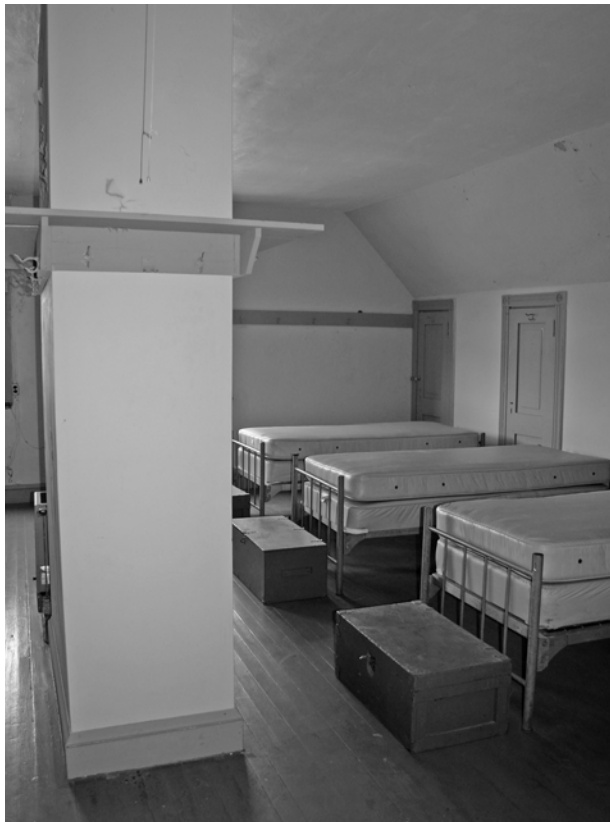
FIGURE 135. View west in Room 201. (T. Jones, NPS, 2005)

remains intact, although much of the plaster has fallen from the lath.

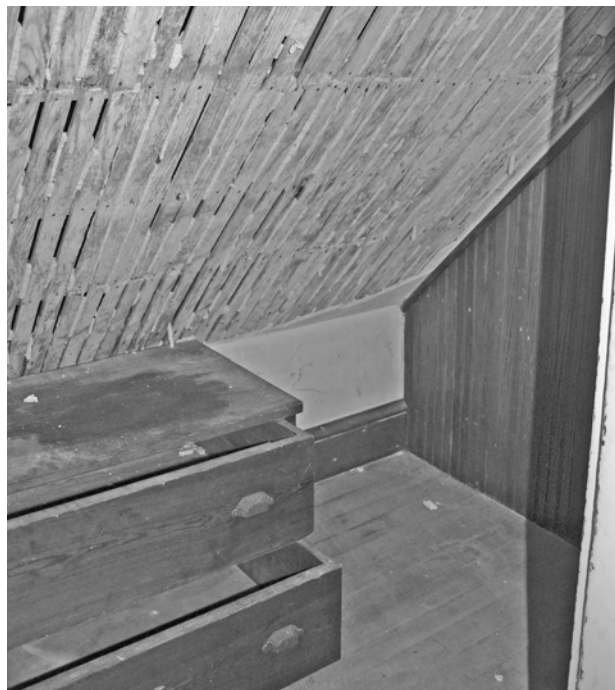
FIGURE 136. View of typical closet in Room 201. (T. Jones, NPS, 2005)

Miscellaneous: Each of the closets has a small, built-in chest of drawers. Each has two drawers and measures 21" deep, 36" long, and 22" high. Birds nesting above the ceiling in the closets on the southwest side of the building have soiled the space with their droppings and contributed to damage to the plaster.

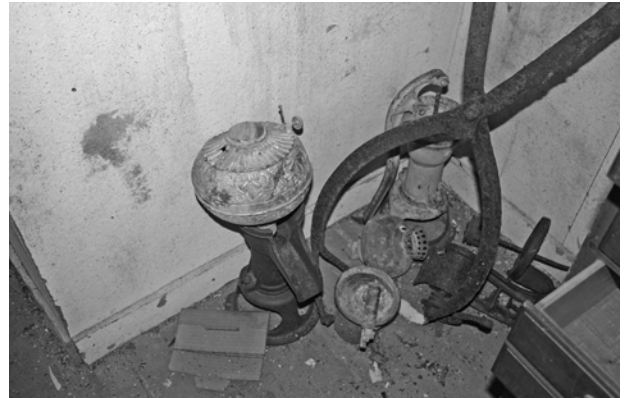
FIGURE 143. View of artifacts in Room 203; also note intact fiberboard walls and baseboard. (T. Jones, NPS, 2005)

Trim: Wooden casing, baseboard, and other trim were not used in this room. Instead, when the fiber-board walls and ceiling were installed, 4"- wide strips of fiberboard were used for casing and baseboard. Most of that material is now missing.

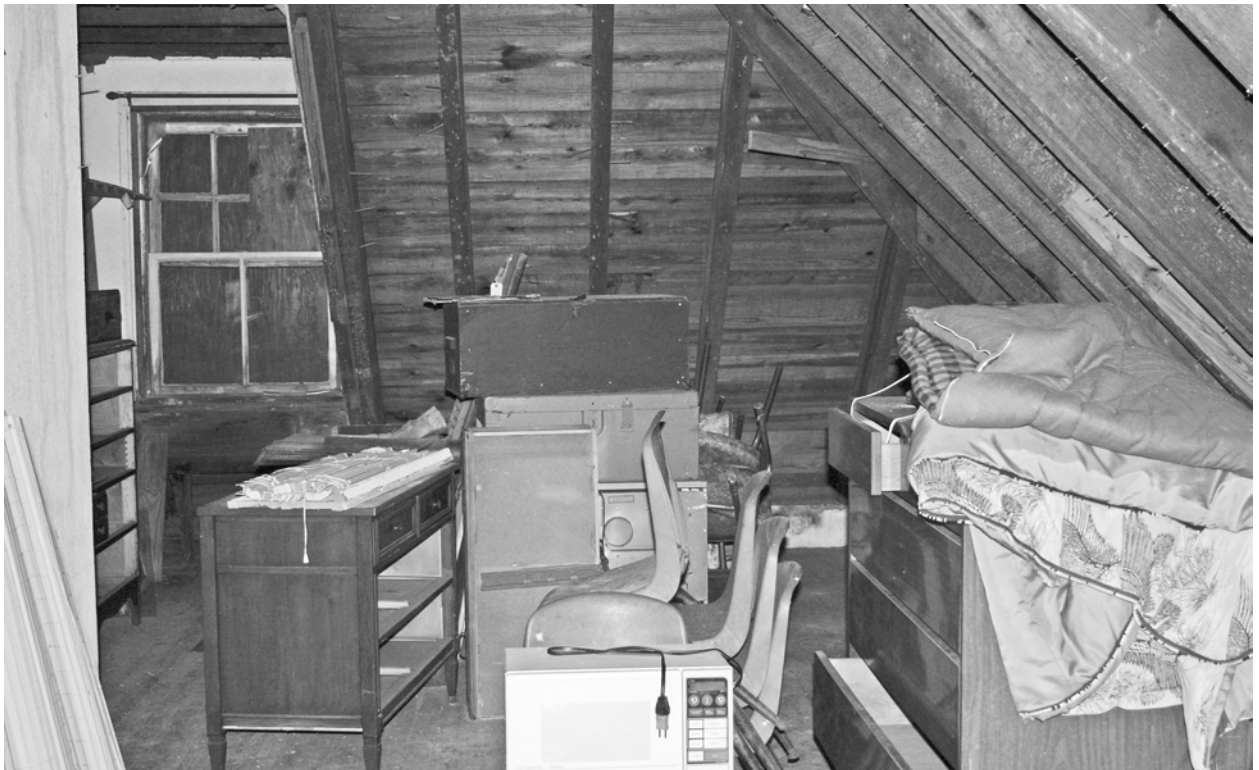
FIGURE 141. View northeast in Room 203. (T. Jones, NPS, 2005)

Windows: As in Room 202, this room has two windows. One of the double dormer windows provided light for this room but is now boarded up. The six-over- two sash is in poor condition. Also as in Room 202, opposite the dormer window, there is a borrow light for the adjacent hall (Room 200). It, too, is missing all glass and is boarded over.

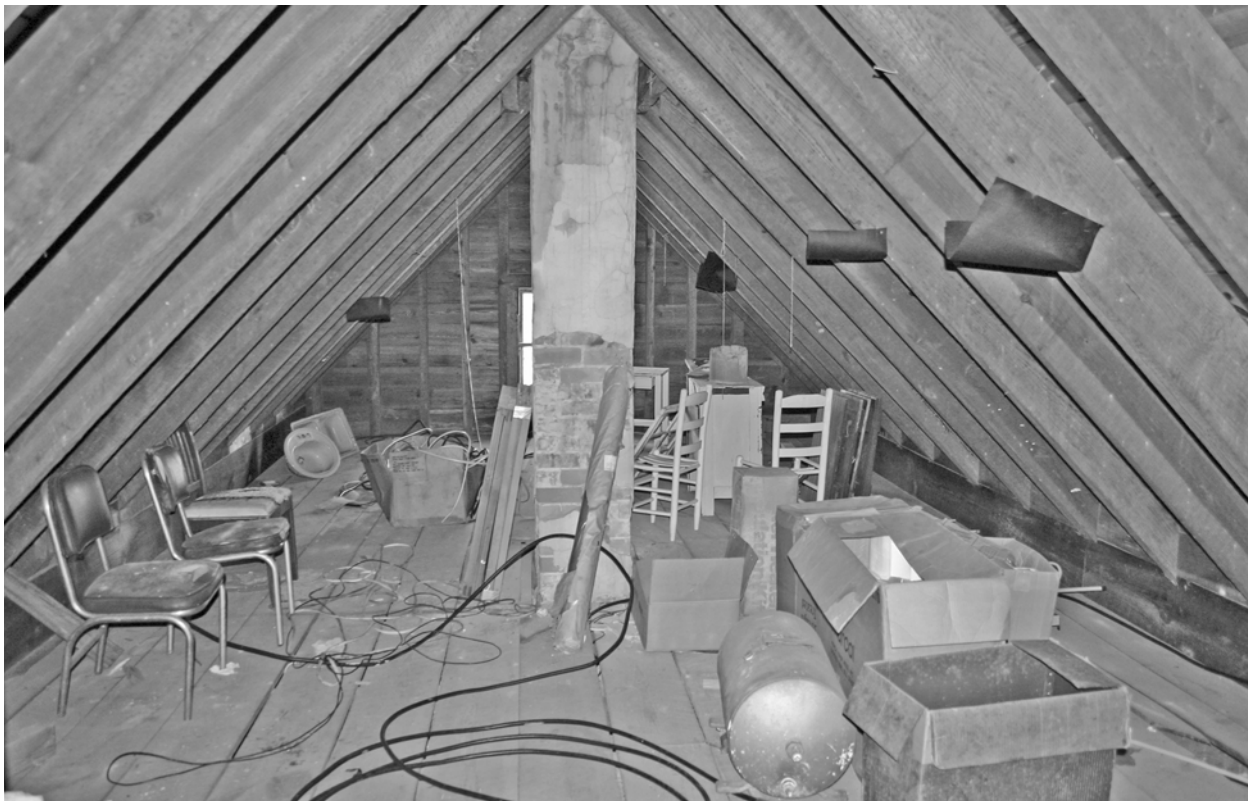
FIGURE 145. View southwest in attic. (T. Jones, NPS, 2005)

Window: A single window in the southwest gable lights the attic. It is the only two-over-two window in the building and measures 2'-4" by 3'-5". Because the interior of the sash has never been painted or varnished, there has been significant UV degradation of the soft wood.

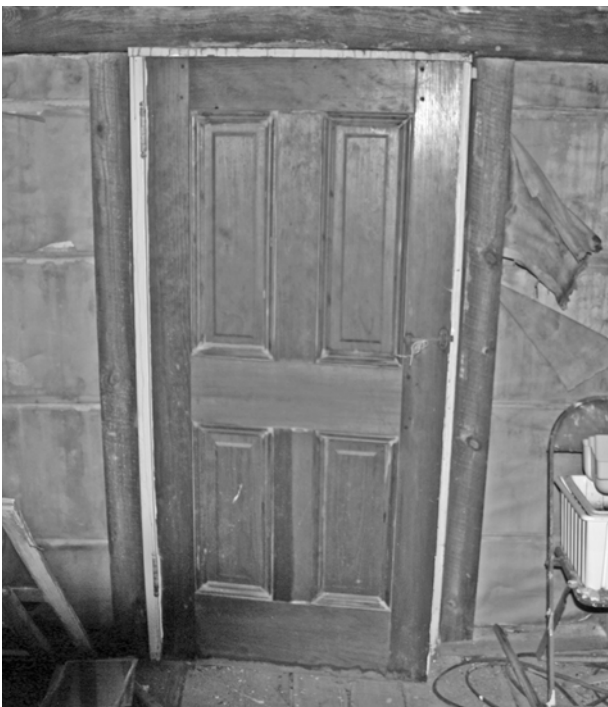
FIGURE 146. View of attic door. (T. Jones, NPS, 2005)

Door: The door from the landing into the attic is a four-panel door, 2'-6" by 5'-6". It is the only door in the building that retains its original varnished finish and has not been painted. It is fitted with a simple thumb latch, which is probably original.

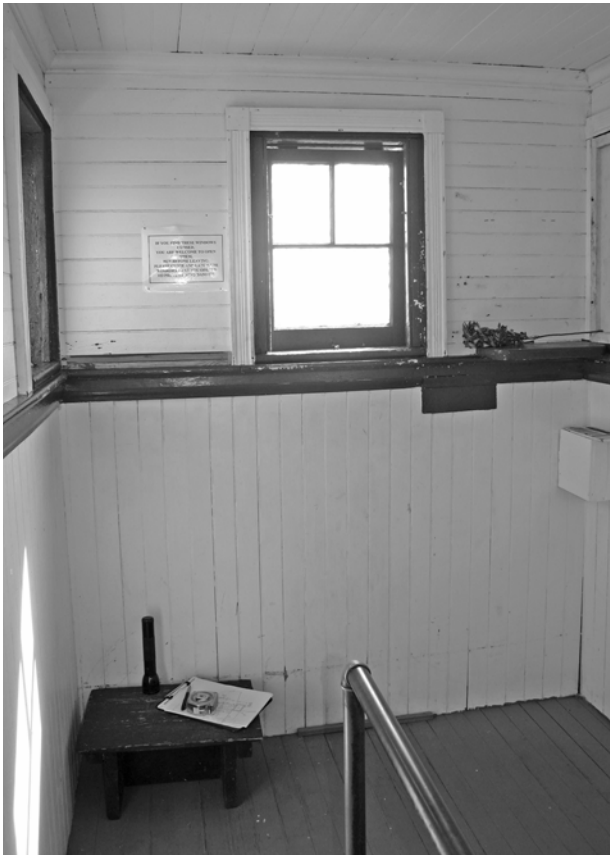
FIGURE 149. View northeast of watch room. (T. Jones, NPS, 2005)

Windows: The room has seven windows, not eight as shown on some plans of the building. Two are located on each of the northwest, southwest, and southeast walls, with one located on the northeast wall. Sash are 20- 1/2" by 28", top hinged, and divided into three lights. Both sash are missing from the two windows on the northwest side of the room, and the openings are now covered by plywood.

Miscellaneous: A small wooden box is mounted on the east corner of the room and may have once held the time clock used to record the watchman’s time on duty. For unknown reasons, a 6” by 8” hole has been opened in the southeast wall and a portion of the chair rail is missing in that location.

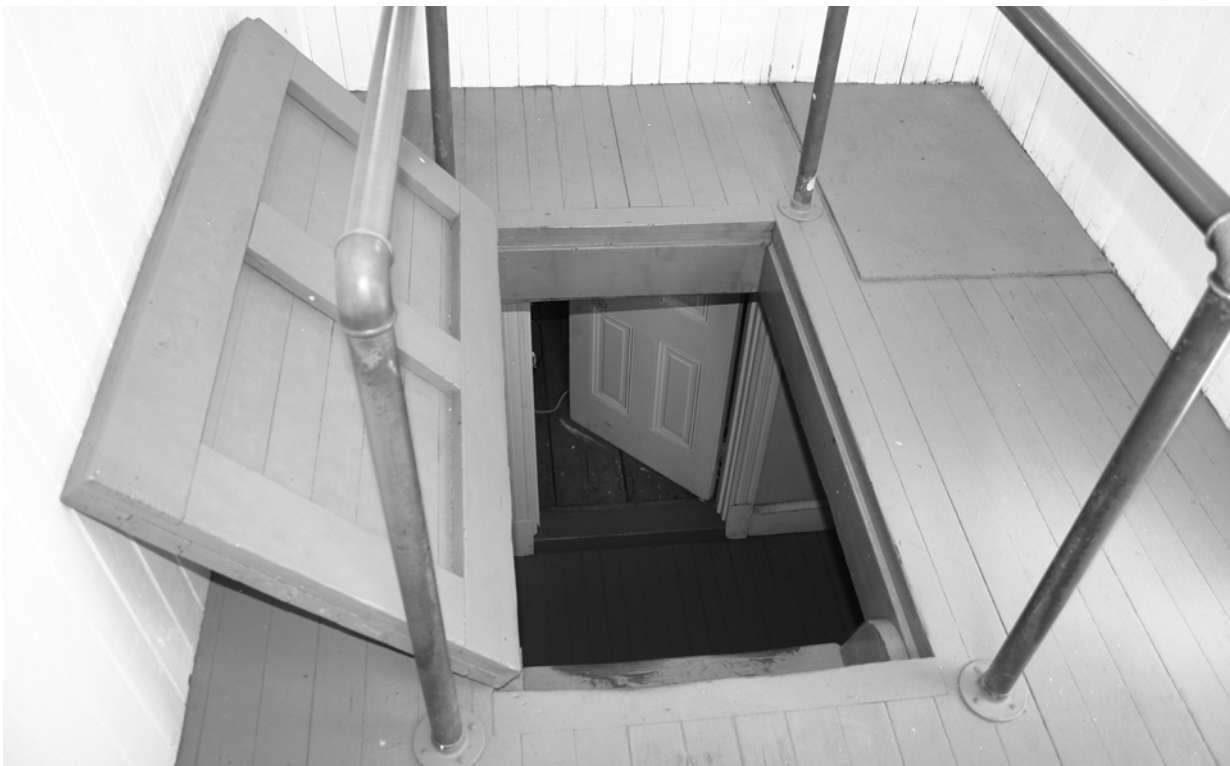
FIGURE 150. View west of watch room's hatch door. (T. Jones, NPS, 2005)

Door: The door or hatch in the floor, which provides the only access into the room, is 26- 1/2" by 44". It has a frame made of 7/8" by 5" boards and is covered by the same 3" tongue- and- groove material used on the floor. The opening is surrounded on three sides by a 1- 5/8"- diameter brass pipe rail, 33" high.
