Jean Lafitte National Historical Park and Preserve  
Chalmette National Cemetery  
Superintendent's Lodge

# Historic Structure Report

June 2006

National Park Service

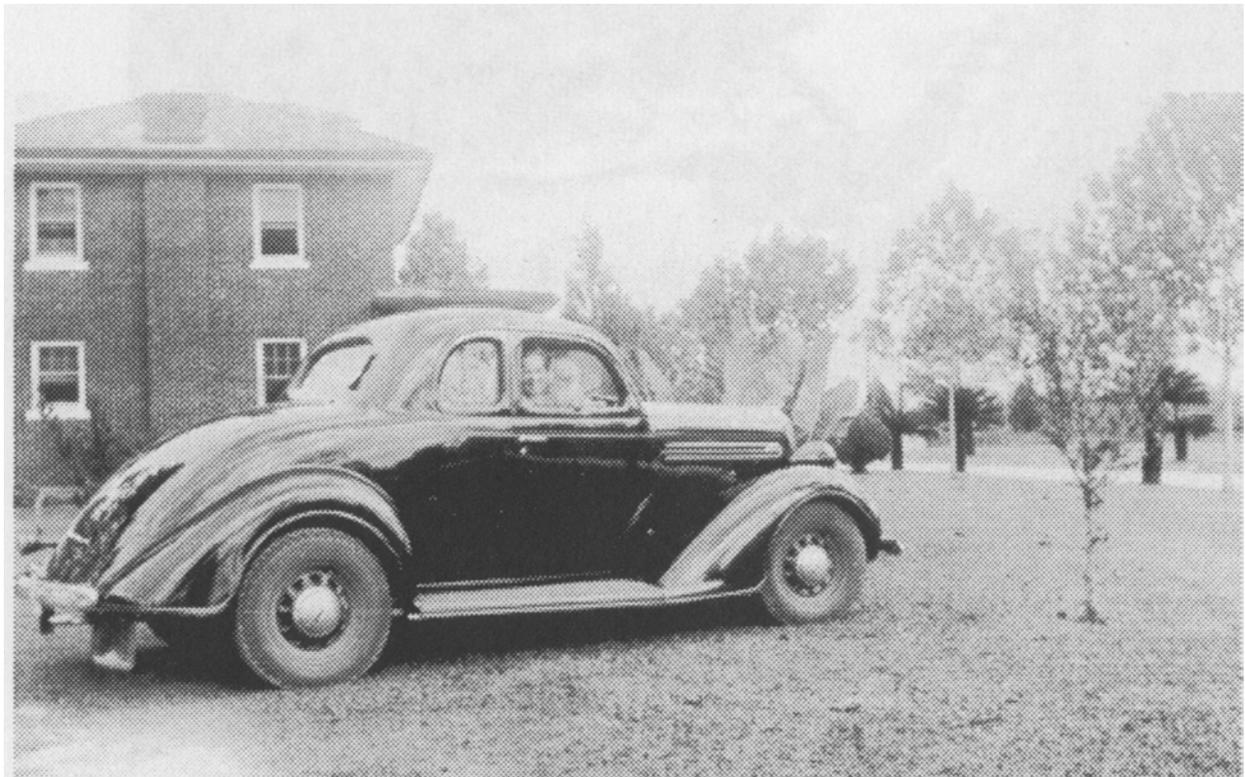
**FIGURE 11.** The earliest known image of the Chalmette Cemetery lodge, c. 1937. Note the chimney on the southeast side of the house, although it appears to have already lost part of its stack by the time this image was made. (From Risk's Cultural Landscape Report)

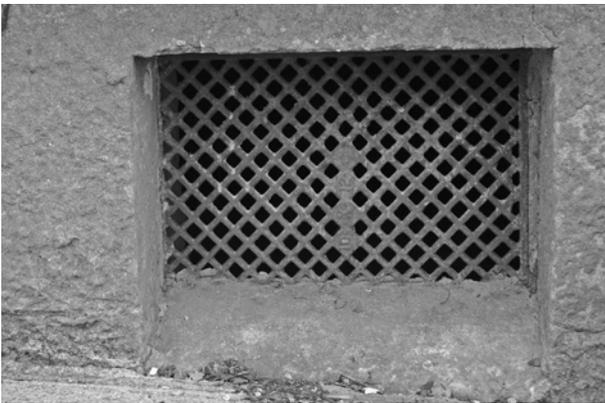
FIGURE 29. View of typical porch foundation vent.

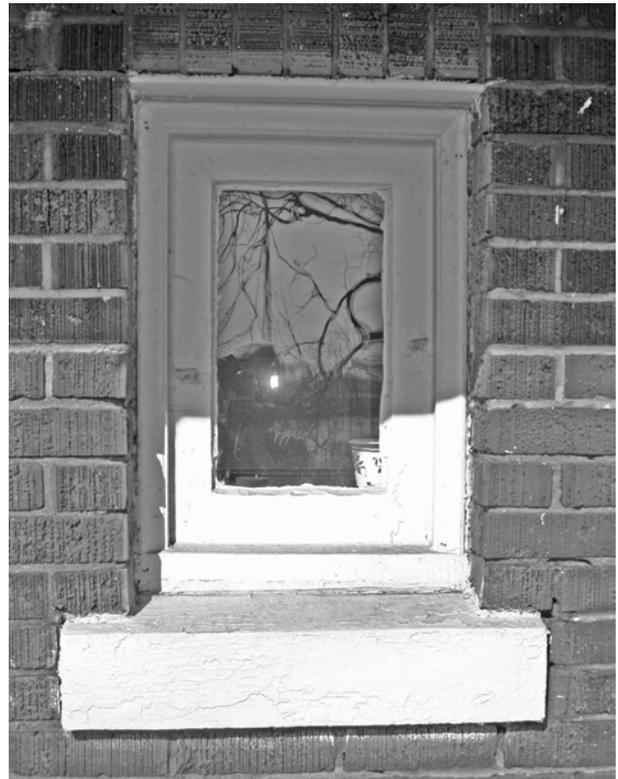
FIGURE 31. View of wood-framed window with typical cast-iron angle-iron lintel and cast-stone sill.

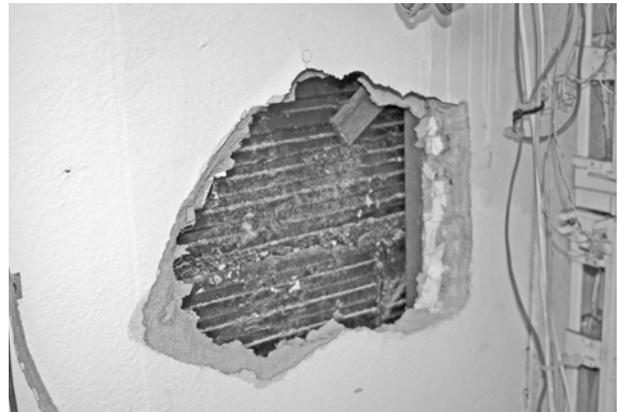
FIGURE 32. View of water-proofed interior face of structural clay tile walls behind plaster-board walls.

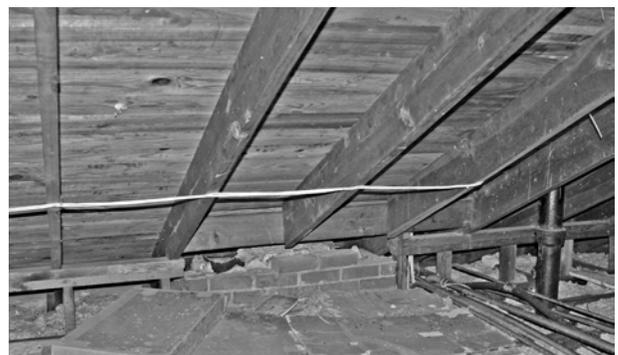
FIGURE 33. View of attic framing.

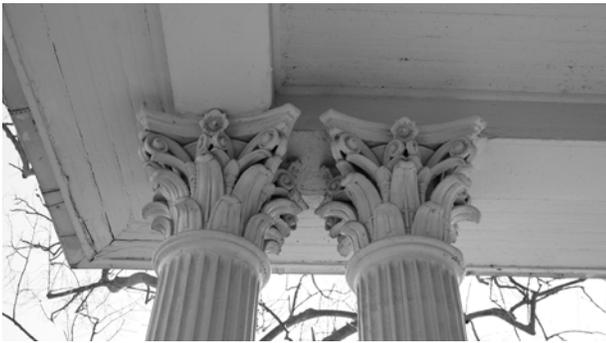
FIGURE 34. View of typical column capitals.

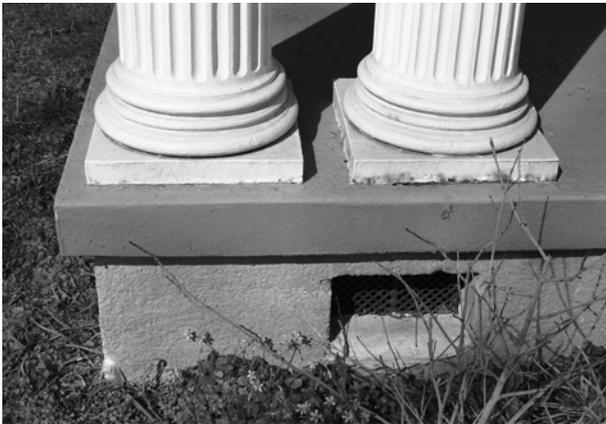
FIGURE 35. View of typical column plinths.

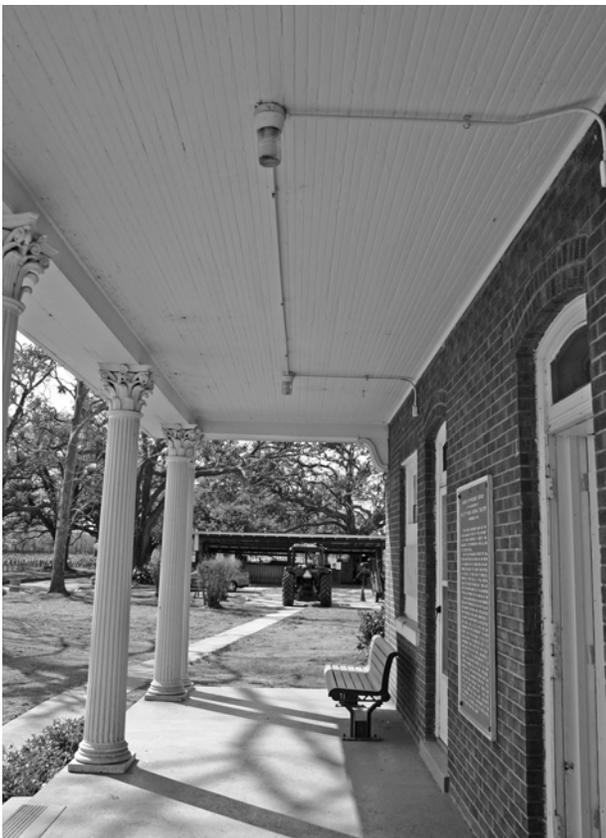
FIGURE 36. View southwest on front porch.

**Existing Condition.** Except for the alterations to the rear porch and damage to the rear porch's soffit, which will be discussed below, the porches remain in reasonably good condition. Some rusting of the columns is evident, but the floor slab and ceiling remain in good condition. The additions to the rear porch were constructed in a way that does not impact the columns or headers and appear to have done only minimal damage to the ceiling boards.

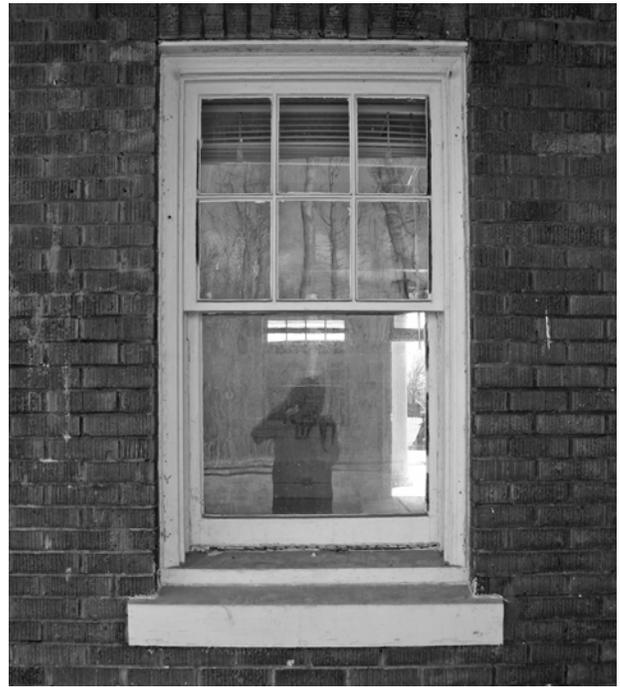
FIGURE 37. A typical 6/1 window.

**Existing Condition.** Windows and doors are in mostly good condition, although built-up paint and broken sash rope have rendered some sash inoperable, and a few panes of glass are broken.

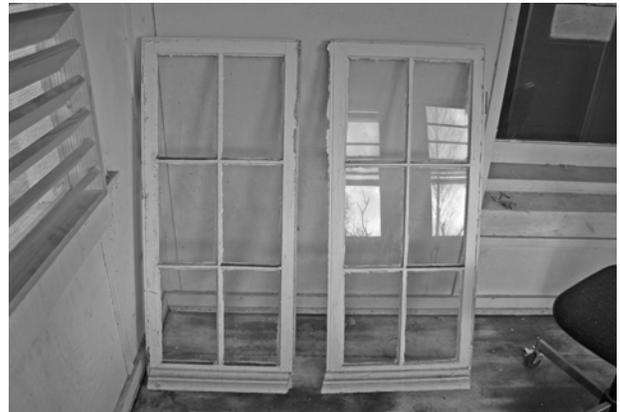
FIGURE 38. One of the surviving pairs of original sleeping porch windows.

The second-floor sleeping porch was originally constructed with ten pairs of six-light casement windows, 1"- 9" by 4'- 0" by 1- 3/8", mounted on 3" butt hinges. The eight pairs of windows across the rear of the porch have since been replaced with 1/1 aluminum windows, but the original pair of windows at each end of the porch remain intact.

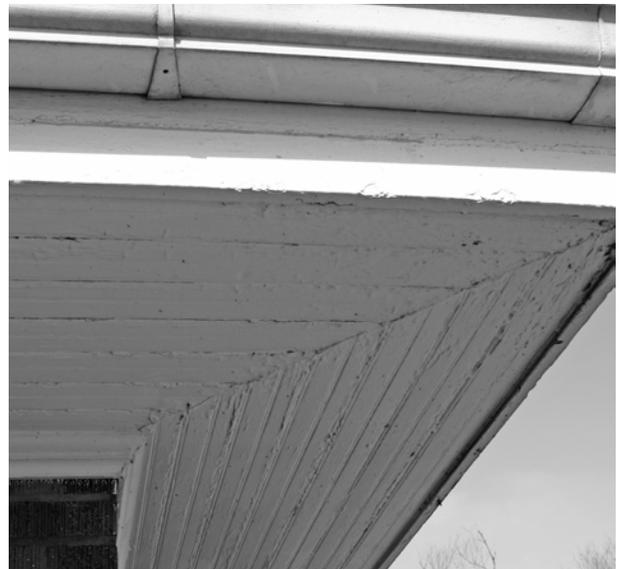
**Existing Condition.** Eaves are in good condition except on the back porch. There, an eight-foot section near the middle of the porch has been severely damaged by water penetration, probably through faulty flashing around a plumbing vent stack that penetrates the eaves at that location.

FIGURE 43. View of southeast corner of eaves on main block.

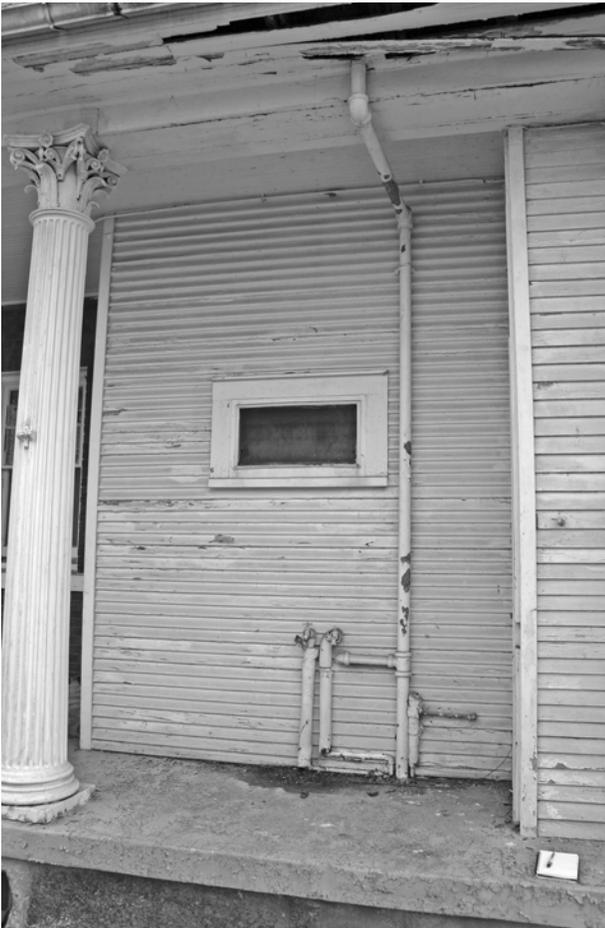
FIGURE 46. View of added bathroom.

**Existing Condition.** While the siding appears to be in good condition except for deteriorating paint, removal of a run of siding on the northeast side of the bathroom revealed significant termite damage between the sheathing and the siding. The 1965 siding remains in good condition, and because of its elevation, the sleeping porch may not have suffered damage.

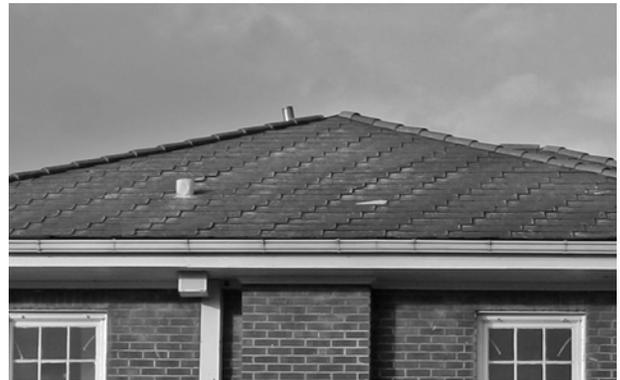
**Existing Condition.** The surviving cement- asbestos roof covering appears in good condition but significant damage was done to the northeast shed of the main roof when the chimney collapsed in the 2005 storm. All of the ridge cap is also missing from the north ridge of the roof. The other roofs appear to be functioning, although the pent roof at the rear porch is rusting. The condition of the tar- and- gravel roof of the sleeping porch was not examined. Gutters are in fair condition, but appear to be undersized. Along with temporary repairs to the roof in the fall of 2005, temporary extensions were added to the downspouts to keep run- off away from the house.

FIGURE 47. View of southwest shed of main roof.

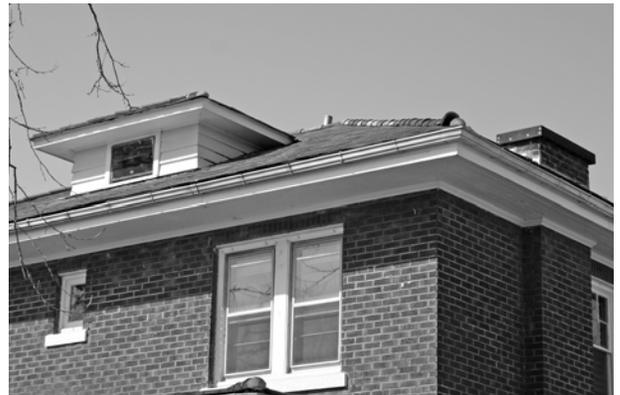
FIGURE 48. View of front dormer and capped chimney.

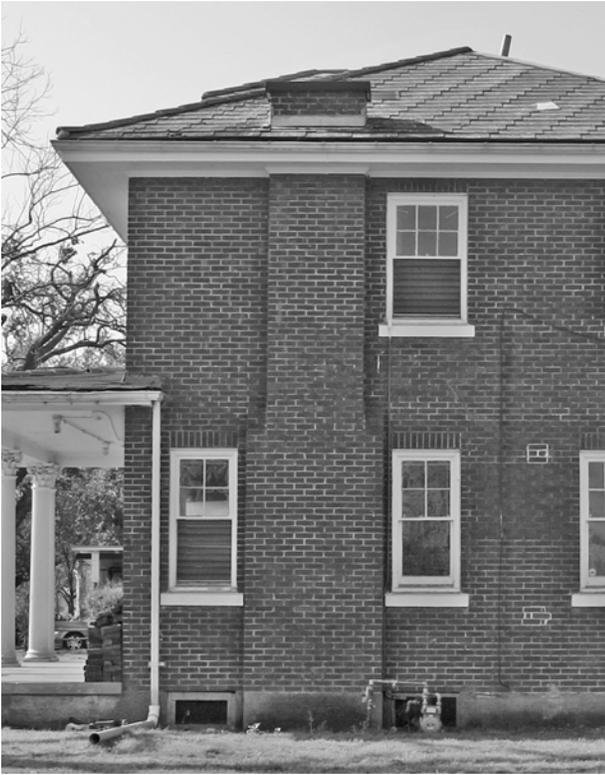
FIGURE 50. View of northeast chimney.

The house has three brick chimneys, but none of them is intact above the roofs. The principal chimney, located on the northeast side of the house, was destroyed during the recent hurricane. It has two flues which originally served the living room fireplace and a wood-burning stove in Room 201. Five feet wide at its base, this chimney corbels to about 44" at the height of the first floor window lintels before rising through the eaves and the roof. Originally rising some 7- 1/2' above the roof, the upper portion of this chimney was largely destroyed during the recent hurricane. The cast-stone coping which measures 4" by 21" by 46" and originally capped the chimney, is now leaning against the front porch. The chimney has been temporarily capped just above the roof line, and brick from the chimney are piled near the northeast end of the porch.

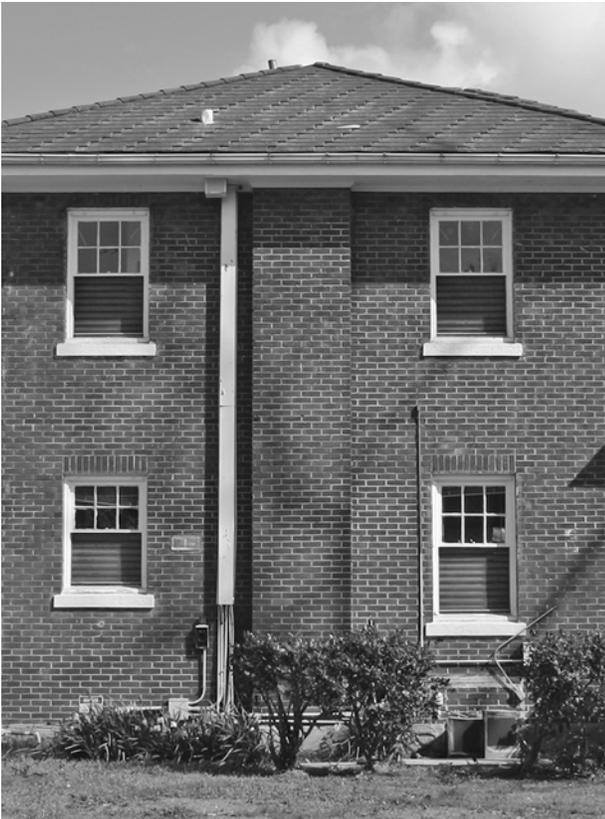
FIGURE 51. View of southwest chimney.

The chimney on the southwest side of the house is also an original chimney, but the stack above the roof was removed as early as the 1940s or early 1950s. Forty-two inches wide, this chimney also has two flues, which originally served wood-burning stoves in Rooms 102 and 103.

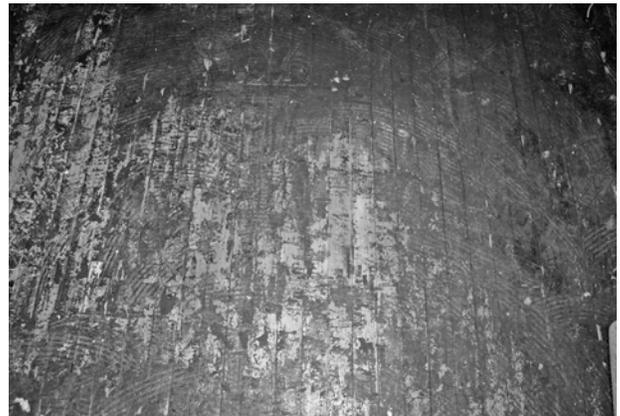
**Existing Condition.** In spite of flooding, the flooring remains in surprisingly good condition, with only minimal cupping and with buckled flooring only in one or two isolated locations. It is unclear, however, how much permanent discoloration has occurred due to water damage. Mastics from rubber or vinyl floor coverings cover much of the flooring in Rooms 103 and 206, although the vinyl floor covering itself has been removed. In room 203, sheet vinyl was installed over 9" by 9" vinyl tiles, much of which remains intact, although in poor condition. Remnants of carpet backing adhere to the flooring in Rooms 101, 102, and 104. The flooring in Rooms 201, 202, 204, and 205 remains in good condition.

FIGURE 53. Oak flooring in Room 103 with mastic from vinyl floor coverings.

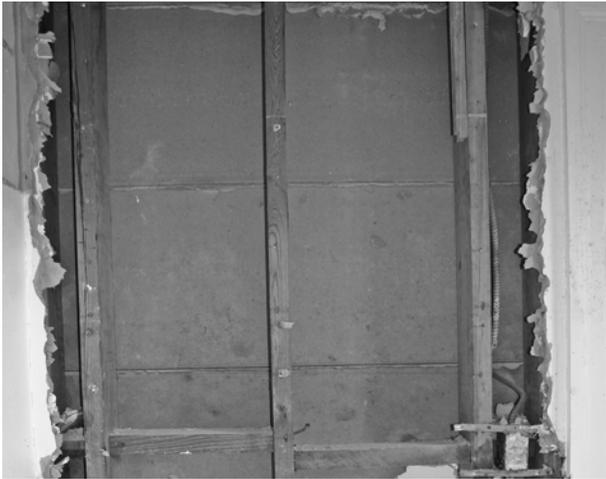
FIGURE 56. View of wall in Room 103 with rock lath in adjacent room exposed.

**Existing Condition.** In spite of flooding, most of the surviving interior plaster remains sound. Most plaster has been removed from the southeast wall of Room 103, and there is significant ceiling damage in Room 205. All of the fiberboard in Room 105 and all drywall in Room 106 were removed during stabilization after the flood. Fiberboard remains mostly intact in Room 206, except for some holes punched in the back wall and a panel of the ceiling which has been removed. Painted finishes on all surfaces are in fair to poor condition, with significant peeling and flaking in the kitchen and bathroom.

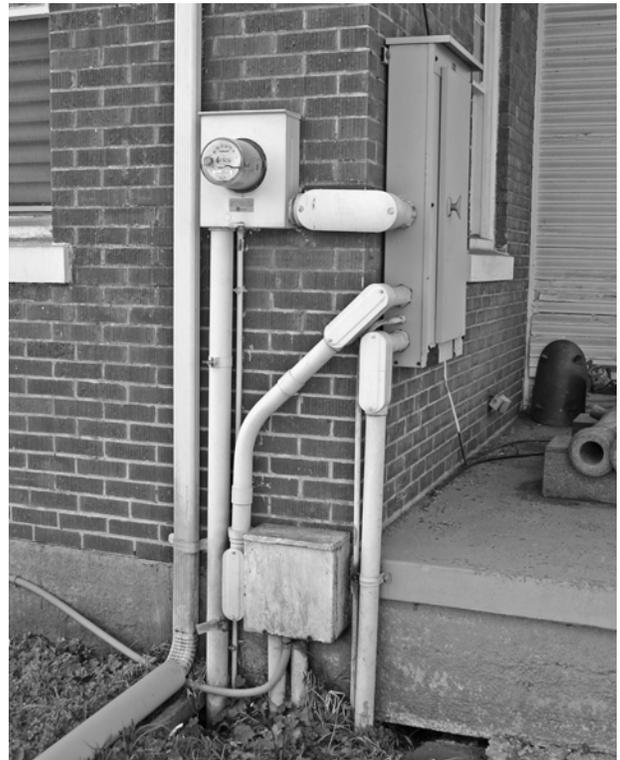
FIGURE 63. View of electrical service at north corner of house.

**Existing Condition.** Although some components might be suitable for re- use, most of the building's mechanical and electrical systems are either missing or in poor condition.

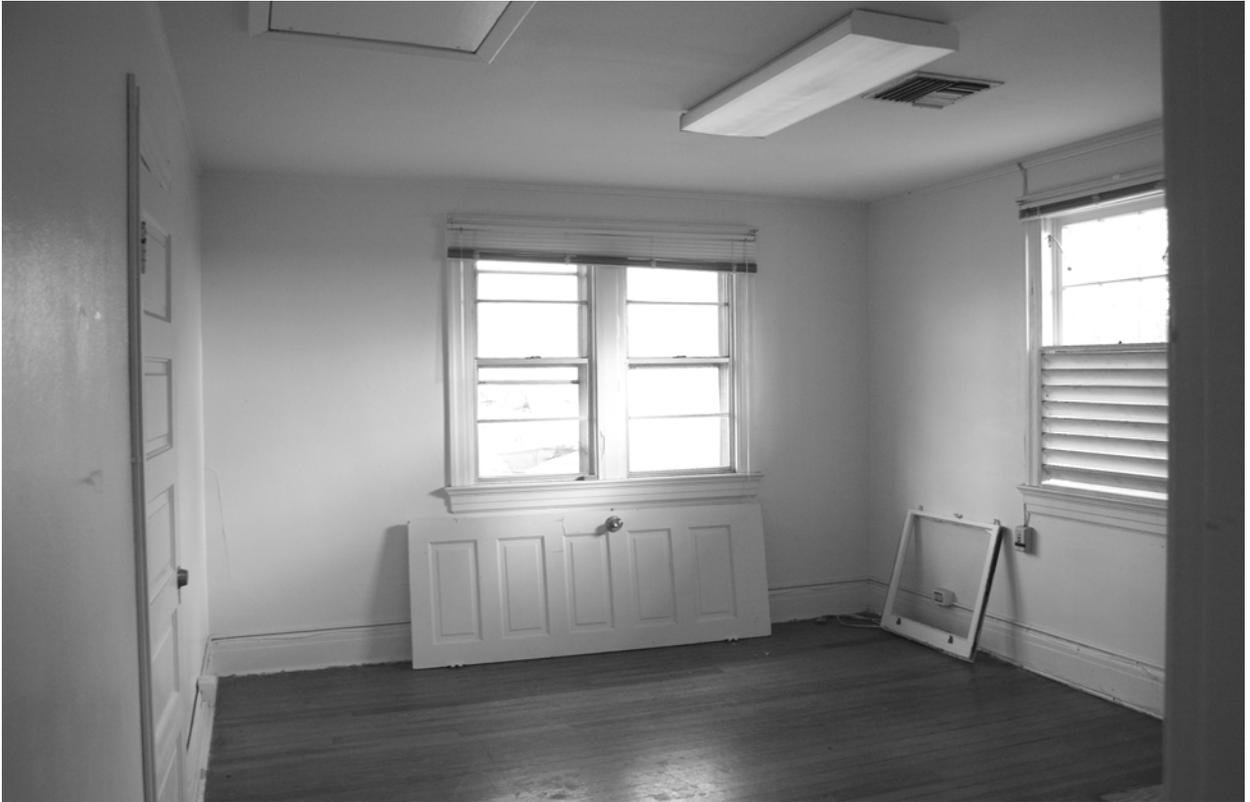
**Master Bedroom (202)**

FIGURE 74. View south in Room 202.

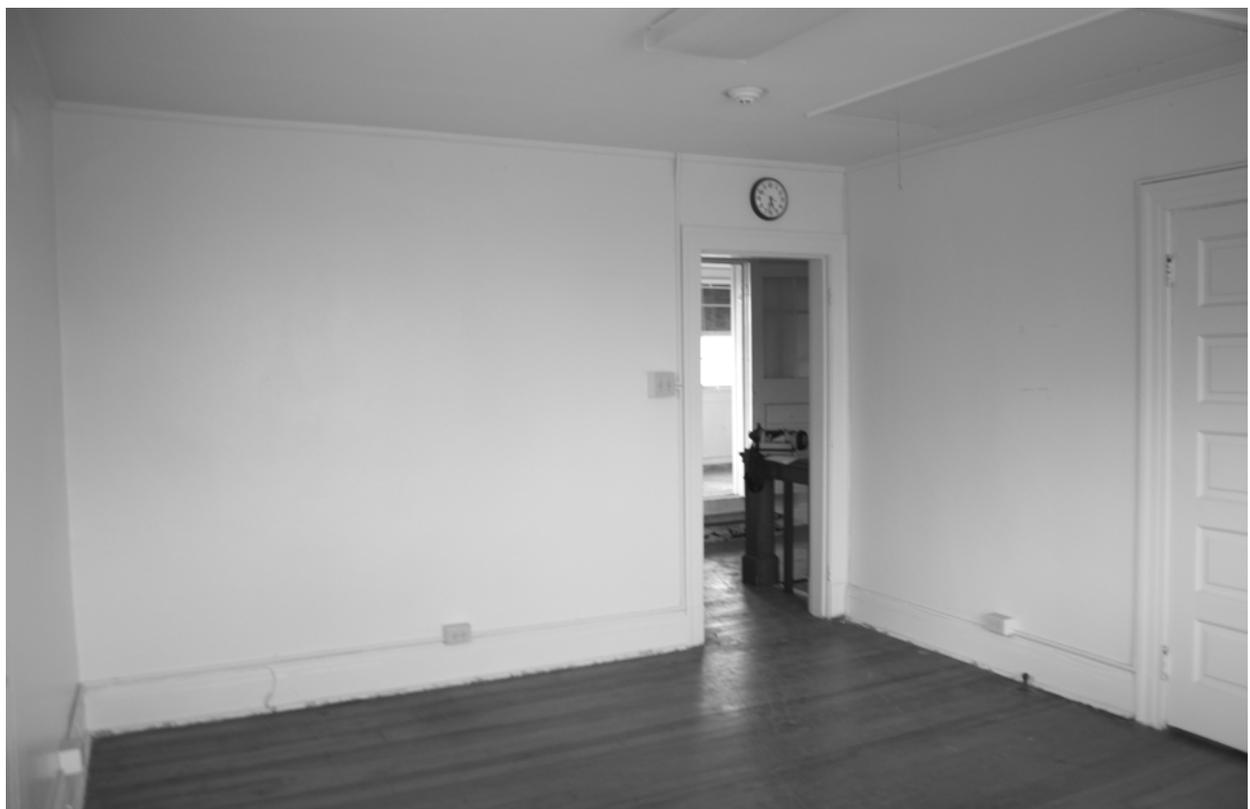
FIGURE 75. View north in Room 202.
