Ocmulgee National Monument
Dunlap House
Historic Structure Report

March 2011

2011
Historic Structure Report
Dunlap House
Ocmulgee National Monument

Management Summary

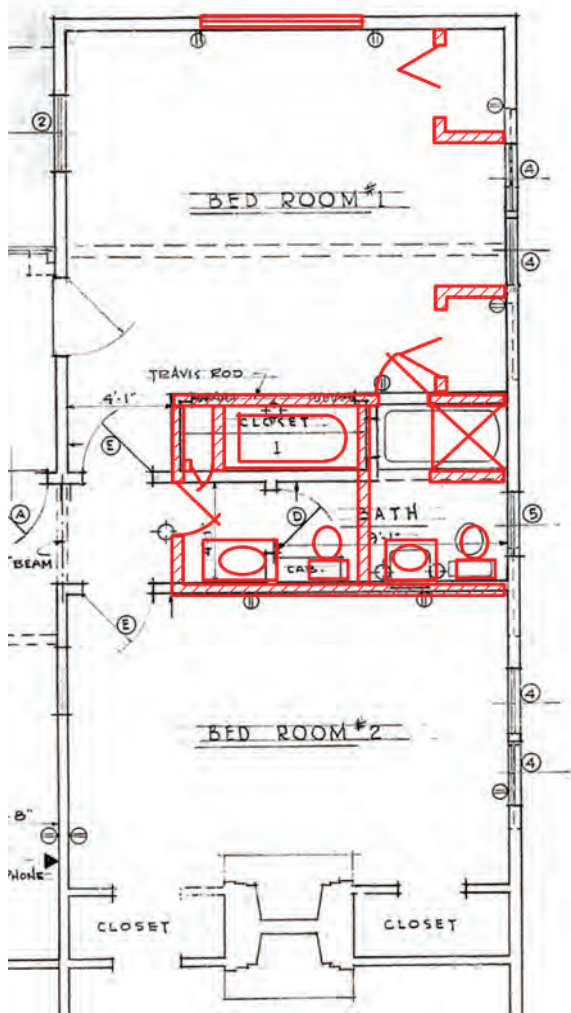
Figure 13. Detail from 1952 plan overlaid with alterations that were made in the late twentieth century. The plan of the rest of the house has not been altered since 1952.

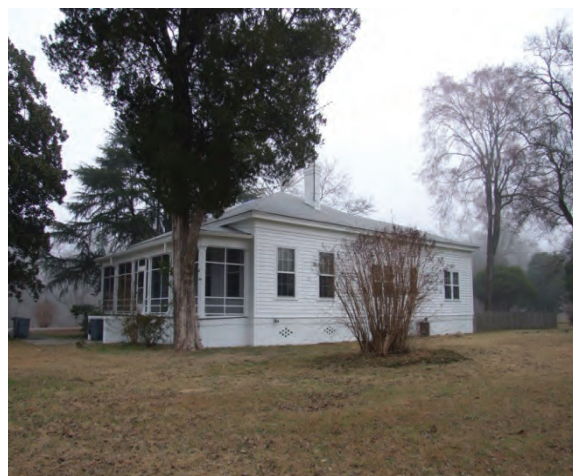
Figure 2. View southeast showing historic red cedar near northwest corner of house.

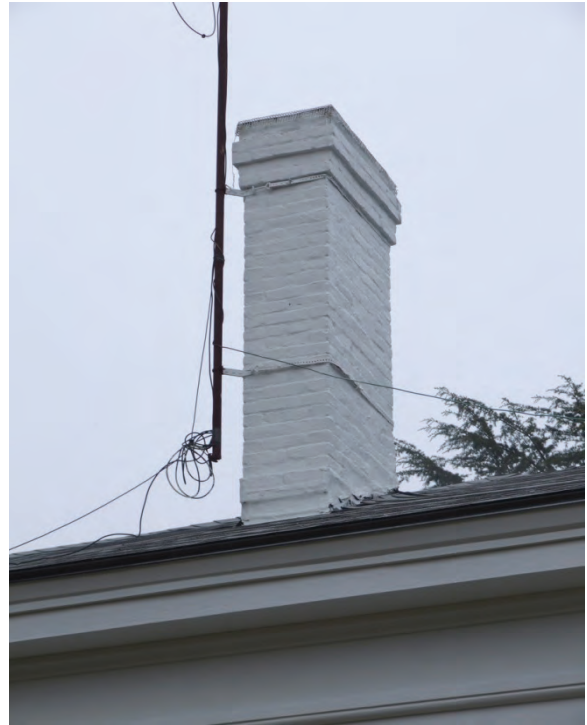
Figure 5. View of west chimney and part of attached television antenna.

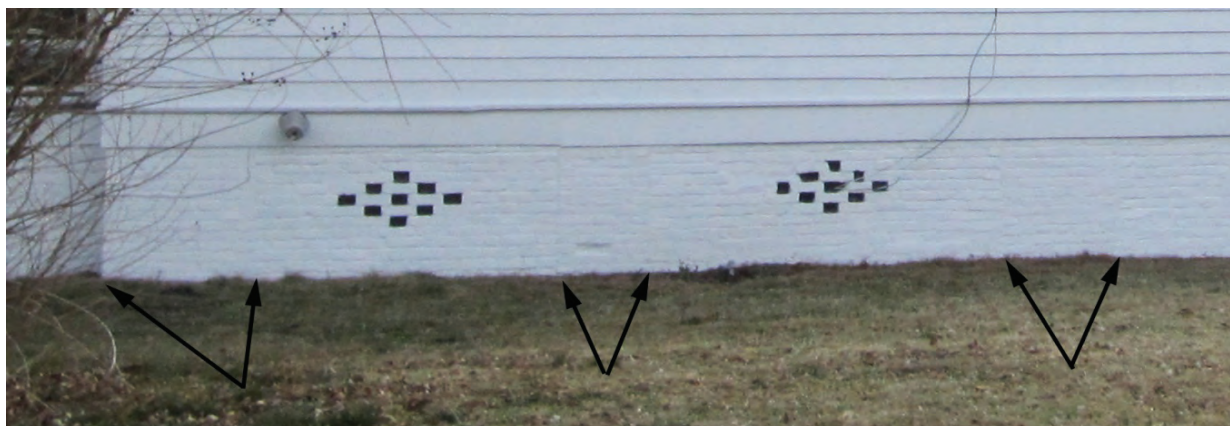
Four types of original piers, all of which vary slightly in height, were observed. The outside corners of the house rest on piers that are L-shaped in plan, 12" by 38" by 38". The intersections of load-bearing sills with the perimeter sills are supported by T-shaped piers, 12" by 28" by 14". Between the L piers and the T piers, a single rectangular pier, 20" by 12", is typical. A series of 16" piers supported the original structure, but these have been supplemented by additional piers to accommodate the mid-twentieth century alterations to the house. Original cross-shaped piers were not observed but probably support the junction of sills along either side of the central hall. No significant problems were observed in the present arrangement of the present foundation.

Figure 5. View of foundation at north end of west side of house, annotated with arrows to indicate the three types of perimeter piers: L-shaped, left; rectangular, center; and T-shaped, right. The vented brick panels between these piers were part of the 1938 remodeling.

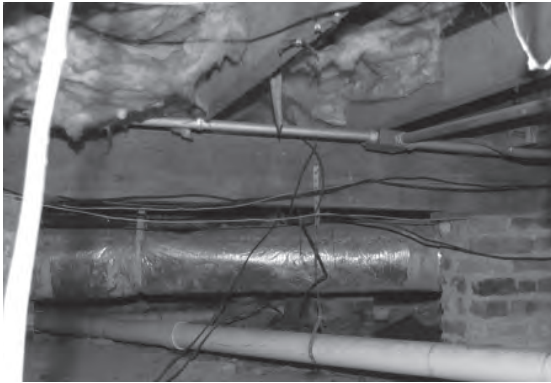
Figure 6. View of typical connection between original floor joists running east and west and the girders that run north and south on each side of the original center hall. The tangle of wires is typical in much of the crawl space beneath the house.

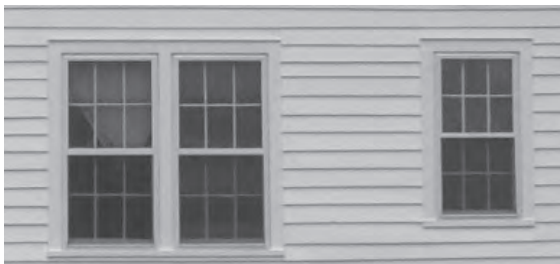
Figure 10. View of window openings created in 1952, all of which included a drip cap not present on the original window openings.

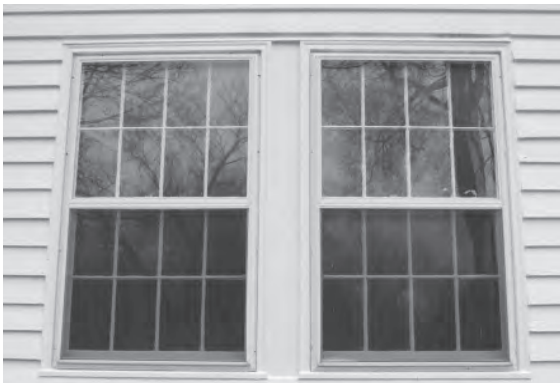
Figure 11. View of window opening at south end of Room 107, created in the last quarter of the twentieth century.

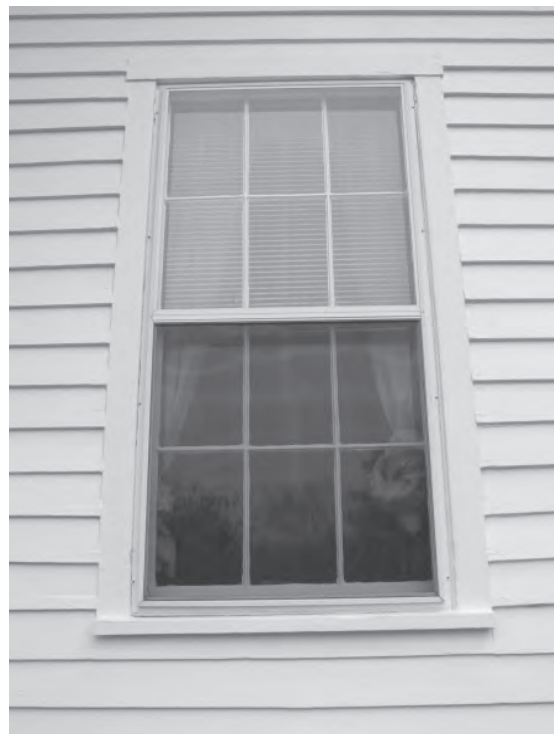
Figure 9. View of typical 1856 window opening.

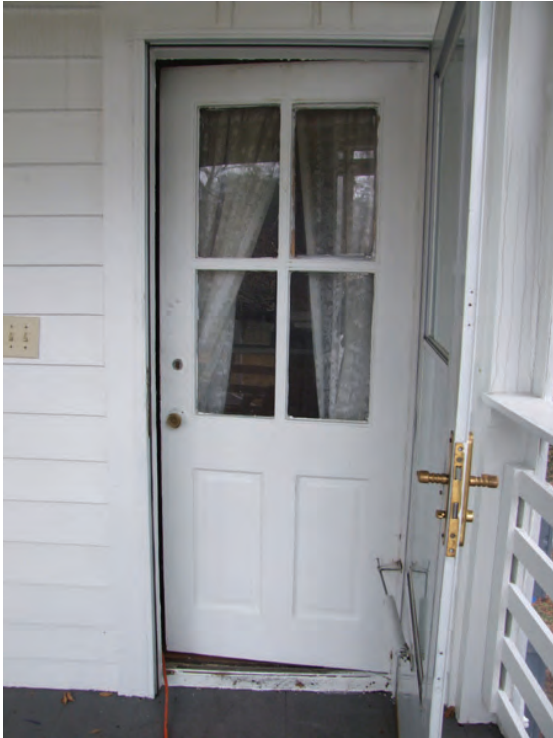
Figure 13. View of kitchen back door, installed in 1952.

The 1952 plans call for new doors at the back porch door openings at Rooms 105 and 109. Both doors still exist, each with four lights above two vertical panels and with some of their original hardware, but the door at Room 105 was damaged by fire fighters gaining entry to the building.

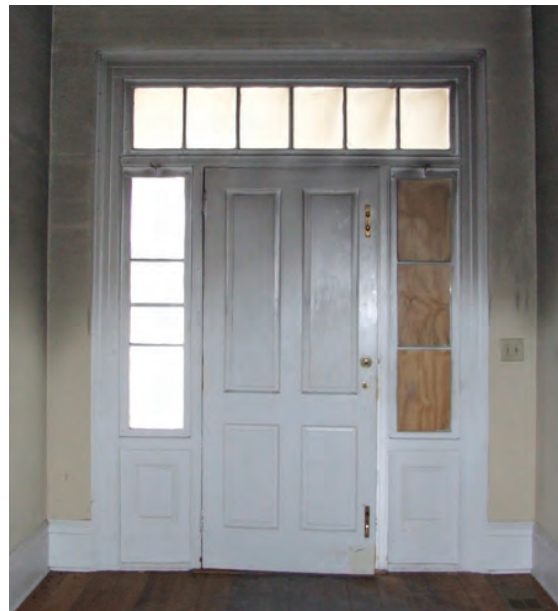
7'-2" by 1¾" and dates to the 1980s. There appears to be a solid door in place in the 1952 photographs, but how many panels it might have had is not known. Because of its location, it might be assumed that the historic character of the front door was replicated in the present door.

Figure 12. View of front door, transom, and side lights.

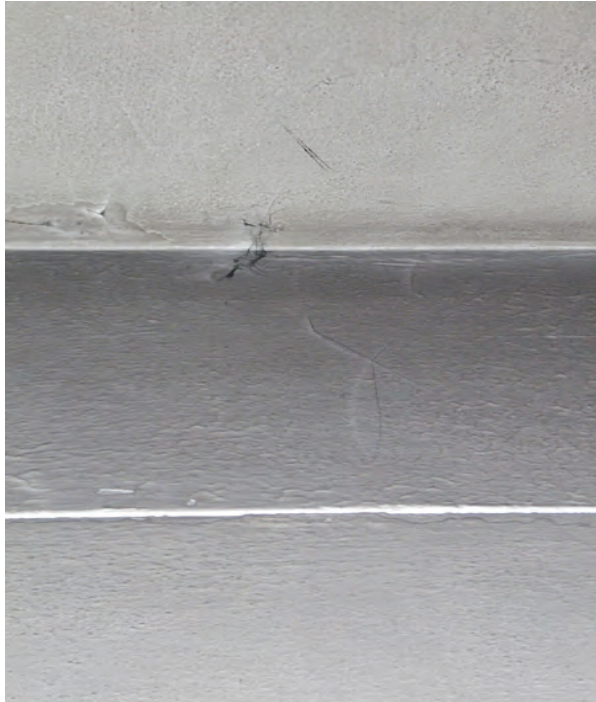
Figure 18. View of juncture of living room wall with ceiling, showing the slightly thicker plaster evident in the frieze.

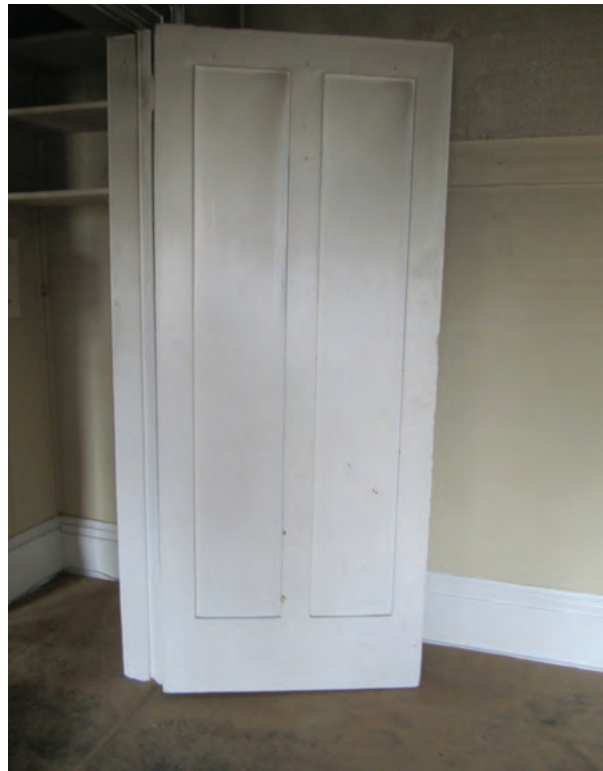
Figure 20. View of one of the two, two-panel doors in Bedroom #2, probably the only nineteenth century doors left in the house.

The only two nineteenth-century doors remaining in the house appear to be the closet doors in Bedroom #2 (102). With two vertical panels, these would have been considered very old-fashioned in the 1850s. Neither the 1936 nor the 1952 plans call explicitly for replacement of doors, but the 1952 plans call for new doors in nearly every opening in the house. Most of the original openings that were not altered do not show doors at all, including the openings with the present two-panel doors in Bedroom #2 (102), but it is not clear if doors were not present or simply not shown on the plan. The plans also give no indication that the present four-panel doors replicated the original door design, but it is likely that they did. It would not be surprising to have had four-panel doors at the openings off the center hall, and probably the front and back doors as well, while having two-panel doors at the closets.

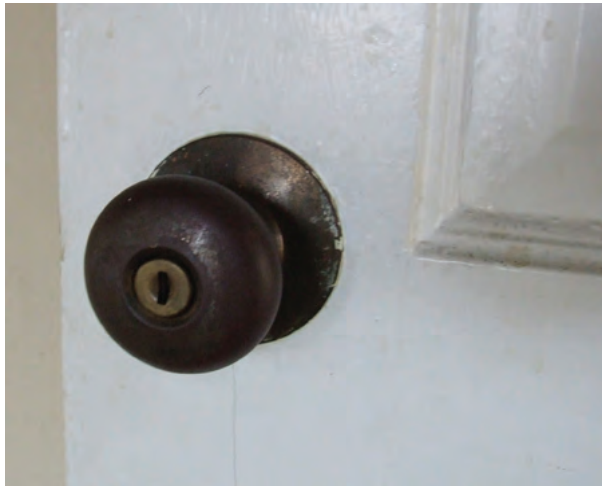
No nineteenth century hardware has been observed in the house. All of the window lifts, hinges, and locksets date to the twentieth century, most to the early 1950s. All are brass-plated.

Figure 23. View of a typical lockset from the 1950s.
