**WRIGHT BROTHERS NATIONAL MEMORIAL
VISITOR CENTER**

**HISTORIC STRUCTURE
REPORT**

2002
Historic Structure Report
Wright Brothers
National Memorial Visitor Center
Kill Devil Hills, North Carolina
LCS#: 91645

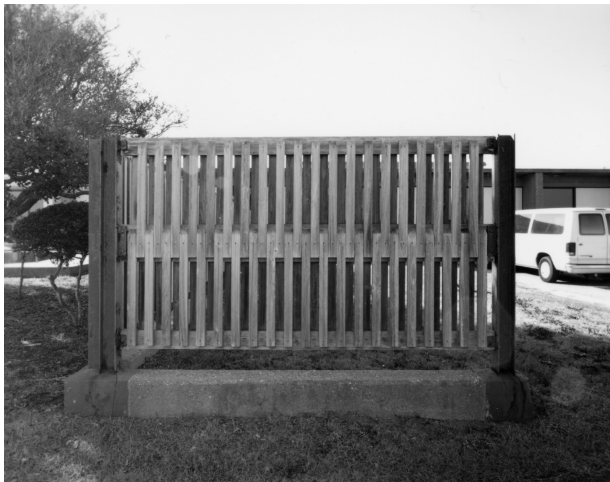
Figure 16 View of fence along east side of employee parking lot (National Park Service, 2000)

There are three fences that mimic the original design but that were added within the last twenty years. One screens the non- original HVAC unit condenser and an above- ground fuel tank at the northeast corner of the building. The second is a fence along the east side of the staff parking lot. The third screens utility equipment east of the staff parking lot. All three of the non- contributing fence/screens have slats similar to the original design but with posts that are pressure- treated 6 x 6's.

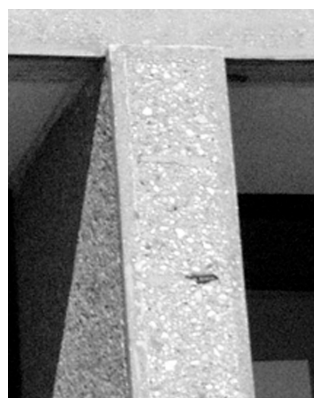
Figure 19 Left, detail of typical pier showing exposed-aggregate panels with smooth-troweled border (National Park Service, 2000)

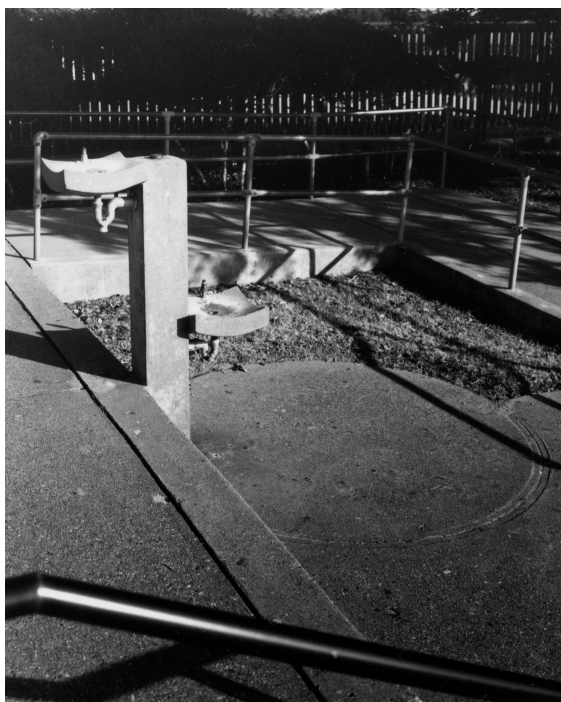
Figure 21 Below, view of original, cast-concrete, water fountains on northeast side of entry terrace. Note original circular pavement at grade and modern ramp and railing. (National Park Service, 2000)

designed for the east side of the Entry Terrace near the rest rooms. No longer operative and now beginning to deteriorate, the fountain features two concave, squarish bowls, one accessible from the Entry Terrace and the other accessible from a semi- circular, ground- level, concrete pad along the east side of the Terrace.

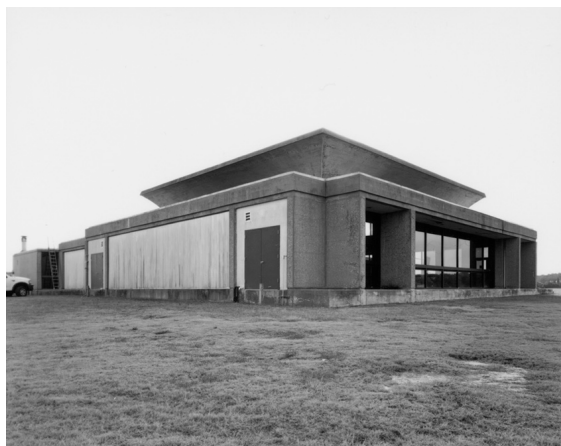
Figure 25 Above, view of northwest corner of building showing modern window system at right, white "Shadowform" panels and infilled window bays on north side of building at left (National Park Service, 2000)

In 1976, in conjunction with replacement of the building's windows and doors, the exterior wood paneling was covered by the existing extruded- aluminum panels. Marketed under the name of "Shadowform" by Kawneer Architectural Products, who also produced the present window- wall system, these panels are finished with a white "Silica Bond" coating that was meant to mimic the appearance of textured concrete surfaces. The loss of the vertical wood paneling on the exterior is, with the window replacement, one of the most significant alterations to the structure's historic appearance.

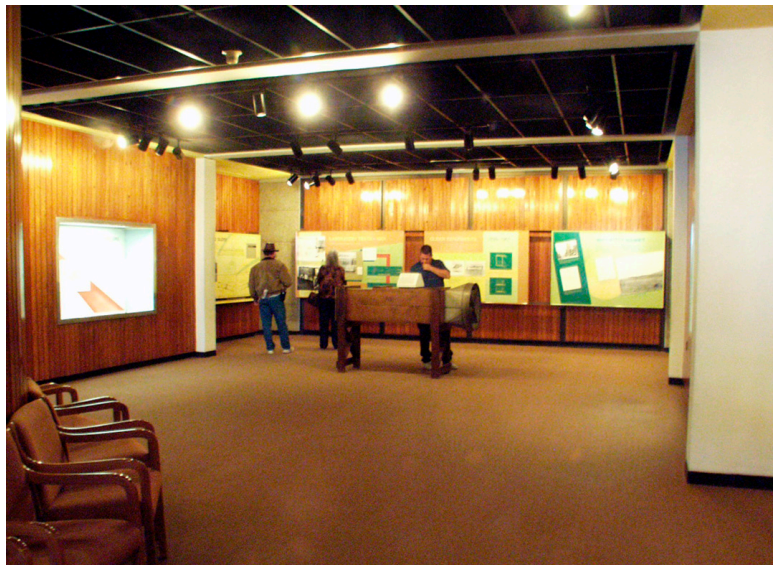
Figure 31 Below, same view, today (National Park Service, 2000)

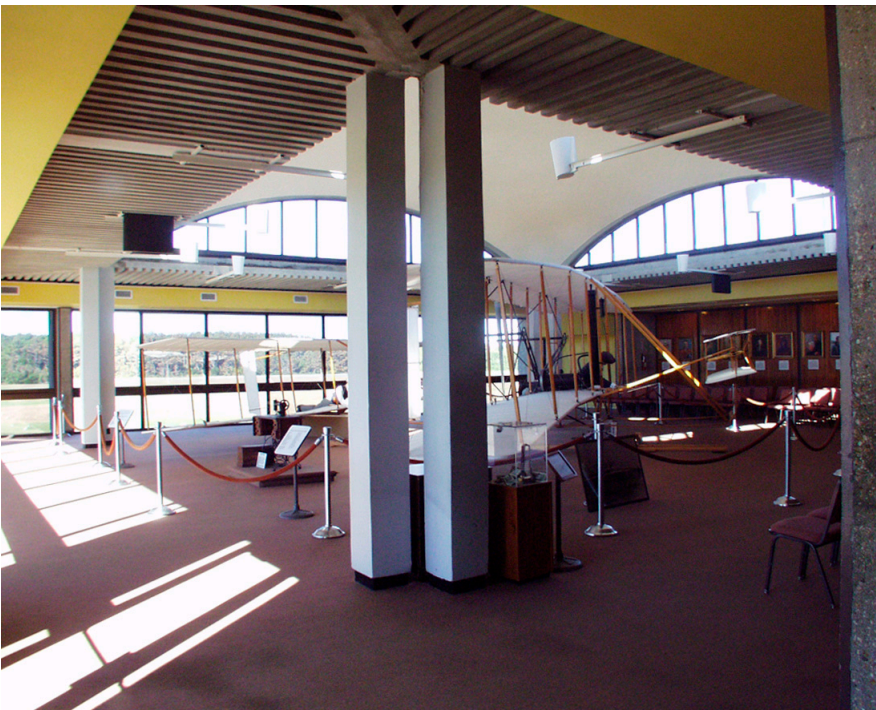
Flooring: Low- pile, industrial- grade carpeting now covers the concrete floor, a significant change from the light- colored reflective quality of the rubber tile which was originally specified. The same rubber tile specified for the Lobby and the Flight Room was also specified for this room but with a 4 inch rubber base rather than the metal base used in the other two spaces. Manufactured by Robbins Floor Products in Tuscumbia, Alabama, "or approved equal," the tile was 9 x 9 x 1/8 in a pattern called "Patio- Tile." No substitution of pattern was permitted, according to the specifications, and "colors [were] selected from full- range available in this pattern."

Figure 33 Below, present view to northwest in Flight Room (National Park Service, 2000)

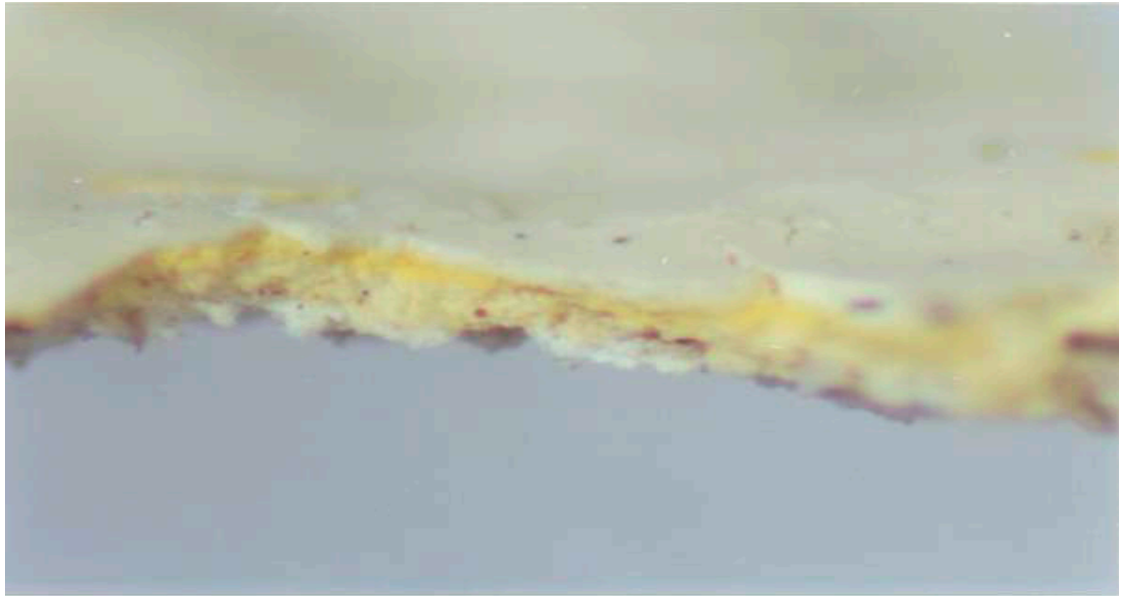
Analysis of paint sample P002 removed from the cement-based plaster soffit at the west side of the building indicates that this element of the building was originally painted light-yellow falling between Munsell colors 2.5Y 9/2 and 2.5Y 9/4 (2.5Y 9/3) and more closely matching Benjamin Moore "Moor-O-Matic" color #170. This finish was applied over a cream-white colored primer. The original light-yellow finish was subsequently replaced with a red-colored paint similar to the 4th paint layer found on the sample removed from the metal fence post (see item C below). In later years the red-colored finish was replaced with a bright-yellow finish, a light yellow-colored finish similar to the original finish and finally with the existing "canary" yellow-colored finish we see today.

Fig. 2 Paint Sample WRBR-VC-P002 removed from Exterior Facia of Wright Brothers National Memorial Visitor Center, Viewed at 30x. Note Original Light-Yellow Finish and Cream-White Primer Beneath Later Bright Yellow Finish (Intermediate Red-Colored Finish is not Visible in Photograph), (2000).

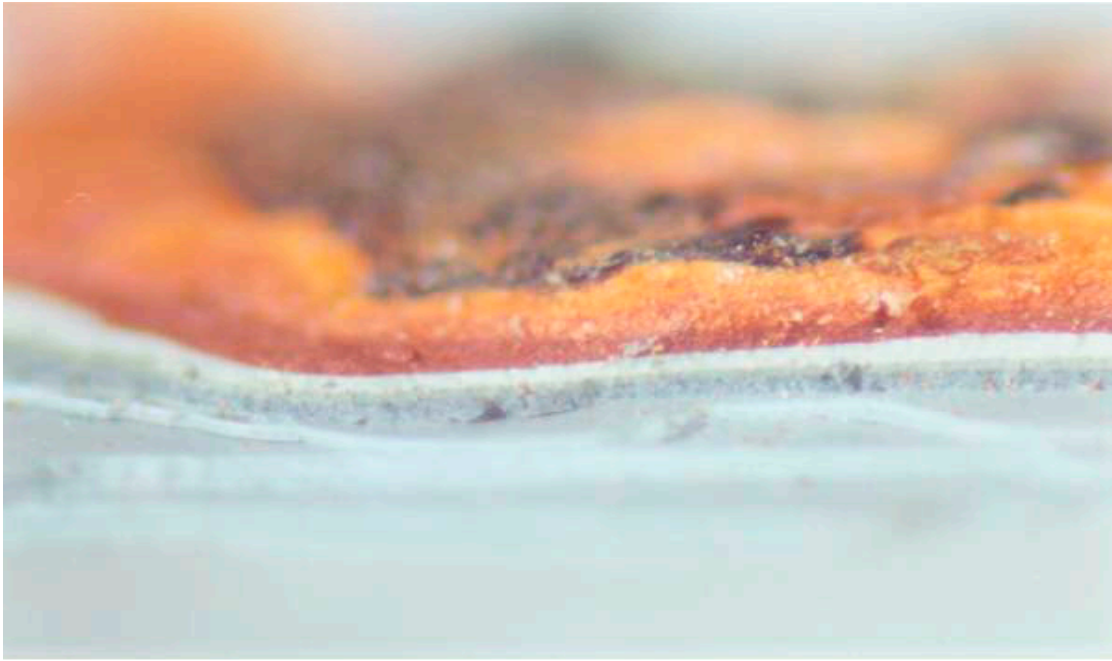
Original painting specifications for the building indicate that exterior ferrous metal elements were to be painted with a rust inhibitive primer and 2 coats of “Noxide” metal paint. Under microscopic examination of paint sample P003 removed from the western most metal fence post located east of the Visitor Center, a light orange-colored primer can be seen beneath what appears to be the 2-coat original finish applied to the fence posts. This original finish is an orange-colored paint matching Munsell color 2.5YR 6/16. This finish was subsequently replaced with a red-colored paint and later with a series of gray-colored paints. The red finish which matches Munsell color 10R 3/4 is very similar to the second finish found in the sample removed from the buildings exterior soffit and was likely applied in the late 1960's or early 1970's based on the number of subsequent paint layers found on these elements.

Fig. 3 Paint Sample WRBR-VC-P003 removed from Fence Post East of Wright Brothers National Memorial Visitor Center, Viewed at 30x. Note Original Orange Finish and Primer Coats. Later Red-Colored Finish is Believed to Date from Late 1960's or Early 1970's, (2000).

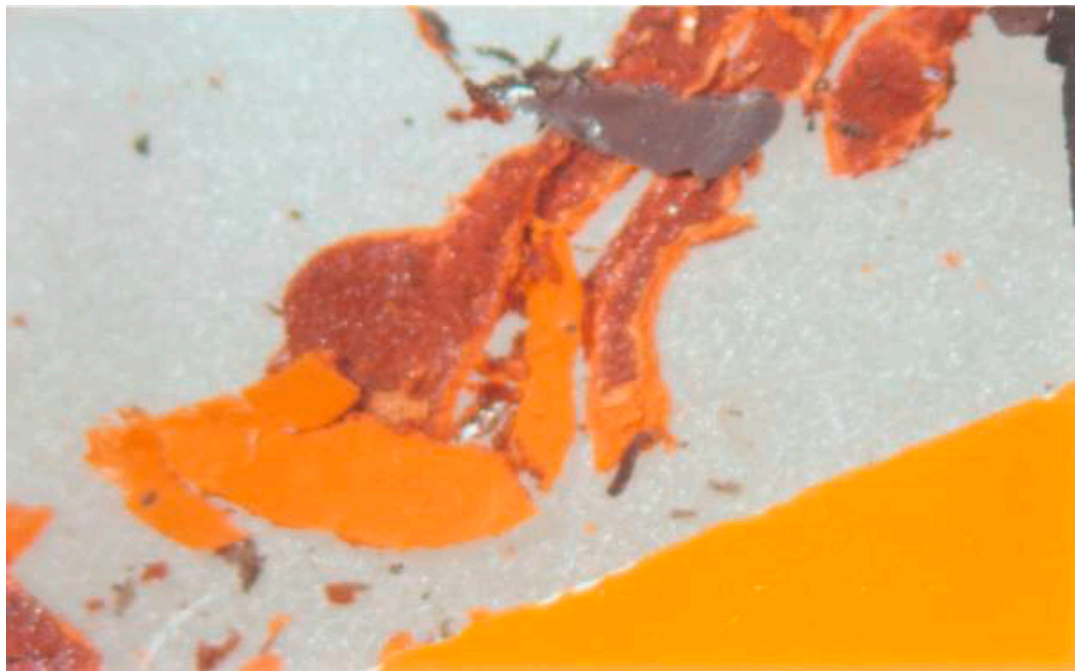
Analysis of paint sample P006 removed from the metal trim at the room's east wall indicates that these elements of the room were originally primed with a red-colored metal primer and an orange-colored paint primer. Over the orange paint primer was applied the element's original finish coat, which was an orange-colored paint matching Munsell color 2.5YR 6/16. This orange-colored finish was subsequently painted over with a dark brown-colored paint and later with the existing brown-colored paint we see today.

Fig. 4 Original Orange-Colored Finish and Primers Found on Interior Metal Trim of Wright Brothers National Memorial Visitor Center (Munsell Color Chip 2.5YR 6/16 Visible in Lower Right Corner of Photograph), (2000).

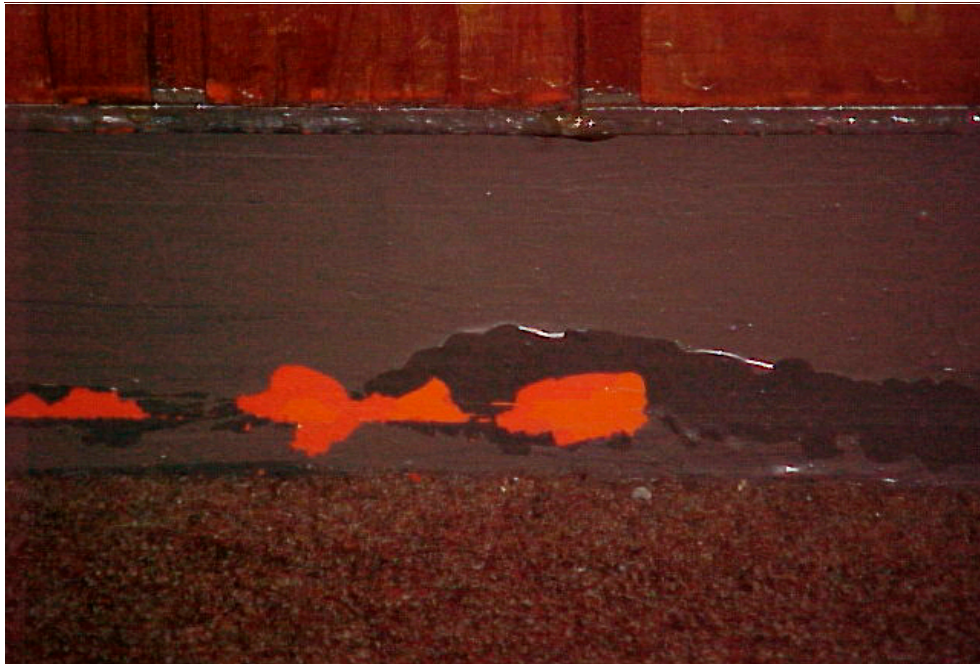
Analysis of paint sample P018 removed from the metal trim associated with the east wall of the room shows that this element was originally finished with an orange-colored paint matching Munsell color 2.5YR 6/16. Subsequent finishes found on this element of the room include an even brighter red-orange colored finish, as well as subsequent yellow-orange, dark brown and brown-colored paint finishes.

Fig. 8 Detail of Metal Baseboard Trim in Assembly Room of Wright Brothers National Memorial Visitor Center. Note Original Orange Finish, and Later Red-Orange, Dark Brown and Brown-Colored Finishes, (2000).

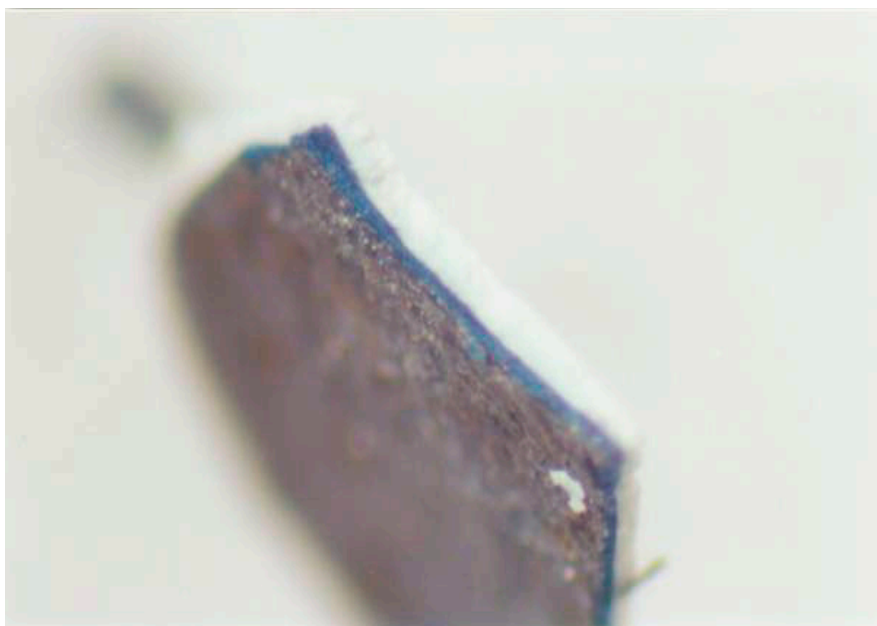
The soffit mounted lamps and support brackets found in the Assembly Room were originally finished with a dark blue paint matching Munsell color 10B 2/6. This finish was applied over a dark blue-colored paint primer and a gray-colored metal primer. The lamps were painted twice more in their history with an off-white colored finish and the existing white-colored finish.

Fig. 11 Paint Sample WRBR-VC-P024 removed from an Original Light Fixture in the Assembly Room of the Wright Brothers National Memorial Visitor Center, Viewed at 40x. Note Original Zinc Powder Metal Primer, Dark Blue Paint Primer and Original Dark Blue Finish, (2000).

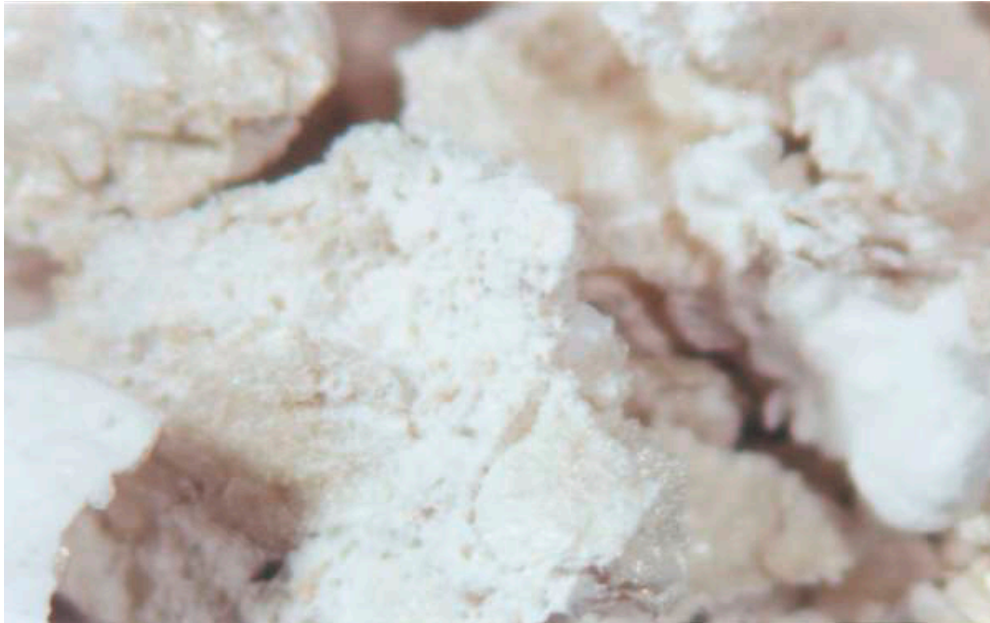
Paint sample P028 removed from the domed ceiling of the Assembly Room showed a single white-colored paint finish applied to what is believed to be replacement acoustical spray material consisting of mica, gypsum and possibly vermiculite materials. Examination of the sample under a polarized light microscope at 40X also verified the absence of asbestos fibers, which the original ceiling material is purported to have contained.

Fig. 12 **Replacement Acoustical Ceiling Material, Wright Brothers National Memorial, Visitor Center, Assembly Room, Viewed at 10x, (2000).**

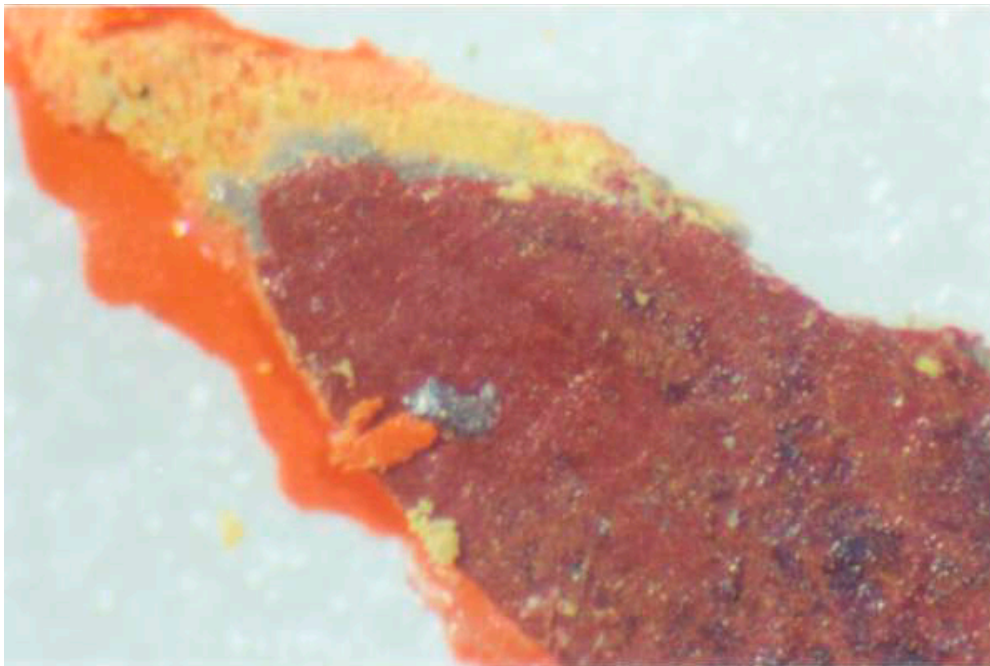
Analysis of paint sample P031 removed from the door jamb of the building's Janitor's Closet indicates that like all of the metal trim work found in the building, the door jambs of the Office Area were also originally finished with an orange-colored paint matching Munsell color 2.5YR 6/16. This finish was applied over a lighter orange-colored primer, as well as original light-yellow paint from the adjacent wall surface. Also present beneath the original orange-colored finish is a "shop" applied red-brown primer and what is likely a touch-up primer specified in the building contract at page 15-3 (Painting and Caulking). Subsequently, three other finishes were applied to this element; the brighter red-orange colored finish found as the second finish on the metal trim work throughout much of the building; a dark brown-colored finish; and the brown-colored paint we see today.

Fig. 13 Paint Sample WRBR-VC-P031 Showing Original Red-Brown and Gray-Colored Primers, Yellow-Colored Paint Found on CMU Wall Surfaces, and Orange-Colored Paint Found on Door Jambs in Office Area of Wright Brothers National Memorial, Visitor Center (Viewed at 50x), (2000).

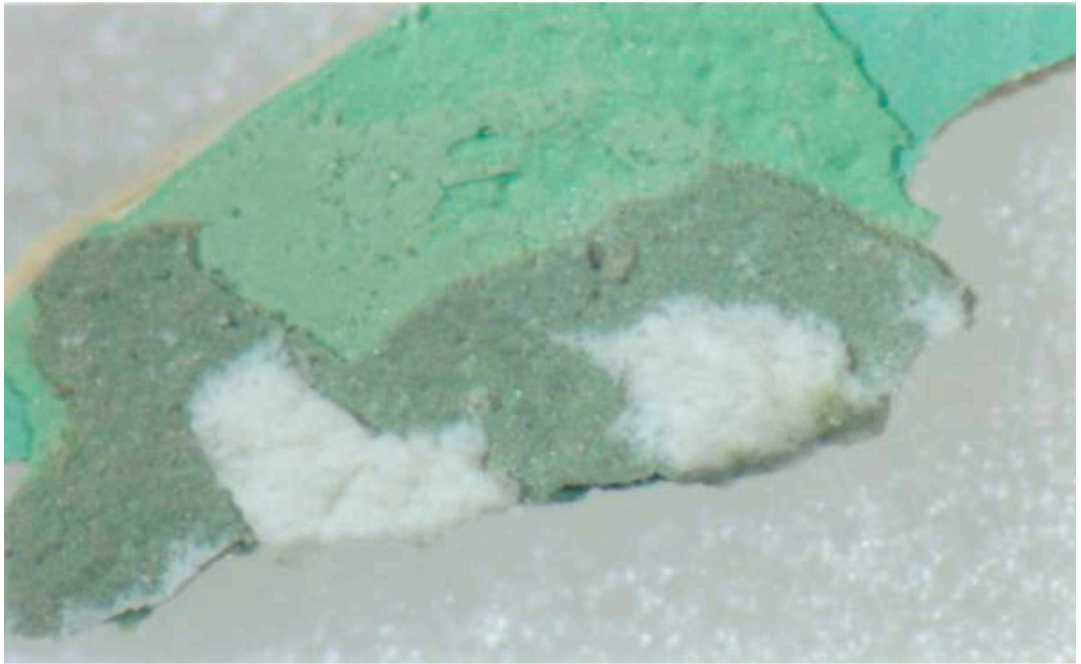
Analysis of paint sample P032 removed from the door of the Janitor's Closet shows that this element of the building was originally painted green matching Munsell color 7.5GY 5/2. Later finishes applied to the door's surface include two lighter green-colored finishes as well as a cream and the white-colored finish found on the door today.

Fig. 14 Paint Sample WRBR-VC-P032 Removed from a Door in the Office Area of the Wright Brothers National Memorial Visitor Center, Showing Original Green-Colored Paint and White-Colored Primer (Viewed at 30x), (2000).

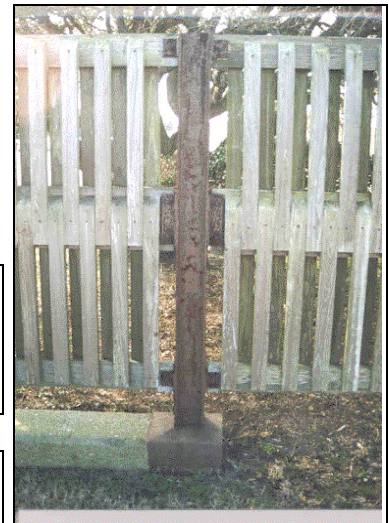
Deficiency: Steel posts are substantially corroded and pitted due to exposure to the elements. Existing wood on remaining original section of fence may not be original but dimensions appear to be faithful to dimensions on original drawings. Wood to wood mechanical attachments appear to be new and either stainless or galvanized.

Recommendation: Replace original fence at two locations shown on original site plan to match details in original drawings.

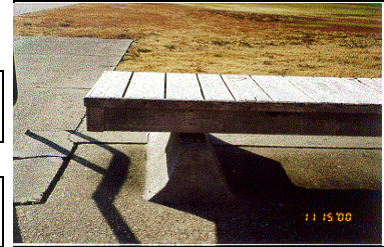
Deficiency: The wood bench is not original. The cove bases appear to be original.

Recommendation: Reconstruct bench to match original design and detail. Restore concrete bases.

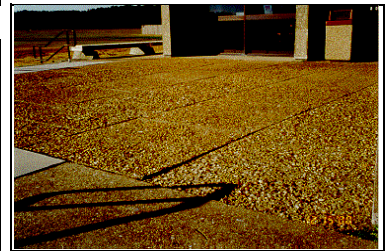
Deficiency: Surface deterioration in exposed coarse aggregate areas from freeze thaw and use. The fine aggregate band is inappropriately altered by the introduction of replacement panels that do not match the original in color or texture. The replacement panels are a cool light gray and textured with a broom finish.

Recommendation: Consideration should be given to the approach to improving the condition of the 4'x4' exposed aggregate units. Alternatives could range from concrete restoration to replacement. The 9" band of broom-like finished concrete should be replaced to match the original finish, unit dimensions and color. Reposition handicapped ramp to not intrude on front approach. Replace ADA railings at the front entry with rails of a design and detail more appropriate to the character of the original design.

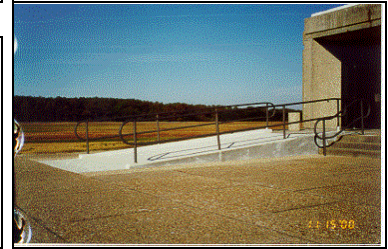
Deficiency: The condition of the ceremonial terrace is similar to the condition of the entry terrace. The lower level of the ceremonial terrace is exposed large aggregate, while the upper presents a fine aggregate exposure. The primary deficiencies include: eroded concrete in exposed large aggregate area, not critical but noticeable; inappropriate ADA ramp intruding into the plaza area; replacement of upper sections of slab with concrete of inappropriate color and texture; installation of inappropriate ADA railings in style of railing and method of insertion into the concrete surface.

Recommendation: The treatment of the ceremonial terrace is similar to the entry terrace. Consider the repair/replacement of the exposed large aggregate areas on the lower terrace where appropriate to match the historic character in texture, color and dimension. Remove and reconsider the ADA ramp to and from the building. Replace non-historic upper terrace concrete units to match original in color, dimension and texture. Remove handicapped railings and replace with detail more sensitive to the design of the original building.

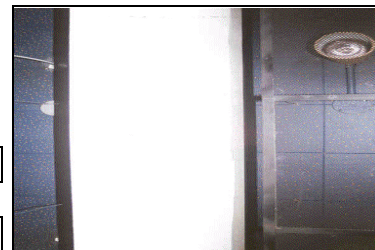
Deficiency: None identified.

Recommendation: Retain and restore as required.

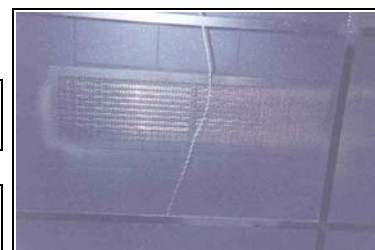
Feature Condition: Good to Excellent

Deficiency: Possibly some modification to the panels has taken place to introduce non-original exhibit spot lights.

Recommendation: Retain honeycombed suspended panels and restore areas of modification where appropriate.

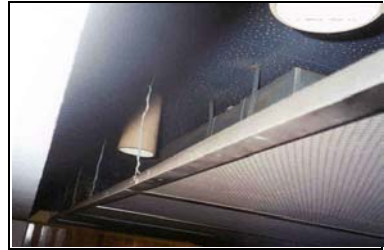
Feature Description:	Metal "T" track with 2'x4' acoustical lay in ceiling panels. This ceiling treatment is not original and appears to have replaced the original honeycombed suspended ceiling panels as found in the museum area and indicated for the Lobby in the original drawings.
-----------------------------	--

Feature Condition: Good to Fair **Total Inventory:** 1,188 SF

Deficiency:	Non-contributing
--------------------	------------------

Recommendation:	Remove and replace with material to match original honeycombed. suspended ceiling.
------------------------	--

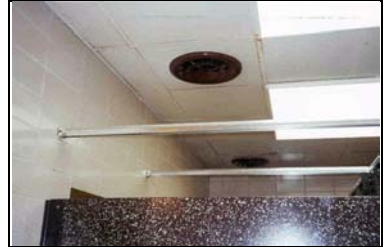
Feature Notes:	The original architectural documents indicate acoustical tile (presumably suspended) at 8'-6" as is indicated in the office area. Given that these spaces are accessed from the exterior, it is likely that they received more exposure to humidity and abuse than those in the office area.
-----------------------	--

Feature Condition: Fair to Poor **Total Inventory:** 462 SF

Deficiency:	Non-contributing
--------------------	------------------

Recommendation:	Remove and replace to match original.
------------------------	---------------------------------------

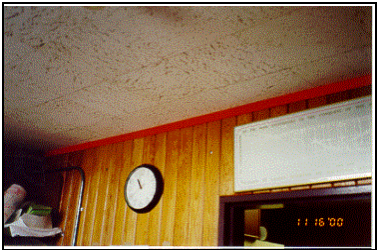
Feature Condition:	Good	Total Inventory:	1,012 SF
--------------------	------	------------------	----------

Deficiency:	Discoloration with age is primary change from original.
-------------	---

Recommendation:	Retain and restore as appropriate.
-----------------	------------------------------------

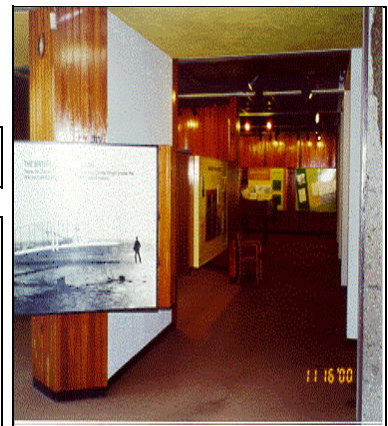
Feature Notes: The only deviation from the original exhibit fixtures observed was the case mounted in the west wall of the museum between column lines B and C. This case appeared to not conform with the trim over the top of the case which was narrower than the case width.

Deficiency: Only the deviation from the apparent original layout as stated above.

Recommendation: Preserve, protect, and, as appropriate, restore to match original. The exhibit issue is one for further discussion related to the expansion of the visitor center and museum. From a preservation standpoint, the exhibits appear virtually unchanged from those indicated in the original architectural drawings. It is significant to note that the exhibit design is a part of the architectural solution. However, a reconciliation between the preservation objectives and the interpretative objectives must be reached in defining an approach to the historic exhibits.

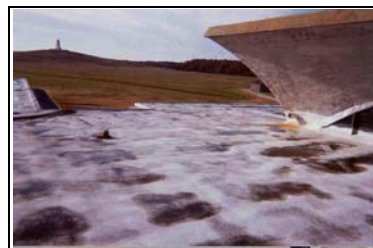
Feature Condition: P **Total Inventory:** 2,862 SF of Dome Area
9,667 SF of Flat Area

Deficiency:	Roof leaks. Emergency patching has taken place in recent weeks. However, this action should only be considered temporary and in the shortest term.
--------------------	--

Recommendation:	Replace existing roof with new roof. Follow original design intent with the consideration of modern variants of original built-up roof. Consider modified bitumen roof or "Hydrostop" type roof. <ol style="list-style-type: none">1. Investigate the full strata of the existing roofing material.2. Appropriately remove and dispose of existing roofing components to original deck.3. Repair structural deck if necessary and according to findings when roofing and, if present, insulation, is removed.4. Design new roofing application. Coordinate with Flashing (See entry for Flashing below)5. Install new roof membrane as per plans and specifications prepared in #4 above.
------------------------	--

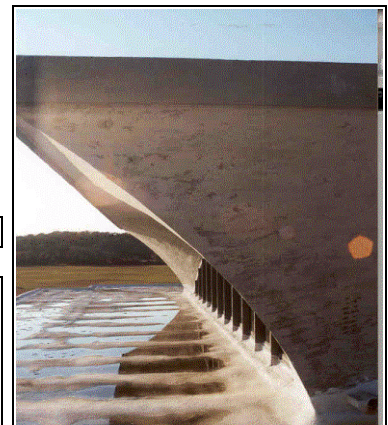
Feature Condition: Good to Fair **Total Inventory:** 2000 SF

Deficiency: Spalling

Recommendation: Conduct a careful evaluation of the cause for the spalling on the arched eaves. Develop and implement remedial improvements consistent with good preservation practices and prepare and implement along-term management plan for the the preservation of the exposed cast in place arched concrete eaves. Cost is based on rehabilitation of 70% of surface area.

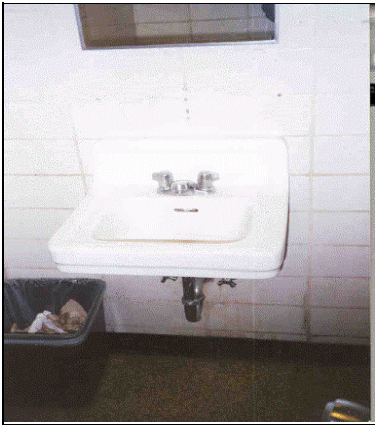
Deficiency:	Not handicapped accessible
--------------------	----------------------------

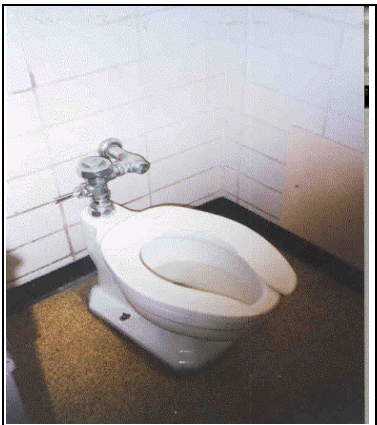
Deficiency:	Water closet designated for handicapped is not mounted at proper height for handicapped accessibility.
--------------------	--

Recommendation:	Mount water closet at handicapped accessible height - 17" to 19" from floor to rim. If rough-in piping cannot be reworked, provide 3" seat for elongated bowl.
------------------------	--

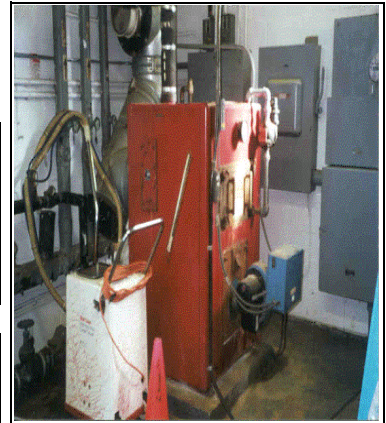
Deficiency: The boiler has been in operation for 32 years. Although the unit appears to be of sturdy construction, major replacement parts may not be available from the manufacturer. The expected service life of this type of boiler is approximately 35 years, based on conversations with the manufacturer's representative. It has reached the end of its serviceable life. Also, the boiler was installed less than 3 feet from the electrical panels, which does not meet code requirements for servicing.

Recommendation: Replace the boiler with a higher efficiency boiler large enough to satisfy the heating requirements of the building. Determine a new location for the boiler which would meet code servicing requirements or relocate the electrical panels.

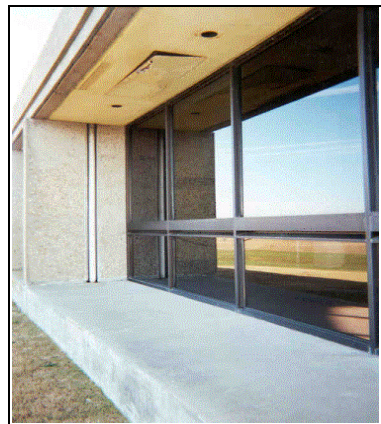
Deficiency:	Deteriorating systems with inadequate capacity.
--------------------	---

Recommendation:	This is a critical issue due to the careful integration of the original system into the building design. Redesign of a system for this building should be accommodated in spaces that do not intrude on the character of the original spaces.
------------------------	---
