Blue Ridge Parkway
Saunders Farm
Historic Structures Report

June 2005

National Park Service

2005
Historic Structures Report
Saunders Farm
Blue Ridge Parkway
Peaks of Otter, VA
LCS#: Saunders House 006493
 Saunders Meat House 006495
 Saunders Chicken House 006496
 Saunders Hog House and Pen 006497

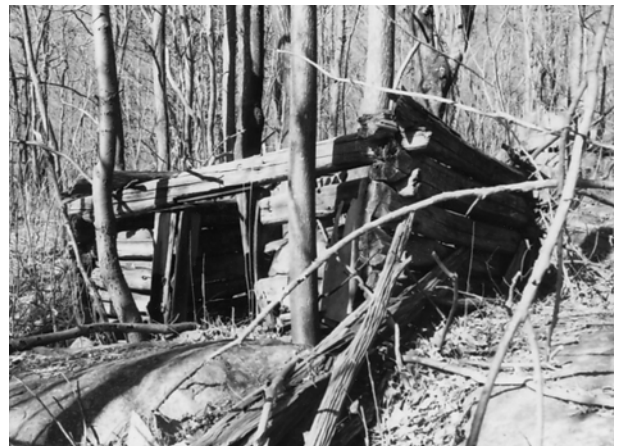
FIGURE 18. View of south end of hog house in 1975. (NPS, BLRI)

first photographed around 1950, a number of the slabs covering the roof were already missing, and by the time the next photographs were taken in 1975, the building was in ruins. No trace of the fence remains.

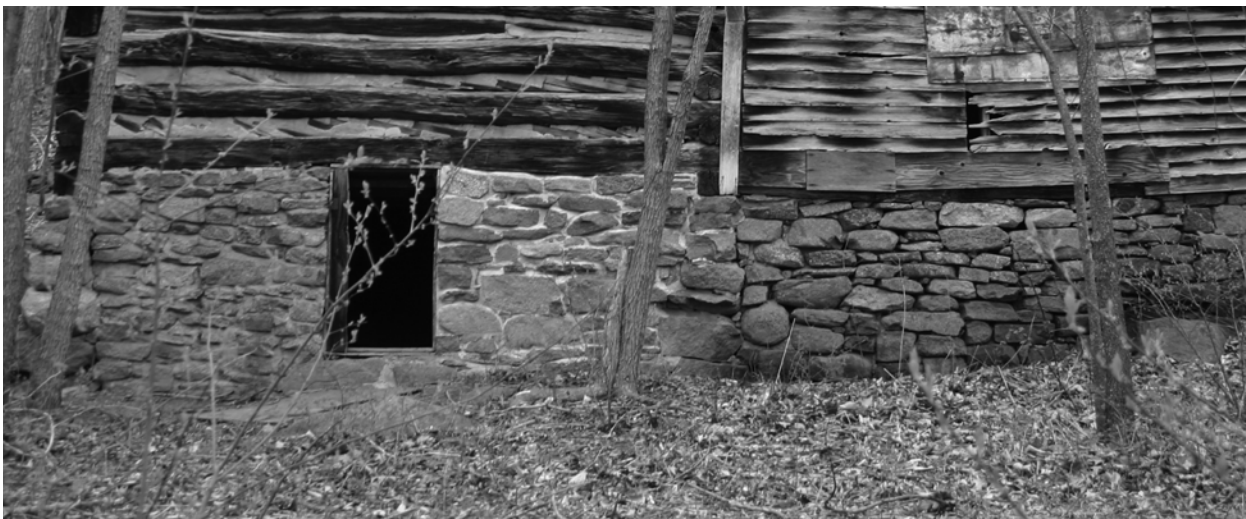
There has been no laboratory analysis of the mortars, but visual analysis distinguishes three separate mortars. The oldest that has not been repointed is that found on the west side of the cellar door and along the front of the house. This mortar is relatively

FIGURE 22. View of foundation at south end of house, showing cellar doorway.

hard, but utilized a coarse aggregate that was probably taken from one of the nearby creeks and gives the mortar a pinkish- tan cast. It appears similar to the mortar used for chinking of the log pen. On the east side of the cellar door, the historic masonry was reconstructed in 1977 using a hard light- grey mortar that contrasts sharply with the areas that have not been repointed.

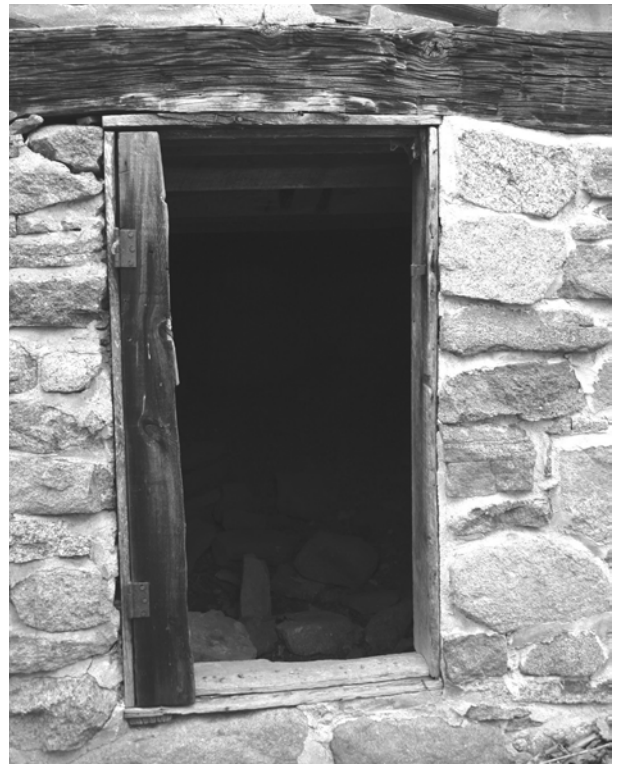
Near the center of the foundation on the south side of the log pen is an opening around 2' by 4' that allows access into a cellar where Saunders probably stored potatoes and other produce. A board- and- batten door was originally hung in the opening, but

FIGURE 23. View of cellar door. (NPS, 2005)

only the board on the hinge side of the door remains intact.

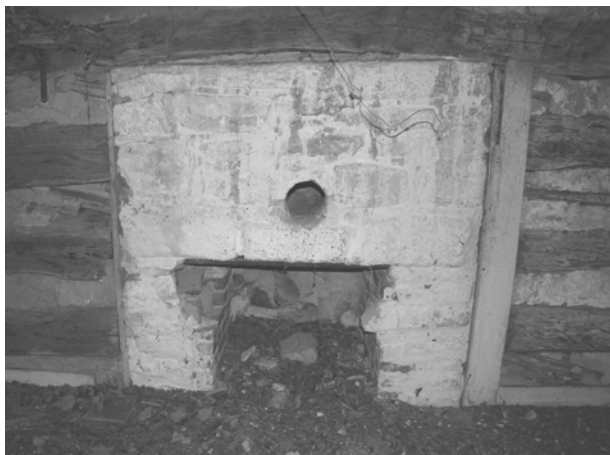
FIGURE 26. View of fireplace. (NPS, 2005)

In the Front Room, a piece of terra cotta stove- pipe flue liner was built into the interior face of the chimney breast, probably originally. A similar piece of yellowish terra cotta flue liner was once mounted at the top of the chimney, but it is now lying in pieces at the north end of the house. Sometime after the original construction, an opening was made on the back side of the chimney to serve a flue for a stove at the north end of the log pen loft. The chimney is in fair condition, but some stones have been dislodged from the sides of the firebox inside the house.

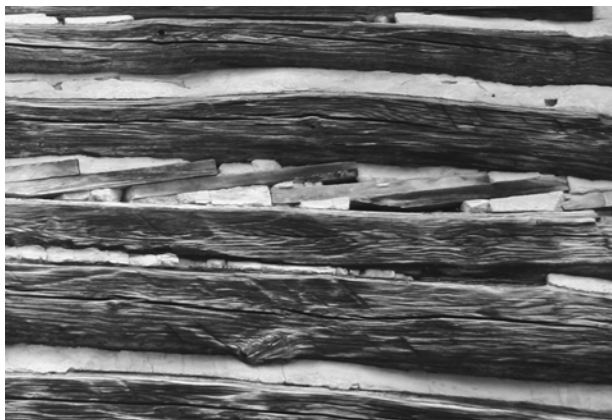
FIGURE 29. View of a portion of south wall, showing typical treatment of gap between the logs. (NPS, 2005)

nique in completing the chinking. Wire around 12 or 14 gauge was looped over nails and run back and forth across the gaps of the logs to form a sort of lath for the cement chinking material. Although the wire lath appears at first glance to be associated with the last layer of chinking, close inspection reveals that the second, tan layer of chinking was placed over some of the wire lath. It is not clear why Saunders employed this technique only on part of the house, but he may have had second thoughts about its durability or someone may have informed him that the technique might create problems. Whatever, the reason for abandoning the technique, it was fortuitous, since wherever the wire was installed, nearly all of the original mortar apparently deteriorated and had to be replaced.

Deterioration of the mortar chinking was probably due to moisture penetration that caused the wire to rust or else it was due to thermal expansion and contraction of the metal which cracked and dislocated the mortar. The replacement chinking material, which only appears where the wire lath was installed, was apparently formulated using a high proportion of cement and a fine aggregate that gives the chinking a whitish color.

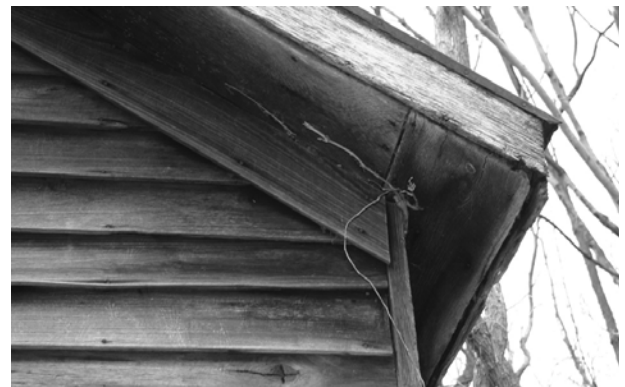
FIGURE 33. View of northeast corner of building showing typical exterior finishes. (NPS, 2005)

Siding was laid with an exposure of about 5- 1/2", and put up with wire nails. Single boards, 2" by 4", are used as corner boards against which the siding is butted. Siding is missing on the north side to a height of about two feet, and several runs of siding are missing from the east end of the house as well. Eaves extend about a foot beyond the face of the walls and do not have rafter returns. Eaves are boxed to a frieze board around 1" by 6". Windows and doors are cased with plain boards about 6" wide.

Exterior Finishes. Most of the exterior finishes remain intact but are in need of significant repairs. Most of the existing siding on the north and east sides can be re-nailed where necessary and preserved. Siding is entirely missing from the lower half of the north wall and some is missing from the east end. Much of the siding on the south side of the enclosed porch, which is not contemporaneous with the other siding, may require complete replacement. If that is necessary, the vertical seam on the west side of the window opening should be replicated. Most of the soffit is intact and can be preserved, but some of the fascia will need replacement.

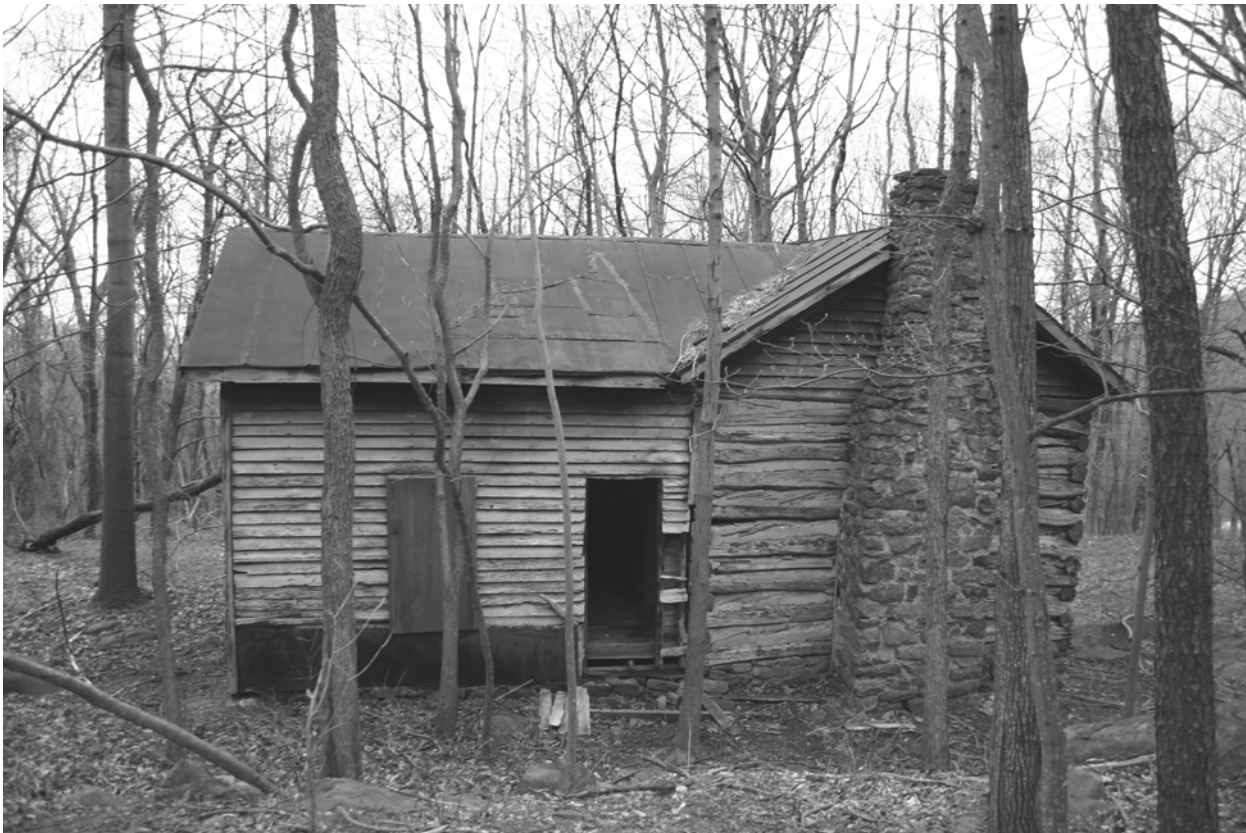
Roofing. The rafters are decked with circular-sawn lumber, generally 3/4" thick and around 4" to 11" in width. Roofing is standing- seam metal, probably galvanized steel but badly rusted. For the most part it remains functional except where it has been damaged by falling trees. On the north shed of the kitchen roof, a large area has been roughly patched with sheet metal. Significant damage has been done

FIGURE 36. View of north side of house. (NPS, 2005)

to the roof of the enclosed back porch by a fallen tree that is still lying across the roof.

The roof of the enclosed porch (102) has been badly damaged by a falling tree. The tree should be removed and the area covered with a tarpaulin to prevent water entry. Rafters can be temporarily braced up on the interior. The remainder of the roof appears to be generally shedding water, but if additional leaks are found they should be closed. Since the entire roof covering will have to be replaced, cold asphalt patching compound could be used if necessary.

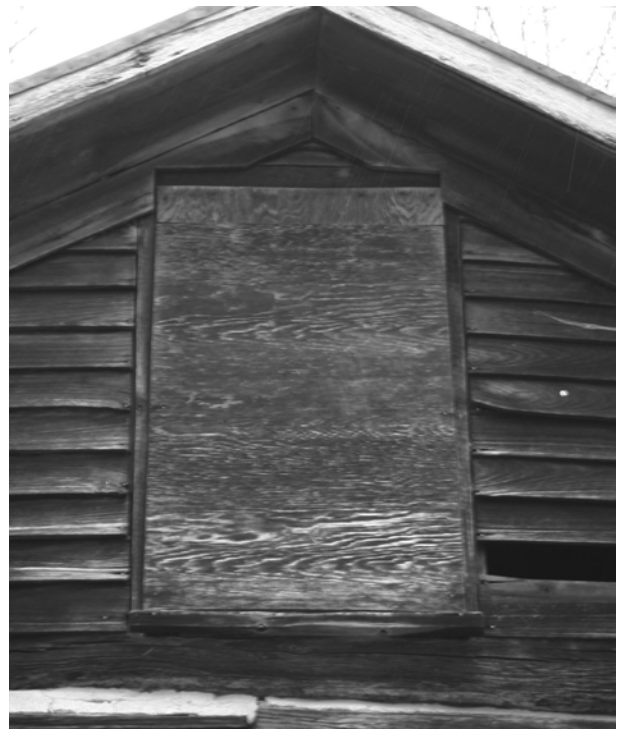
At the south end of the loft of the log pen is another window opening, also measuring around 2'-0" by 4'-4". Sash are missing, but historic photographs show they were originally four- over- four like those in the kitchen.

FIGURE 38. View of window in south gable. (NPS, 2005)

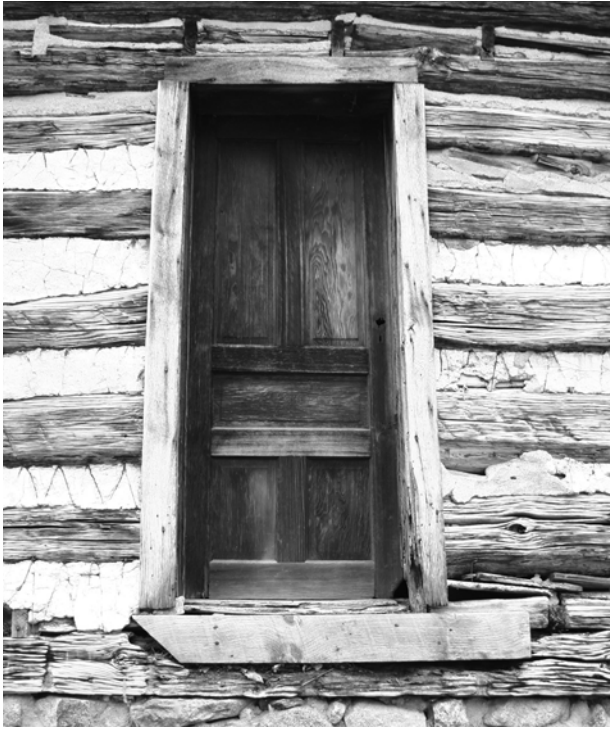
FIGURE 39. View of front door. (NPS, 2005)

Only the front door remains in place; the back door, which is not in its original location, is covered with plywood and the door is missing. The front door is a pine door, 2'-8" by 6'-5", with five raised panels. The door is hung with plain 3" butt hinges and was originally fitted with a vertical rim lock about 3" by 4", but the lock is now missing. The back door may have been similar.

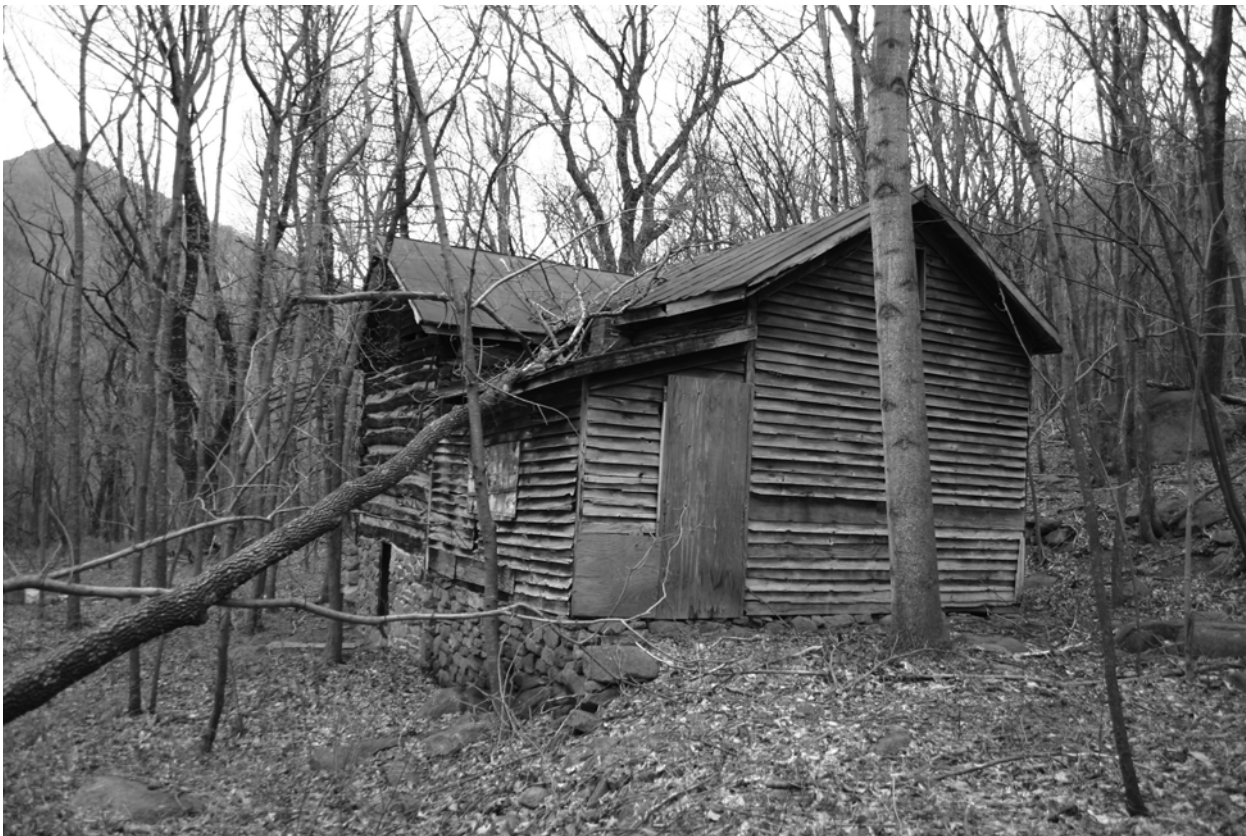
Exterior Doors. The house originally had two entrances, a front door and a door off the back porch. An opening in the north wall of the kitchen, which had been present but was then closed prior to 1949, now provides access into the house. Framing and siding that once filled that opening are now laying on the ground beside the house.

FIGURE 40. View west-northwest of rear and south sides. (NPS, 2005)

Exterior. The portion of the north wall of the kitchen that has been removed should be repaired and the opening closed, using as much as possible of the existing material now lying on the ground outside the opening, or by simply covering the opening with plywood. The front door and the window openings should be secured with vented plywood panels screwed to the frames at the outside of each opening. A temporary door should be installed at the east end of the old porch (102) to provide access into the building.

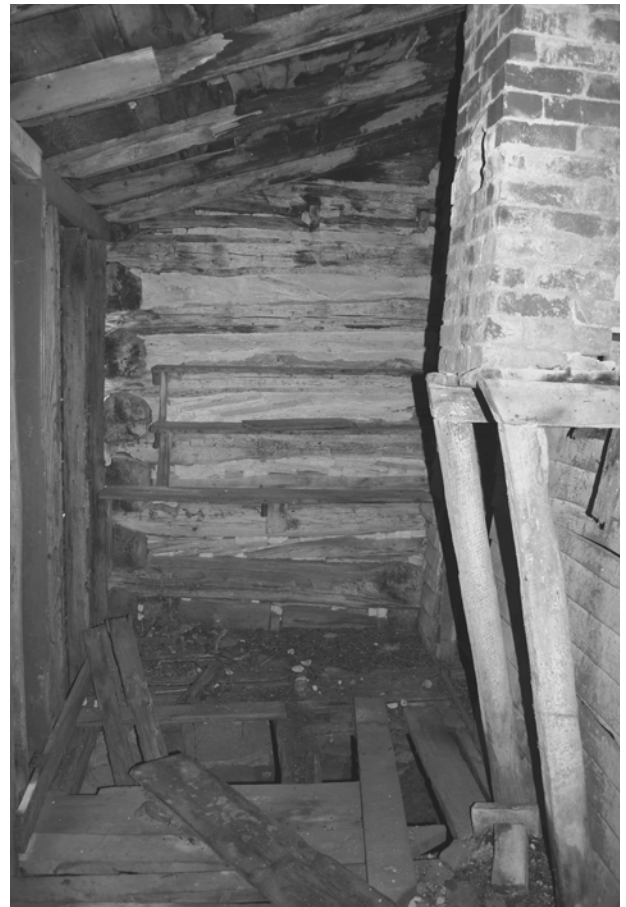
Old Porch (Room 102). The evolution of this space is uncertain, but it seems most likely that it was originally an open porch with a small pantry at the west end that was accessible from the Kitchen. The room is now in nearly ruinous condition, with much of the flooring missing and serious damage from a leaking roof. Sash for the window opening on the south wall and the door on the east wall are both missing.

FIGURE 56. View west in Room 102. (NPS, 2005)

Interior. The interior of the house must be cleared of the large amount of debris that covers the floors in every room. Holes in flooring on the first floor should be covered temporarily with plywood, anchored without the use of nails or screws but secured against animal entry. Plywood can also be laid over the loose boards on the enclosed porch (102).

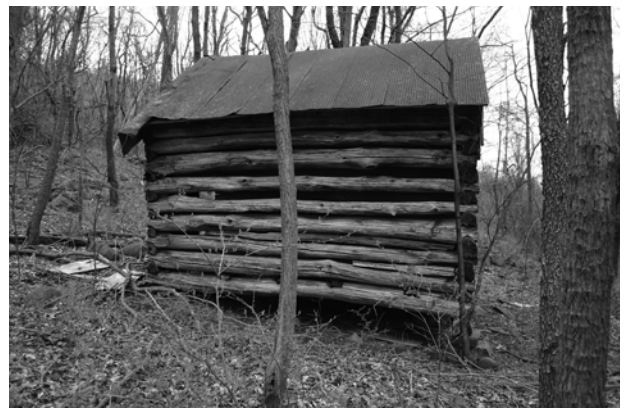
The roof is covered with 24"-wide panels of corrugated steel, which are badly rusted but still without major leaks. The end gables are finished with vertically installed, circular-sawn boards, 6" to 8" wide and attached with wire nails. Floor boards are circular-sawn, 10"-14" wide, but several are missing or only loosely attached to the joists.

FIGURE 58. View of west side of meat house. (NPS, 2005)
