Cape Lookout National Seashore

Cape Lookout Life-Saving Station HISTORIC STRUCTURE REPORT

2004
Historic Structure Report
Life- Saving Station
Cape Lookout National Seashore
Cape Lookout Village
LCS#: 091835

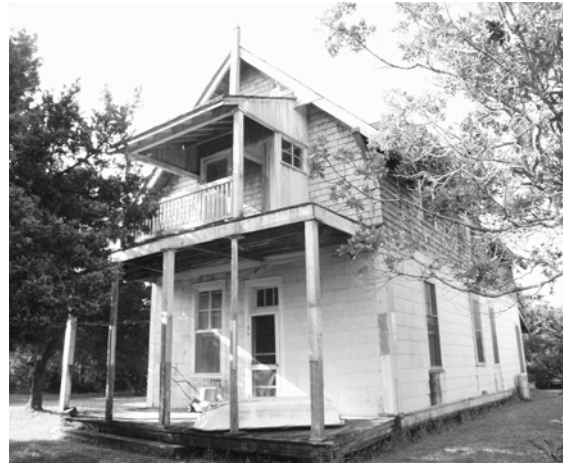
Front Porch: The front porch, located on the northeast end of the house, was added before World War II, but unlike the back porch, which is considerably older, is badly deteriorated and in unstable condition. Floor framing at the first floor level was inaccessible but the condition of the floor deck indicates serious problems with the underlying framing. Flooring, which appears to be mostly original, is 7/8" by 2- 1/2", tongue- and groove.

Deterioration, especially of the sills and floor framing at the first floor level, has allowed the roof of the upper porch to pull away from the building as much as 2", and the framing for the second floor is in very poor condition.

Figure 59 View of front porches, added in 1920s. (NPS-SERO-CRS, 2002)

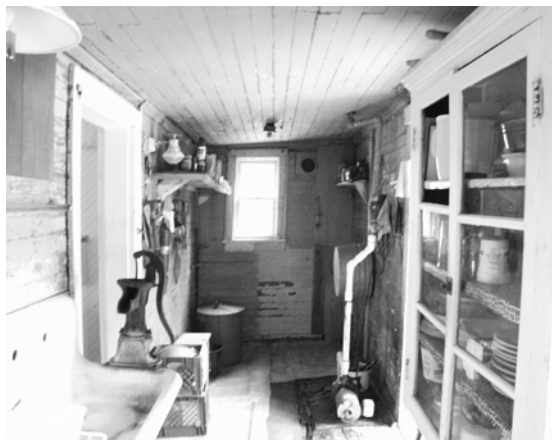
Floors: Measuring about 5'-7" by 19'-4", the wooden floor in this room is covered with modern vinyl floor coverings but appears to be in very poor condition. Where the wall was

removed separating the pantry and the original entry hall, the floor is collapsing.

Figure 63 View to north in Room 100, showing location of original pantry. (NPS-SERO-CRS, 2002)

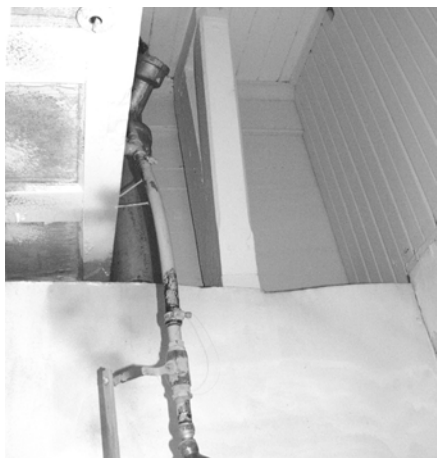
Figure 73 View of large bracket behind and above shower, installed to support water tank at second floor. Note original cornice on rear wall. (NPS-SERO-CRS, 2002)

Miscellaneous: Next to the toilet is a large, cast- iron water tank set on wooden blocks and supported from below by a large bracket mounted against the ceiling below in Room 103. It was installed after 1969 to replace the original 1920s tank, which was moved but remains in the room after an unsuccessful attempt to saw it up and remove it.

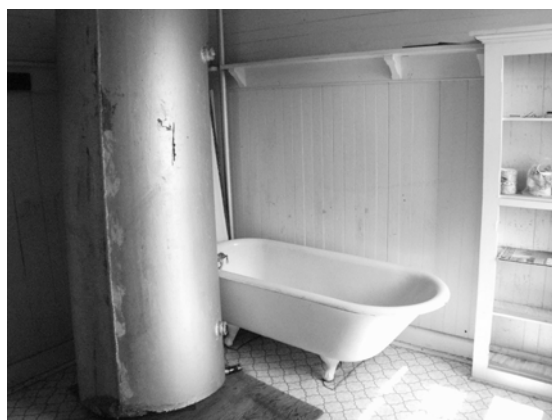
Figure 81 View to north in Room 203, showing tub and original 1920s water tank. (NPS-SERO-CRS, 2002)
