CANE RIVER CREOLE NATIONAL HISTORICAL PARK  
MAGNOLIA PLANTATION

~ GIN BARN ~  
HISTORIC STRUCTURE REPORT

**Cultural Resources, Southeast Region  
National Park Service**

**2004**

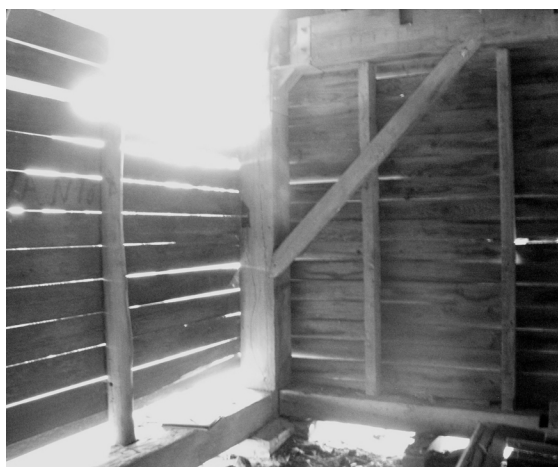
**Figure 25** View of southwest corner of barn; wall at right was added in the late nineteenth or early twentieth century. (NPS-SERO-CRS, 2001)

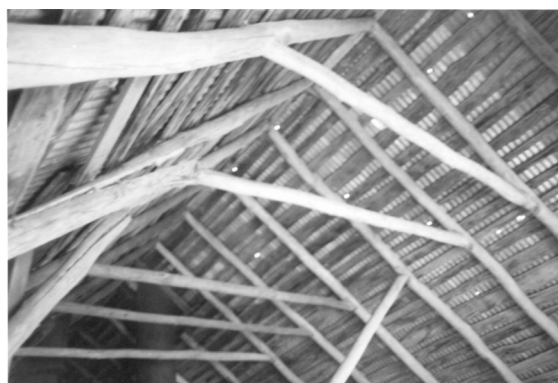
**Figure 27** View of original pole-rafter roof in 1995. (NPS-SERO-Architecture, 1995)

The original roof was entirely removed in 1995, but photographs show that it was originally framed with twenty- nine pairs of pole rafters, set on centers approximately 36" apart. Betty Hertzog remembers these rafters being a combination of cypress and black locust.<sup>59</sup> In addition, two of the original pole rafters (both cypress), complete with lapped- and- pegged ridge connection, have been preserved by the park and, as noted in the previous section, offer important clues to the building's origins.

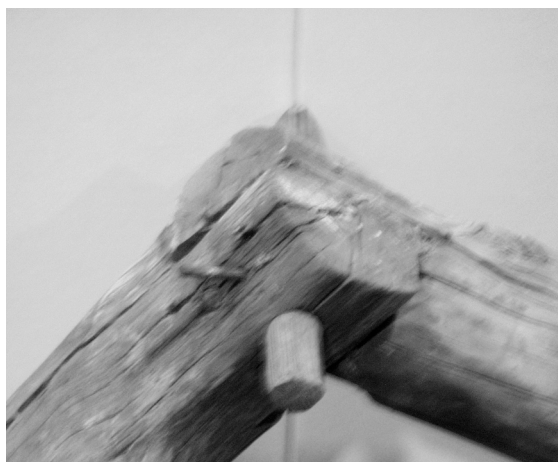
**Figure 28** Detail of typical ridge connection in original roof, from partial rafters now in CARI Collection. (NPS-SERO-CRS, 2001)

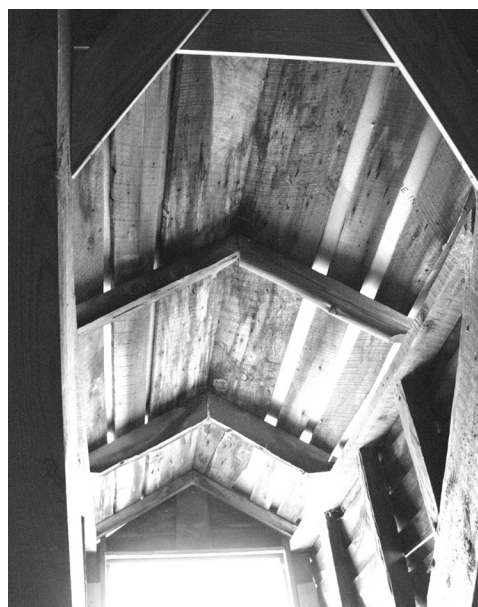
**Figure 29** View of south dormer with original framing and decking intact. (NPS-SERO-CRS, 2001)

In 1995, the original pole rafters on the main roof were replaced by the existing rafters, which are 6" by 8", pressure- treated pine, set on centers 36" to 42" apart. Collar beams are the same size, with the connection reinforced by metal T- shaped plates. On the arcades, the rafters are 3" by 6" set on an outside beam 5½" by 7¼". Roofing is corrugated steel, specified as 18 gauge and attached with 1½" self- tapping, hex- head, galvanized wood screws with sealing washers. Only the framing and decking of the two dormer roofs appears not to have been replaced in 1995.

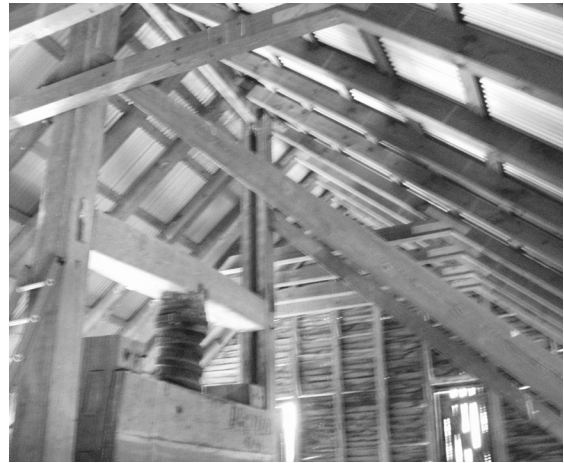
**Figure 30** View southwest of roof framing installed in 1996. (NPS-SERO-CRS, 2001)

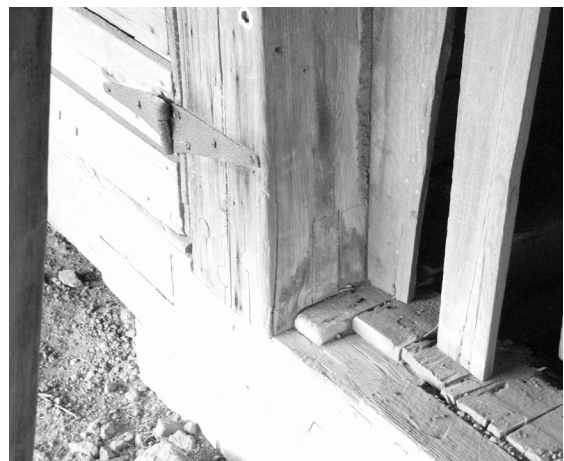
All of the flooring at the first floor level has disappeared except for fragments remaining under the sole plate at the south end of the lint room. Flooring at the second floor is typically 9" to 11" wide, generally ¾" thick.

**Figure 31** View of original flooring at south side of lint room. (NPS-SERO-CRS, 2001)

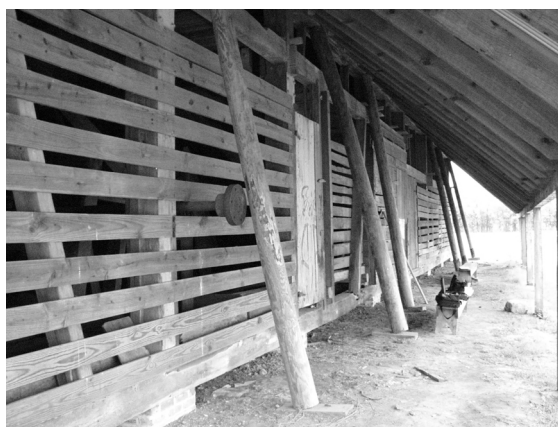
**Figure 32** View of north side of building, showing typical open siding. Note that siding near center is attached to the interior face of the studs. (NPS-SERO-CRS, 2001)

and 5" to 6" wide are spaced 4" to 5" apart. On the north side of the building, most of this siding is installed on the exterior of the framing; on the south side, most is installed on the interior of the framing. The use of wire nails generally distinguishes replacement siding from 1939 or later; earlier siding is attached with cut nails.

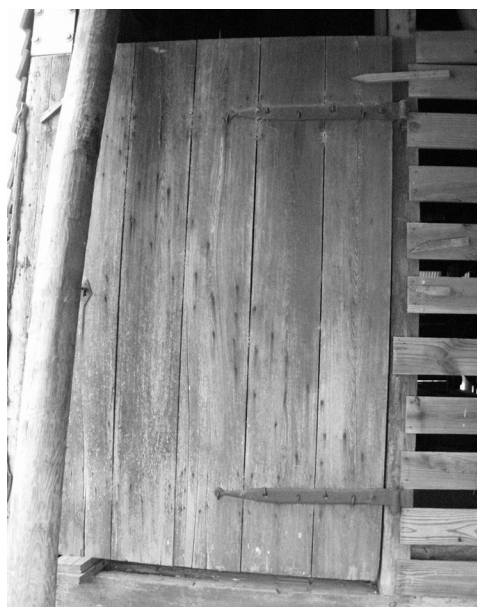
**Figure 34** View of Door D, one of the oldest doors in the barn. (NPS-SERO-CRS, 2001)

- Repair interior and exterior doors as necessary and install appropriate latches.
- Repair all shutters as necessary and provide necessary interior latching mechanism.

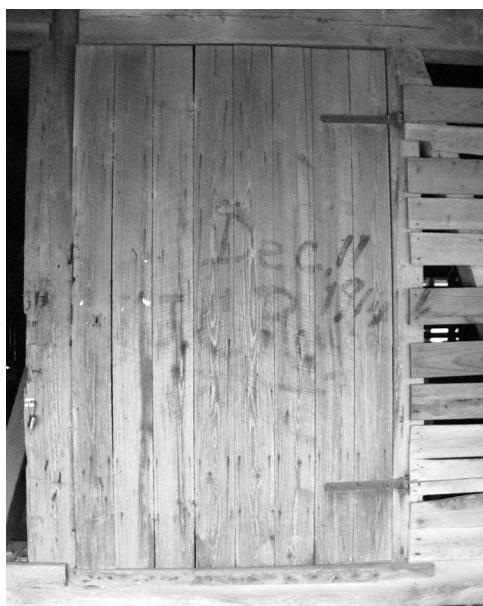
**Figure 33** View of Door A, added to second floor around cotton press. (NPS-SERO-CRS, 2001)

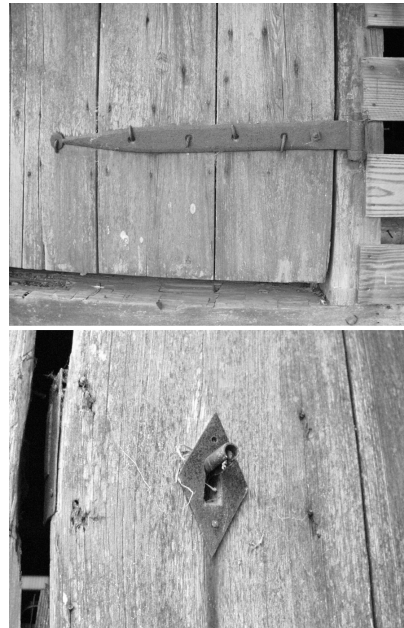
**Figure 35** View of hinge and escutcheon on Door D. (NPS-SERO-CRS, 2001)

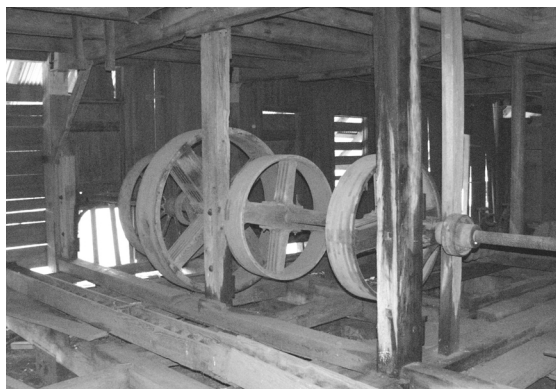
**Figure 38** View of belt-driven flywheels at east end of barn, which would have been connected by leather belts to the engine outside the building and to the machinery inside. (NPS-SERO-CRS, 2001)

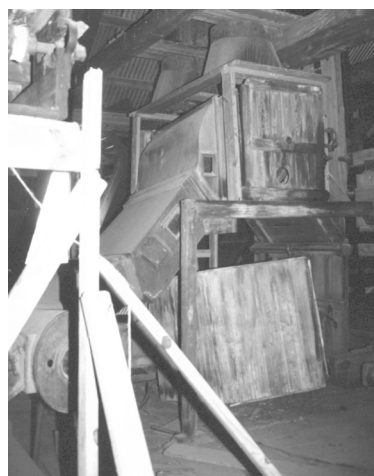
(see Appendix C), most of its components are present although the cotton suction apparatus is almost completely disassembled. The pneumatic elevator includes the fan now lying outside under the south arcade, various flue ducts lying around the second floor, and the vacuum box or separator, which is detached and lying under the condenser but was originally attached to the distributor above the gin stand. Both gin stands remain intact on the second floor. However, replacement of the roof in 1996 and of much of the siding in 1939 and 1982 has obliterated most evidence for how the gin's power train connected to the engine house and how seed was discarded from the system and transported to the seed house.

**Figure 40** View of portion of Munger system gin machinery on second floor of barn. (NPS-SERO-CRS, 2001)

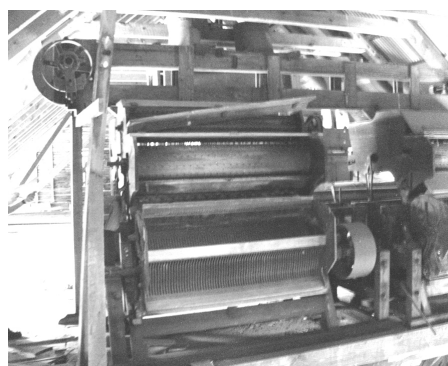
**Figure 41** View of Continental gin stand on second floor. (NPS-SERO-CRS, 2001)

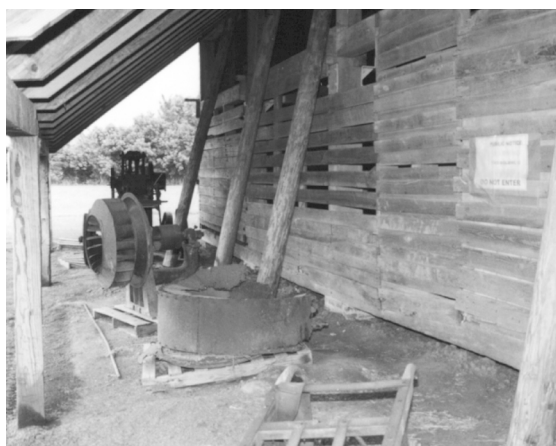
**Figure 42** View west under south arcade, showing blowers and other equipment associated with c. 1900 system gin. (NPS-SERO-CRS, 2001)

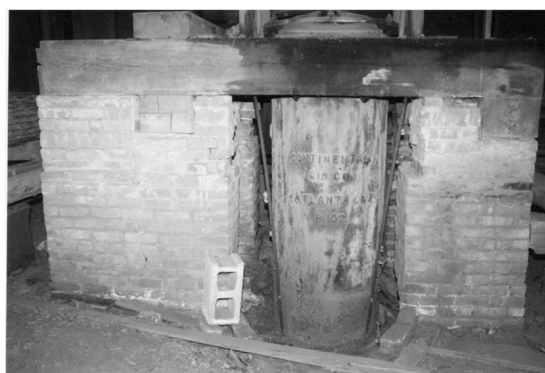
**Figure 43** View of hydraulic cylinder and supporting brick piers for press. (NPS-SERO-CRS, 2001)

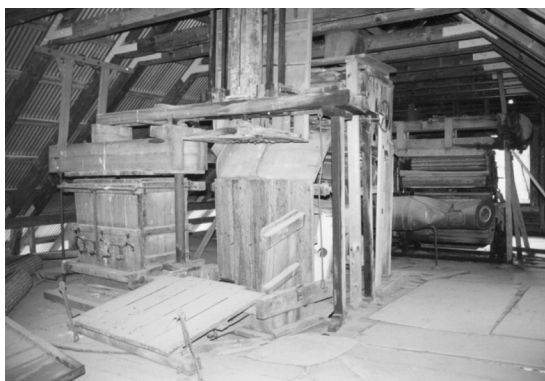
**Figure 44** View east of dual-box, hydraulic press at second floor, with gin stand visible in background. (NPS-SERO-CRS, 2001)

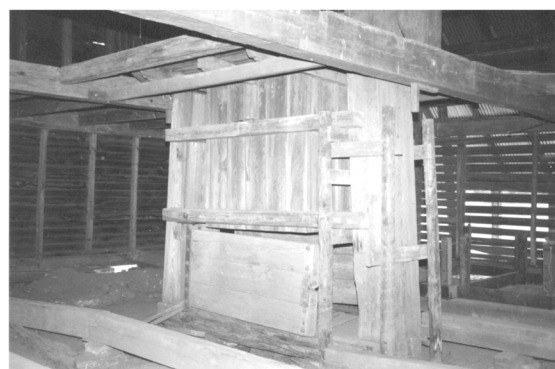
**Figure 46** View of cotton press at ground level, showing door where finished bale was removed. (NPS-SERO-CRS, 2001)

- Determine character and condition of press footing through archaeological investigation.
- Brace press with modern materials if necessary to insure structural stability.
- Avoid any disassembly or replacement of historic materials.
- Do not operate historic press; construct working scale model to demonstrate its operation to visitors.

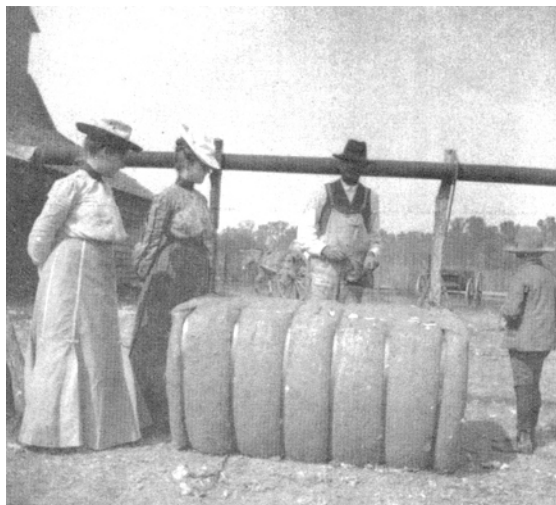
**Figure 48** View of Prud'hommes' gin at Oakland, showing elevated flue to transport seed from gin to seed house. A similar apparatus would have been used at the Magnolia gin, but has now disappeared. (NPS-SERO-CRS, 2001)
