Fort Pulaski National Monument
Quarantine Attendants' Quarters
Historic Structure Report

Historical Architecture, Cultural Resources Division

National Park Service

2004
Historic Structure Report
Quarantine Attendants' Residence
Fort Pulaski National Monument
Savannah, GA
LCS#: 12172

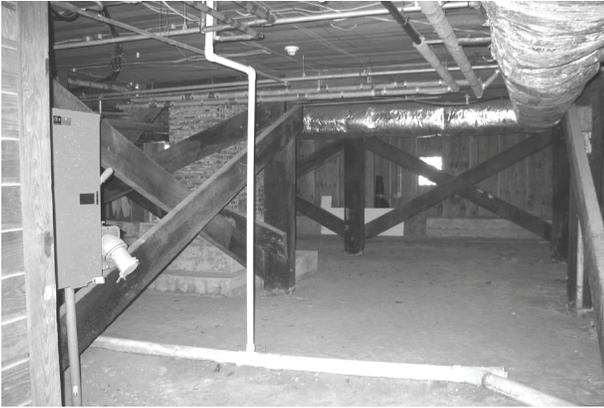
FIGURE 24. View west under north porch, showing typical piles and cross-bracing. (NPS-SERO-CR, 2003)

There is no evidence that the piles and beams forming the foundation have ever been replaced, although there is at least one brace west of the chimney base which was probably added during World War II. Piles and beams are in relatively good condition. There has been some oxidation of the iron straps and bolts, and termite damage is visible on the pile at the southeast corner of the house and in isolated areas elsewhere.

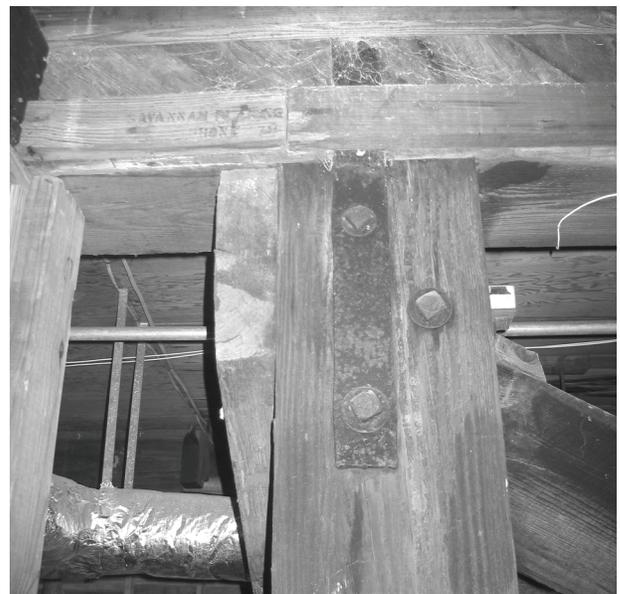
FIGURE 26. View of typical iron strap that secures house framing to pilings. (NPS-SERO-CR, 2003)

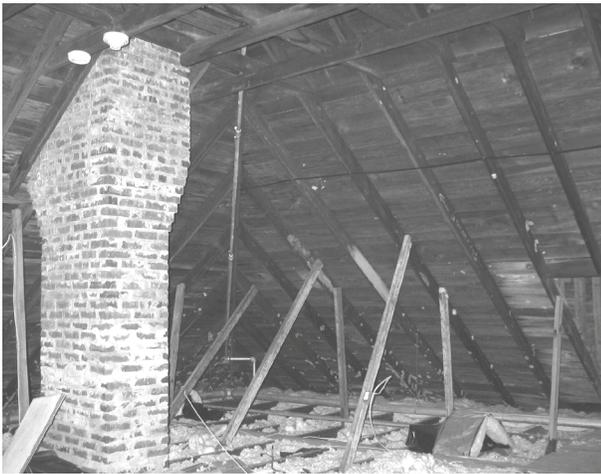
FIGURE 28. View northeast of chimney stack as it rises through the attic. (NPS-SERO-CR, 2003)

was originally finished with a stone or concrete slab raised above the flue opening, but it was damaged by a lightning strike in the 1970s and the chimney was rebuilt to its current configuration by the park's maintenance crew.

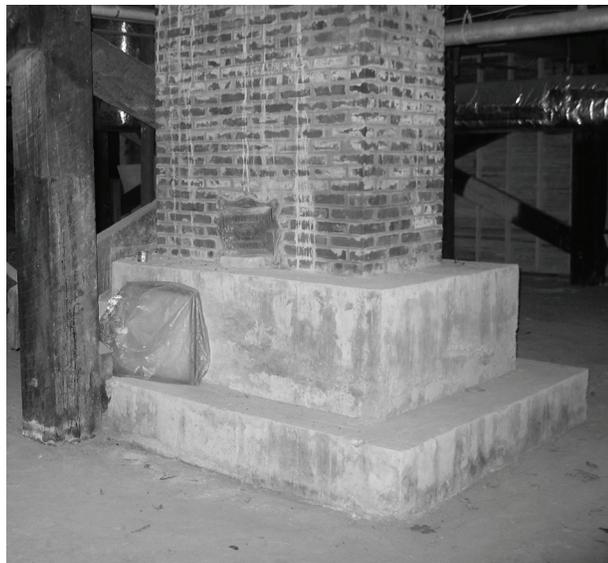
The existing chimney and fireplace were constructed by the Navy in 1942 and are in good condition. The foundation of the chimney is formed by a two-tier, concrete base poured in forms constructed with 6"-wide boards. The bottom tier of the base measures about 6'-6" by 9' and rises about 14" before stepping in to the second tier, which is about 4'-6" by 7'. It rises about 24" to the bottom of the brick chimney base, which itself is about 2'-6" by 5' in plan. Brick are standard, hard-fired, red brick set with a hard, grey, Portland mortar. There was apparently no cleaning of the masonry after construction, leading to its present stained appearance. A cast-iron door for an ash dump is located at the base of the brick shaft. Hinges in the frame are broken and the door is detached. All elements are rusting.

FIGURE 29. View southwest of chimney breast. (NPS-SERO-CR, 2003)

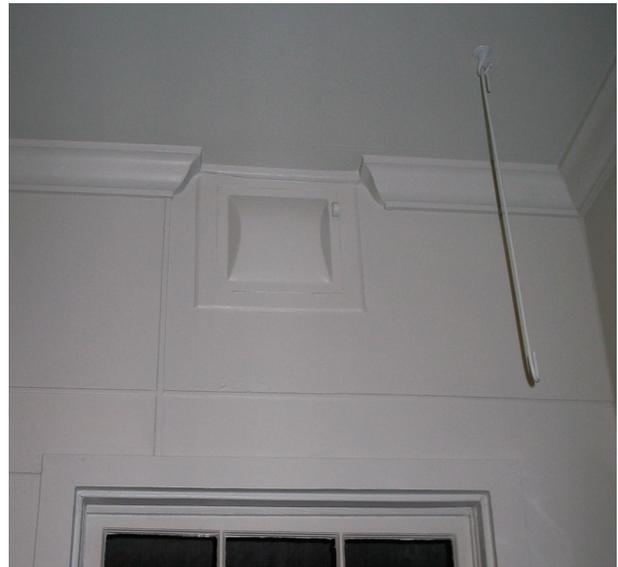
FIGURE 68. View of exhaust fan at west end of kitchen. (NPS-SERO-CR, 2003)

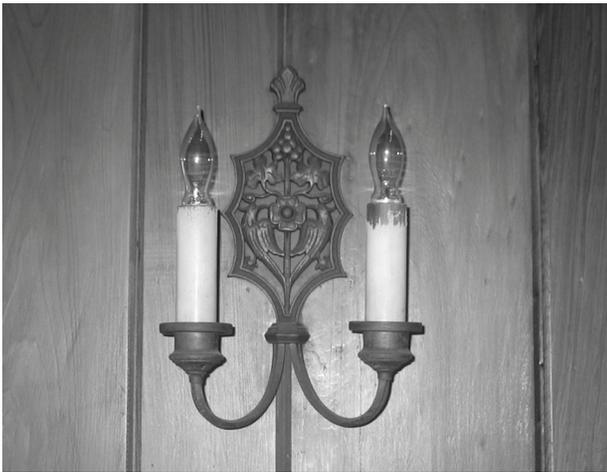
FIGURE 71. View of wall sconce, c. 1942, located in Room 109. (NPS-SERO-CR, 2003)

Electrical. The building's electrical system was rehabilitated in 1995, and presumably is in good condition, although loose wires and coverless junction boxes were noted in the attic. Only three light fixtures remain from the historic period, the overhead light in Room 100 and the two wall sconces in Room 109. The fixture in Room 100 is operative; the sconces are not.
