Ocmulgee National Monument

The Earth Lodge

# Historic Structure Report

Historic Architecture, Cultural Resources Division

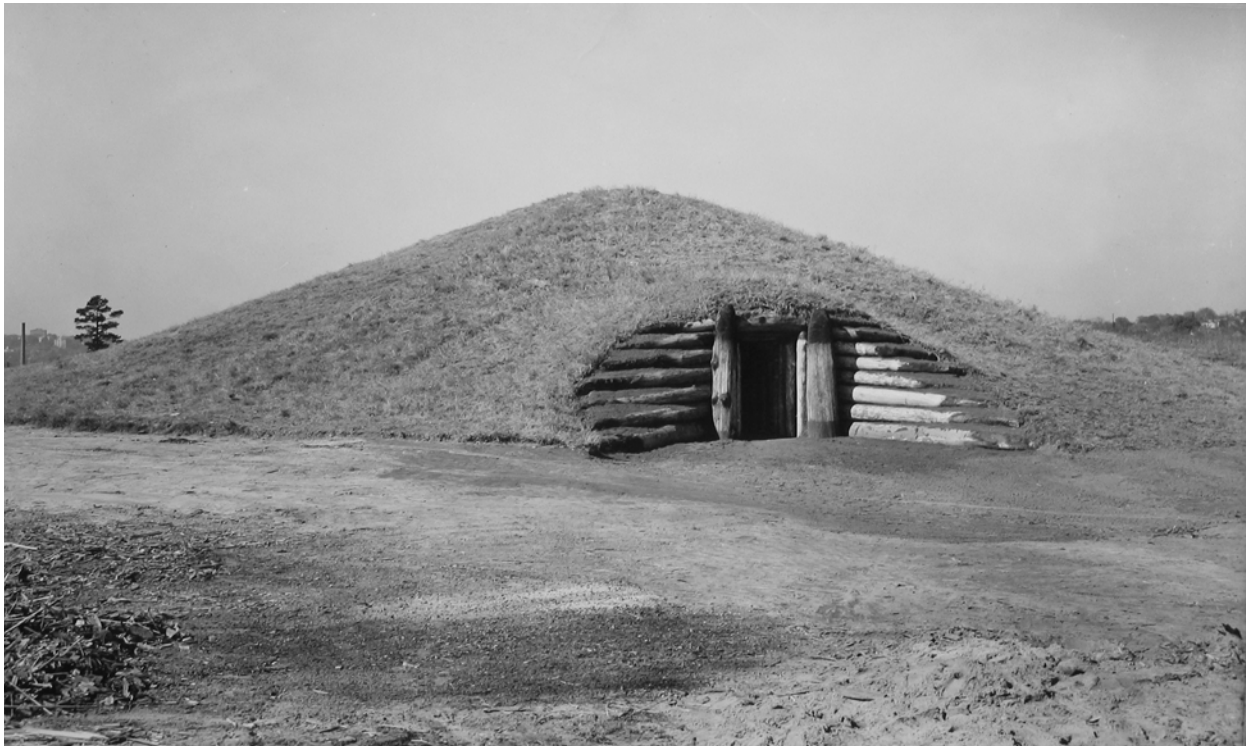
FIGURE 51. View of Earth Lodge, c. 1945, with original entrance which Swanson acknowledged was “purely imaginary.” (OCMU Coll.)

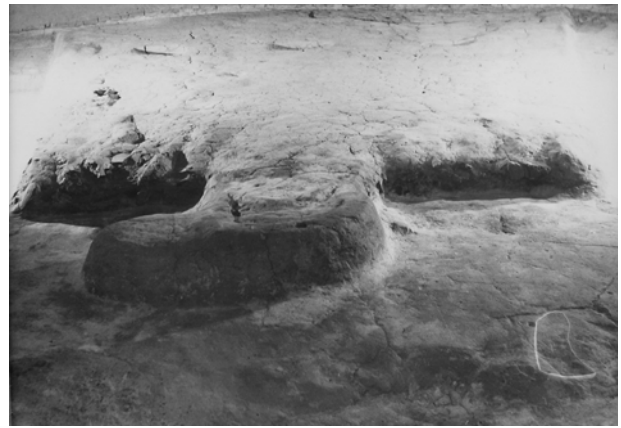
FIGURE 61. View of eagle effigy, 1965. Note sloughing of material on left shoulder. (OCMU Coll.)

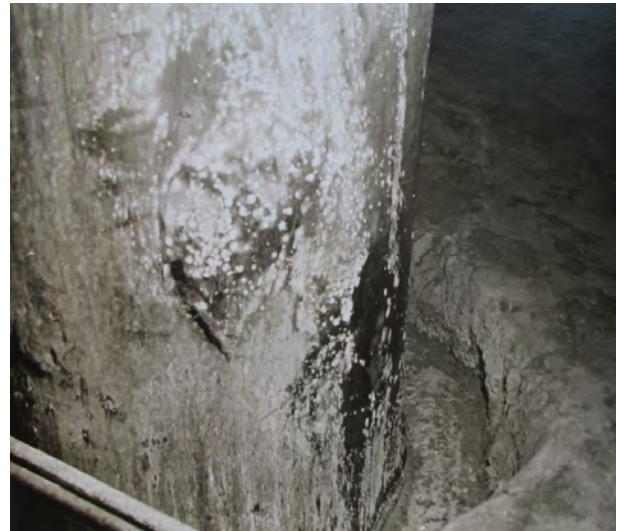
FIGURE 62. View of mold on one of interior posts, 1965. (OCMU Coll.)

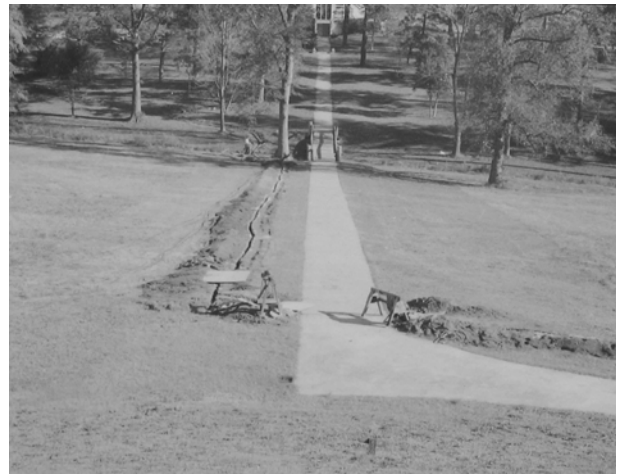
FIGURE 64. View of trench for electrical line from Visitors Center, November 6, 1974. (OCMU Coll.)

Electrical and water service to the lodge is underground. Both run along the northwest side of the walk from the Visitors' Center, with the electrical line crossing to the southeast side of the walk just east of the lodge and entering the structure on the southwest side of the entrance. See Figure 64.

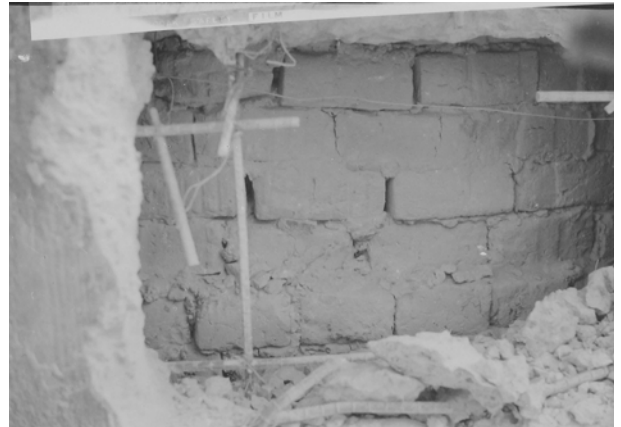
FIGURE 70. View of break in concrete shell for installation of a duct, exposing WPA-era mud brick. (OCMU Coll.)

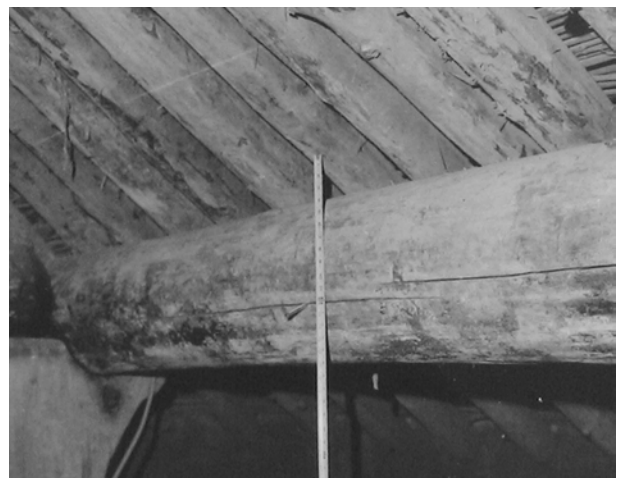
Even before the climate control project was finalized, problems began to emerge, most notably cracking of the timbers inside the lodge. In October 1976, the superintendent reported that "the contractor has made a great many trips here to try to achieve the optimum setting to prevent cracking of timbers and accumulation of mildew on the floors

FIGURE 76. View of log which began splitting as interior of lodge dried out after installation of climate control system. . (OCMU Coll)

and walls without complete success.” Cracking of the timbers was accelerating, according to the superintendent, mildew had reappeared, and the contractor was recommending that all timbers be treated to remove mildew and then sealed to prevent moisture absorption. With that done, the contractor believed, it would be possible to lower the humidity inside the lodge to “at least 56%.”<sup>141</sup>

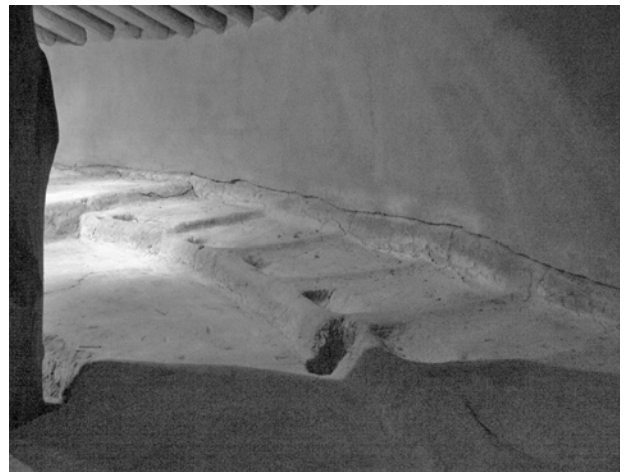
FIGURE 96. View of seats on northeast side of lodge, with highest surviving portion of encircling wall. Whitish band at base of wall is mold. (NPS-SERO-CR, 2004)

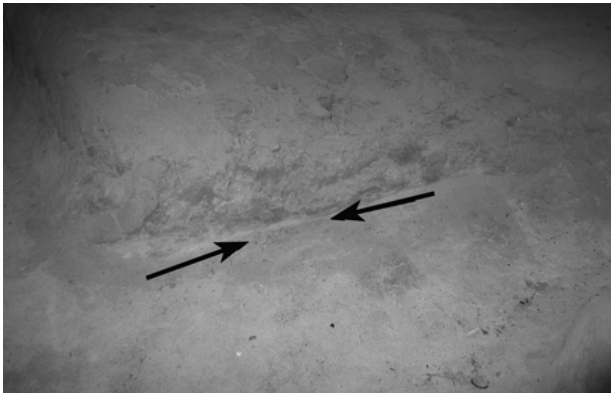
FIGURE 99. View of left (south) shoulder of effigy platform. Arrows mark clay that has detached from the shoulder. Miscellaneous debris is visible in the foreground in this image. (NPS-SERO-CR, 2004)

reconstructed walls, but because this debris is reported by park staff as having accumulated over at least a decade, it gives some sense of the relatively slow rate at which spalling might be occurring. During that interval, perhaps 10- 15 cubic centimeters of material have spalled away on the shoulders of the platform (see Figures 99 and 100, above). Since the material in those areas is quite friable, and has been since the artifact was uncovered, additional spalling can be expected, although there is no indication that it is spreading beyond the existing deteriorated areas of the platform shoulders and fire pit rim. Extreme care should be taken that these areas are not abraded or brushed, since that would dislodge additional, already-loose material. A means of consolidating and securing the friable material could be explored, but any treatment runs the risk of exacerbating the problem, disfiguring or otherwise damaging the pre-Columbian clay.

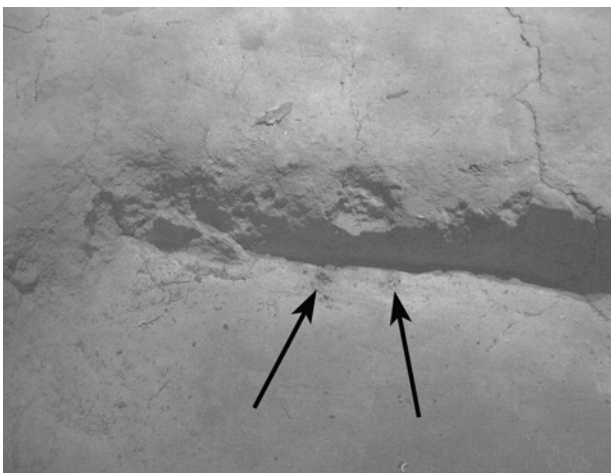
FIGURE 100. View of right (north) shoulder of effigy platform. Arrows mark clay that has detached from the shoulder. (NPS-SERO-CR, 2004)

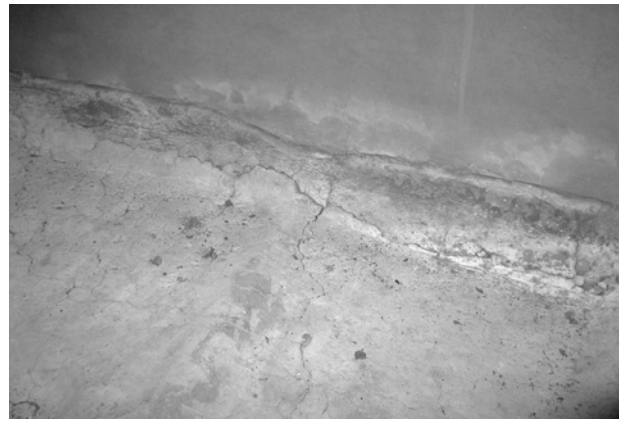
**FIGURE 101.** View of juncture of pre-Columbian features and reconstructed wall along northeast side. White band at base of wall appears to be mold or salts as a result of water penetration. (NPS-SERO-CR, 2004)

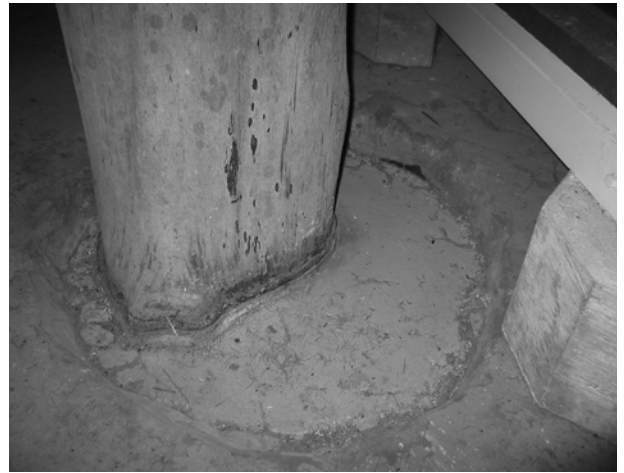
**FIGURE 102.** View of pre-Columbian post hole filled with modern material. (NPS-SERO-CR, 2004)

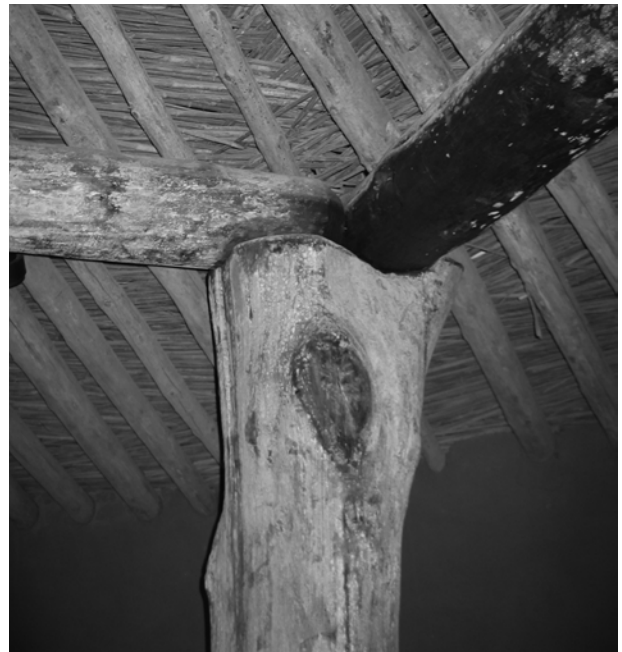
The wood and cane appear to be in fair condition, but inspection was only visual and did not include probes that might reveal hidden damage. All of the cane is heavily soiled and some mildew may be

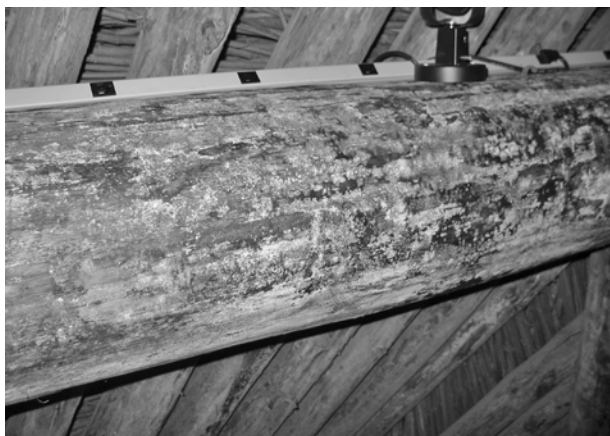
FIGURE 112. View of north beam with typical mold growth. (NPS-SERO-CR, 2004)

present. Most of the mold appears to be confined to the four posts and the cross beams and may be the result of the wood having been installed green. Further testing would be necessary to determine if the mold is alive or dead.

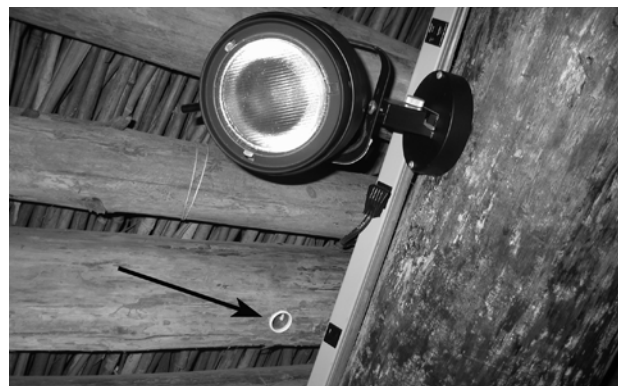
FIGURE 115. View of modern power strip and flood light. Arrow marks recessed porcelain socket for original (1937) lighting system. (NPS-SERO-CR, 2004)

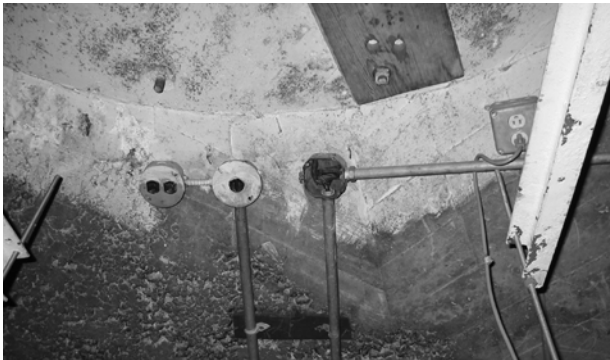
FIGURE 117. View at top of inside of concrete shell, showing remnants of 1937 electrical system and of white paint applied to improve the day-light effect of the original lighting. (NPS-SERO-CR, 2004)
