Cape Lookout National Seashore

Washington Roberts House

Historic Structure Report

Developmental History

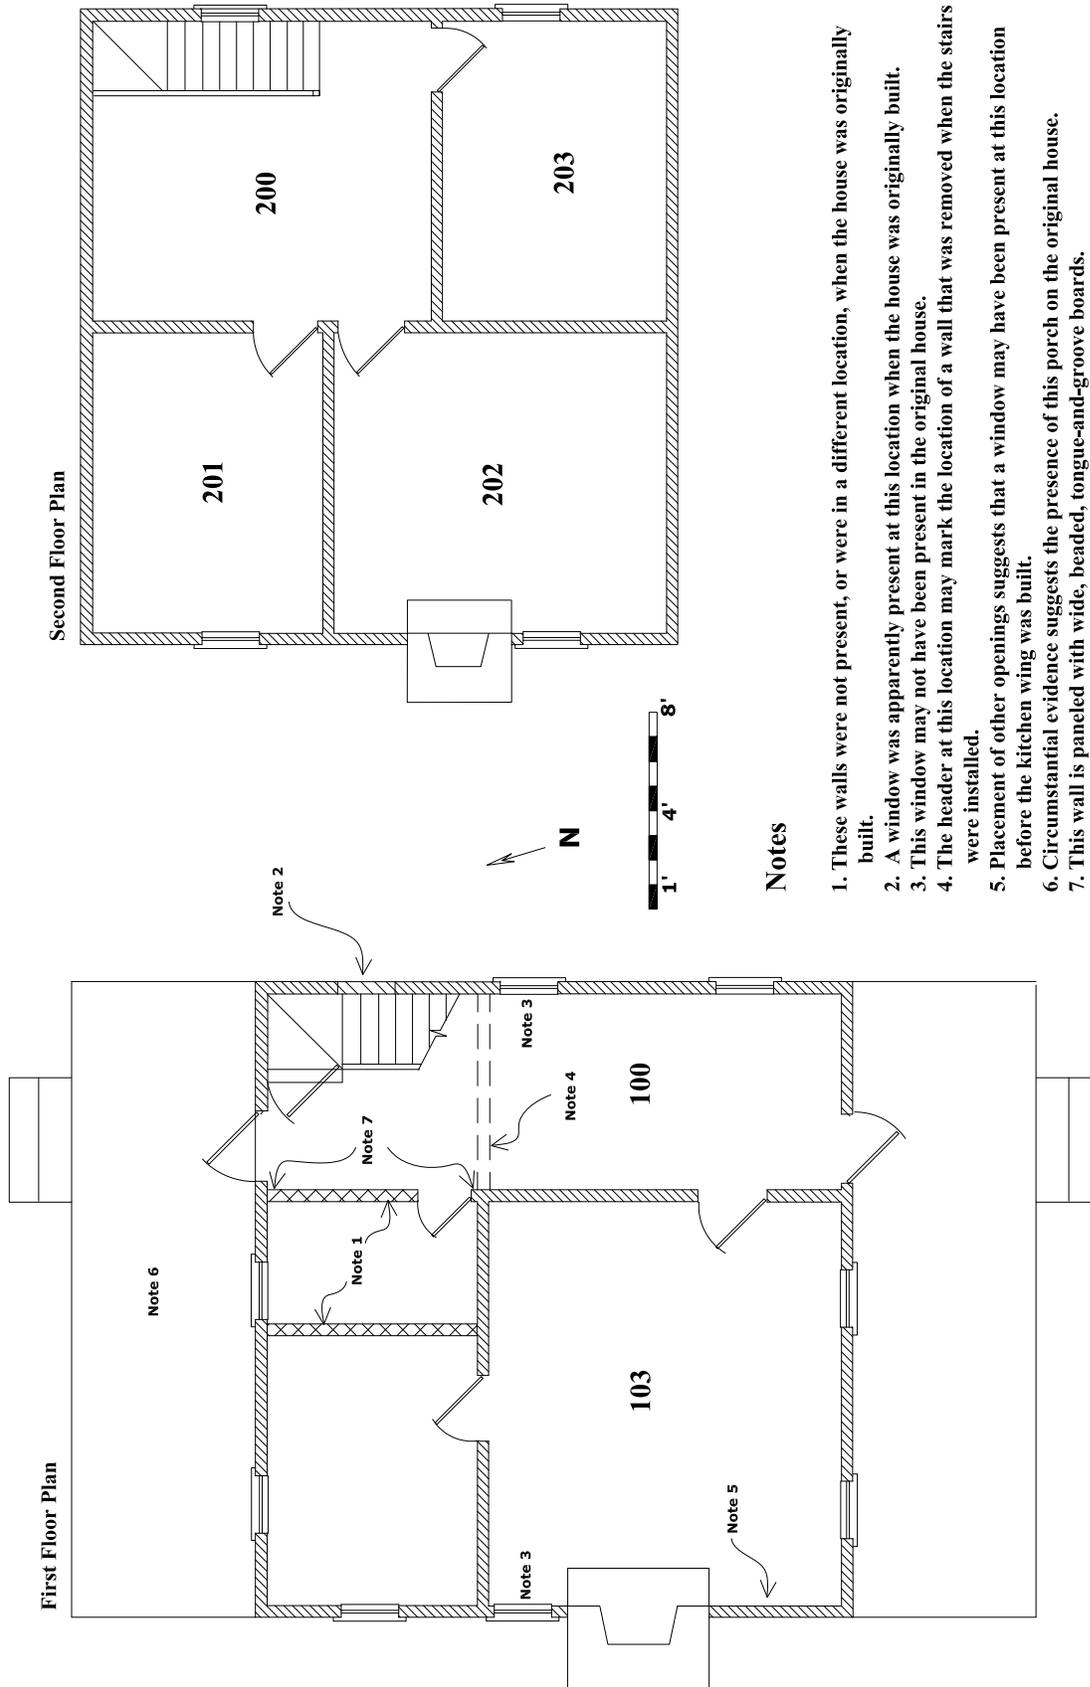
FIGURE 17. Plan explaining some of the changes to the original house. (T. Jones, SERO-CRD, 2003.)

Less clear is the original floor plan of the house (see Figure 16). The fact that baseboards run behind the east and west walls of Room 101 indicates that those walls were constructed (or reconstructed) after the house was originally constructed. The east wall of Room 103 may be in its original location, but that is

1. These walls were not present, or were in a different location, when the house was originally built.
2. A window was apparently present at this location when the house was originally built.
3. This window may not have been present in the original house.
4. The header at this location may mark the location of a wall that was removed when the stairs were installed.
5. Placement of other openings suggests that a window may have been present at this location before the kitchen wing was built.
6. Circumstantial evidence suggests the presence of this porch on the original house.
7. This wall is paneled with wide, beaded, tongue-and-groove boards.

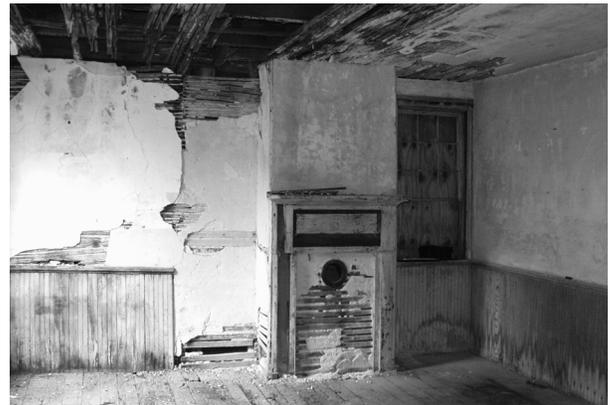
FIGURE 18. View of chimney in Room 103, absence of wainscot indicating extent of original chimney. (NPS-SERO-CR, 2003)

With construction of the kitchen wing, the original external chimney and open fireplace, which were at least partly stone construction, were taken down, the framed opening for the chimney breast in-filled, and a new internal brick chimney constructed. Built in the same location as the original chimney, the brick chimney was designed and constructed for wood- or coal-burning stoves and so was considerably smaller than the original chimney.

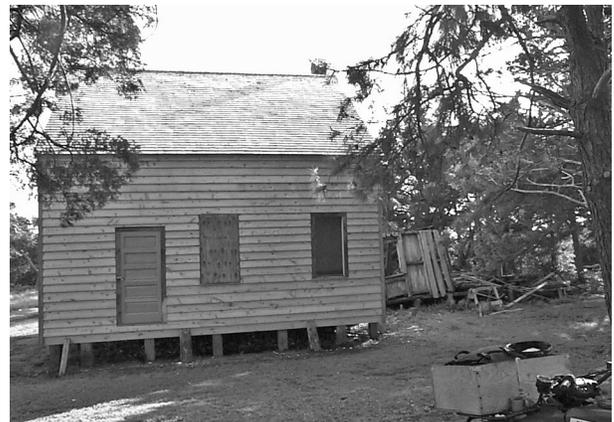
FIGURE 28. View of Roberts House after exterior rehabilitation and Hurricane Isabel. (NPS-SERO-CR, 2003)

In September 2003, as this report was being completed, Hurricane Isabel swept the Outer Banks with the eye coming ashore around Drum Inlet a few miles south of Portsmouth. Although only a Category 2 hurricane, the storm's surge inundated the entire island and a number of structures sustained significant damage. The nearby George Dixon House was severely damaged, but little, if any, damage was sustained by the main block of the Roberts House. Unfortunately, wind and water completed destruction of the house's ruined kitchen wing. It was partially reconstructed in 2006.

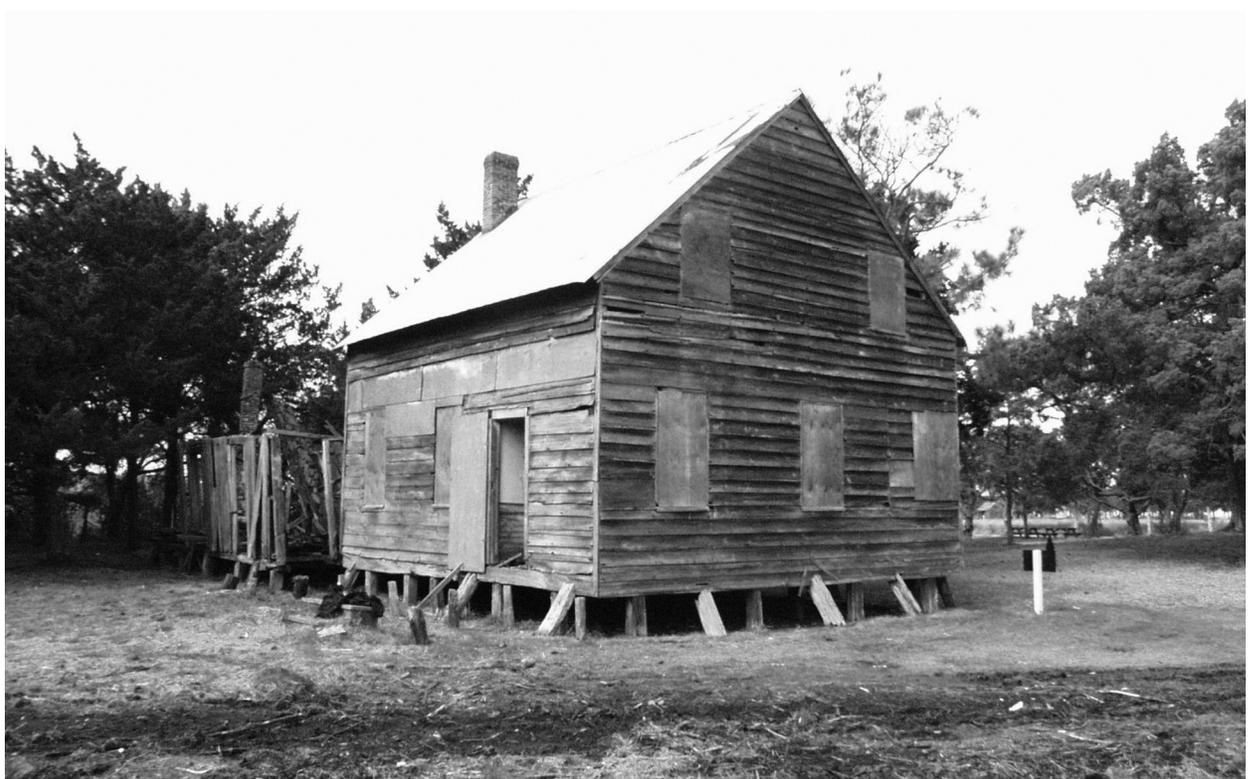
The house is badly deteriorated, with the kitchen wing in ruinous condition.⁴² The front porch was removed before the 1960s, all of the historic doors

FIGURE 30. View northwest of Roberts House. (NPS-SERO-CR, 2002)

but one have been stolen, much of the plaster has been badly water damaged, and the windows, many of which are missing sash, have been covered with plywood. In spite of the losses, most of the building's historic wooden siding, paneling, flooring, and trim remains in place.

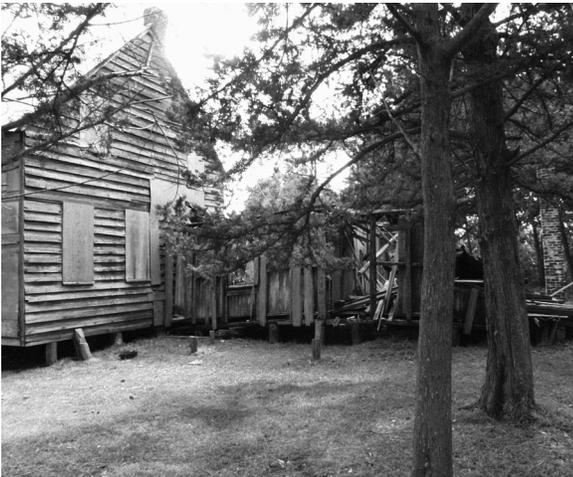
FIGURE 32. View west of west end of house and kitchen wing. (NPS-SERO-CR, 2002)

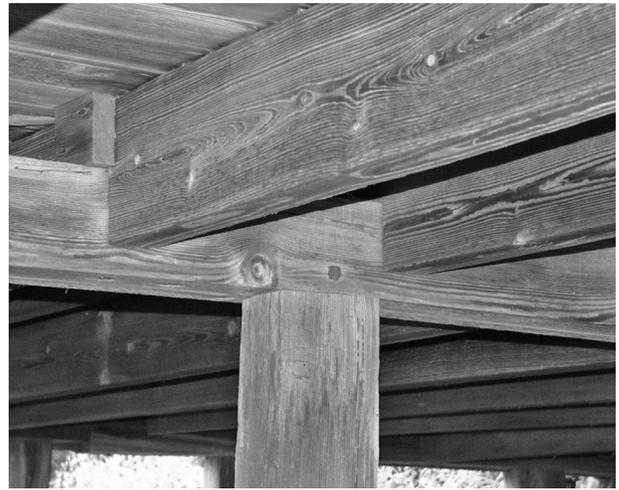
The added kitchen wing was built on creosoted pine piers, but these were toe-nailed, using wire nails, rather than mortised into the sills. Most of the piers appear to be original, but some are badly deteriorated, especially along the south side of the house.

FIGURE 34. View of typical joist and pier connections at center beam. (NPS-SERO-CR, 2002)

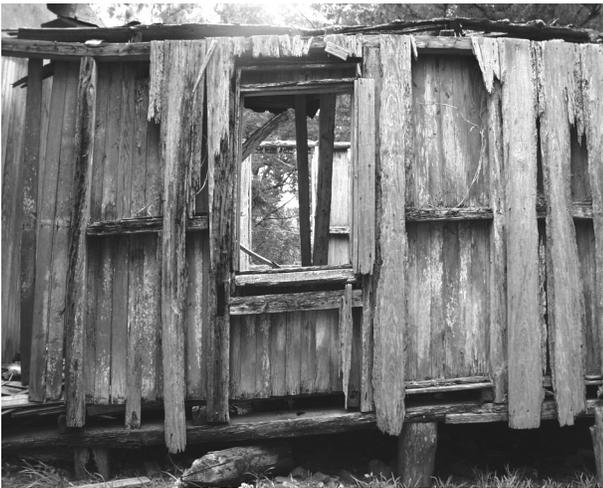
FIGURE 46. View of north side of kitchen wing at Room 104. (NPS-SERO-CR, 2002)

Total neglect of the roof covering has subjected the kitchen wing to water penetration and resulting rot, so that the entire roof structure, the west end wall, and part of the south wall have now collapsed. Except for window sash and doors, however, the character and dimension of all of the original materials and the original floor plan can be identified in the the existing ruins of the building.

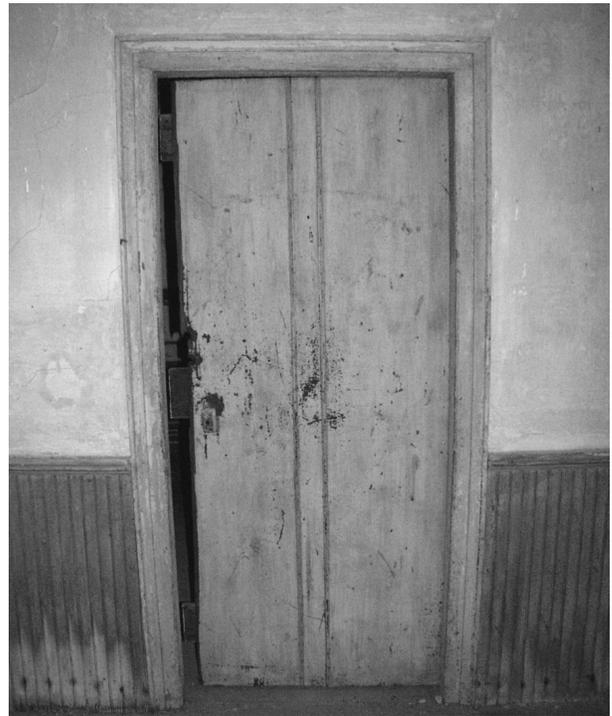
Neither of the interior doors in the kitchen addition could be identified, although evidence may survive under the collapsed roof. Except for the door between Rooms 102 and 103, all of the interior doors in the main block of the house are also missing, most of them torn from their frames. The surviving door is historic and is probably typical of the original interior doors. Measuring 6'-6" by 2'9", it is constructed with three beaded boards, two around 12" wide, and a center board about 5" wide, held together by three chamfered ledger boards. The door is hung on 4-1/2" butt hinges and originally was fitted with a large rim lock. Only the lock catch remains in place on the jamb, the lock having been ripped off by thieves, splintering the door in the process.

FIGURE 47. View of outside face of door D-9 to Room 102. (NPS-SERO-CR, 2002)

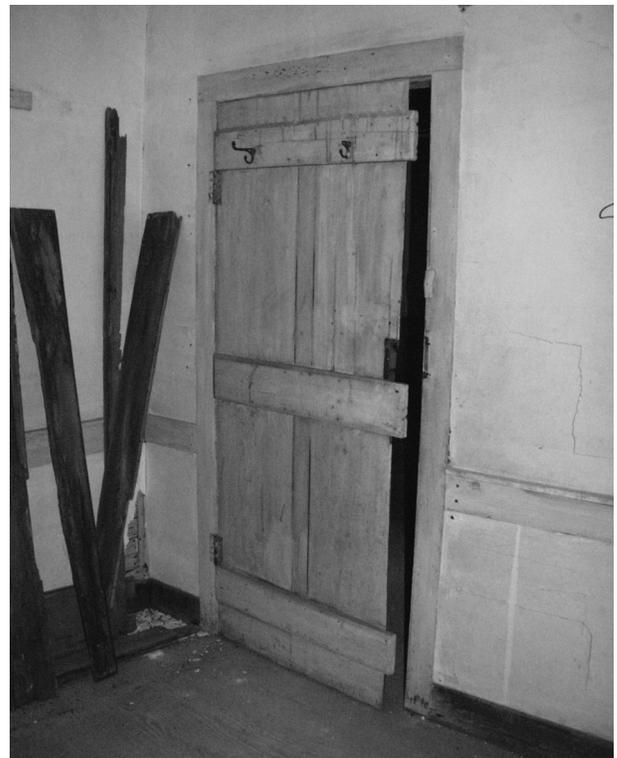
FIGURE 48. View of inside face of door between 102 and 103. (NPS-SERO-CR, 2002)

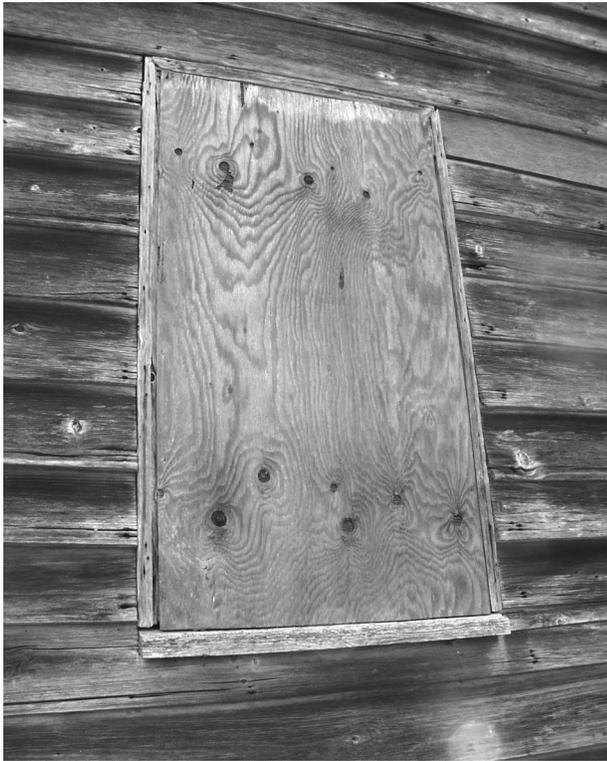
FIGURE 49. View of W-1 with original exterior sill and casing intact. (NPS-SERO-CR, 2002)

W-1: 2'-4" by 4'-6", six-over-nine sash, both sash missing; top of frame damaged; interior stop missing on right side and at header; interior casing and backband complete; one of two windows with exterior sill, casing and backband essentially intact, although badly eroded.

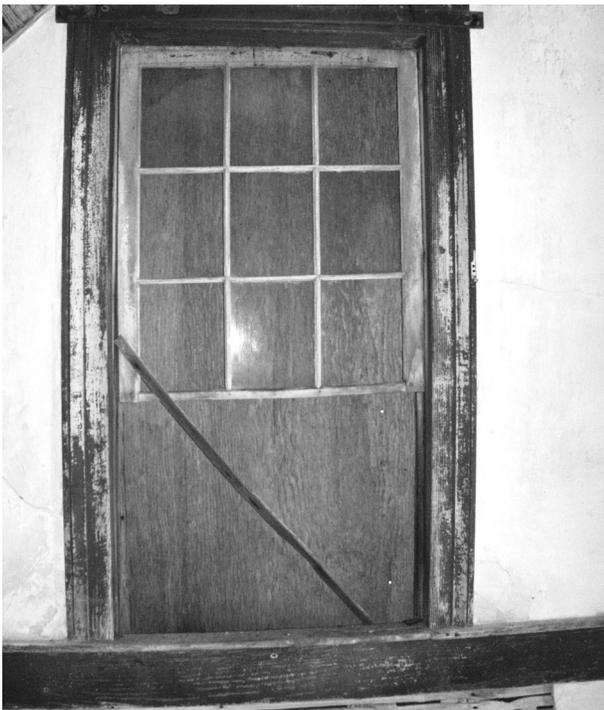
FIGURE 50. View of W-2 with sash and trim typical of first floor windows. (NPS-SERO-CR, 2002)

W-2: 2'-4" by 4'-6", six-over-nine sash, both sash missing; top of frame damaged; interior stop missing on right side and at header; interior casing and

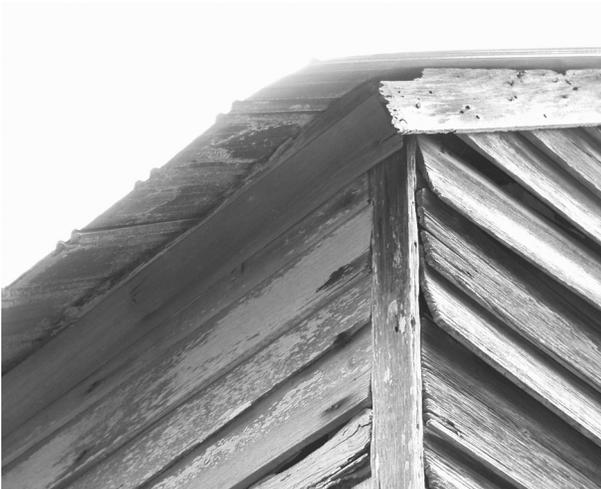
FIGURE 53. View of north corner of house, showing typical treatment of eaves and corners. Light areas appear to be paint but may actually be due to the presence of lichen or other natural discoloration. (NPS-SERO-CR, 2002)

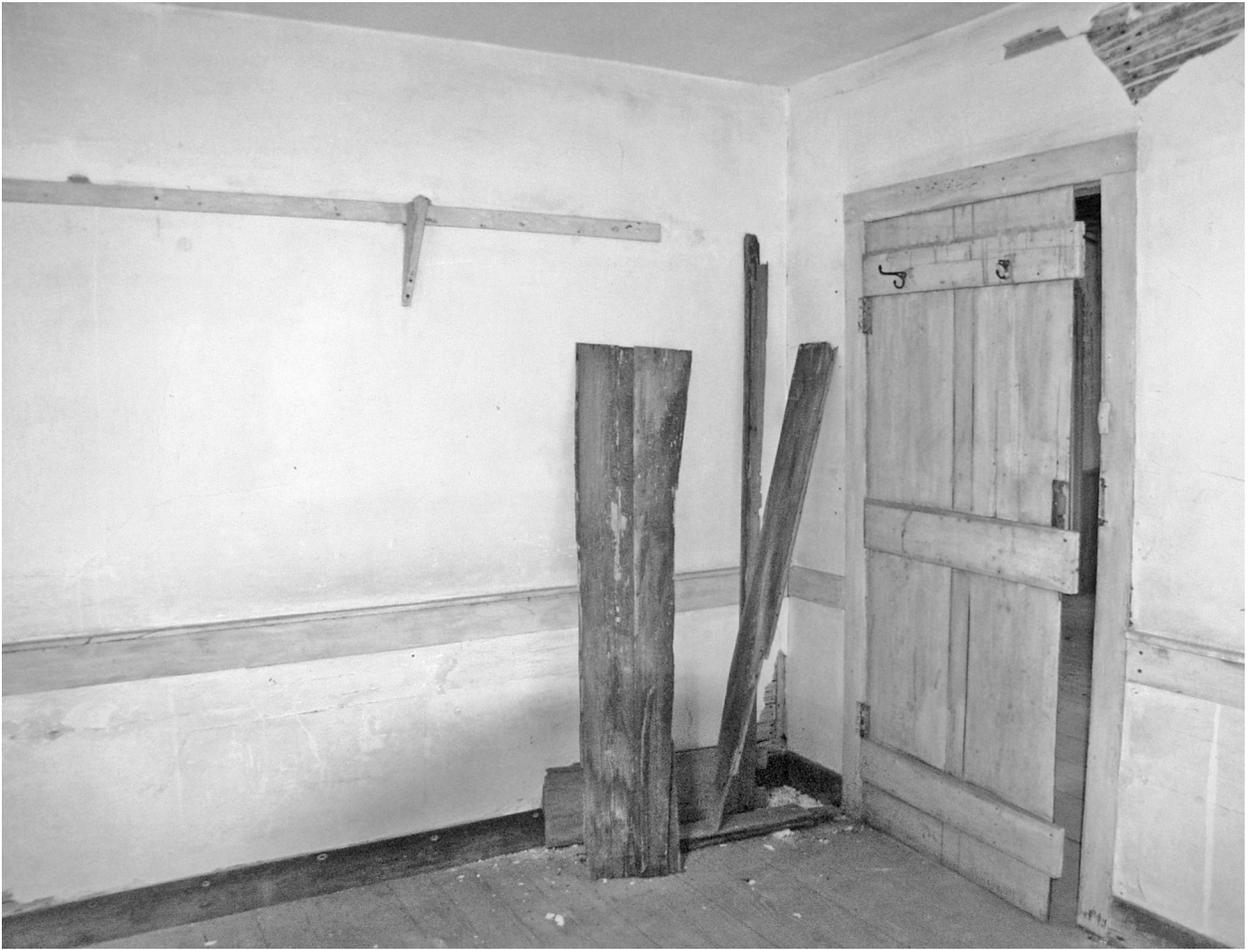
FIGURE 61. View south in Room 102, showing the only original door remaining in the house. (NPS-SERO-CR, 2002)

Used as a bedroom, this space, like Room 101, appears to have been created after the house's initial construction. The room measures 8'-6" by 10'-9". It has the only original interior door remaining in the house, although it has been damaged by vandals.

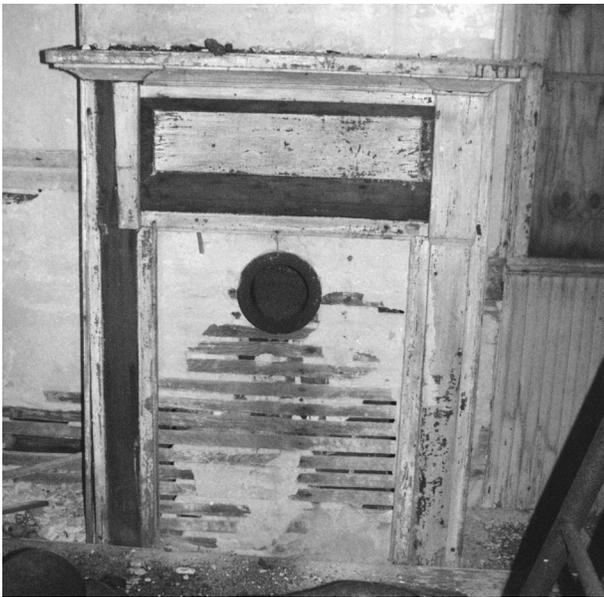
FIGURE 63. View of fireplace and mantel in Room 103, probably installed along with construction of the kitchen wing in the late nineteenth or early twentieth century. (NPS-SERO-CR, 2002)

Simple wooden pilasters support a mantle frieze and shelf above the flue. The top of the mantle shelf is at 57" above the floor. One of the pilasters has been removed along with the molding that finished the frieze panel. A wide, concave bed molding trims the

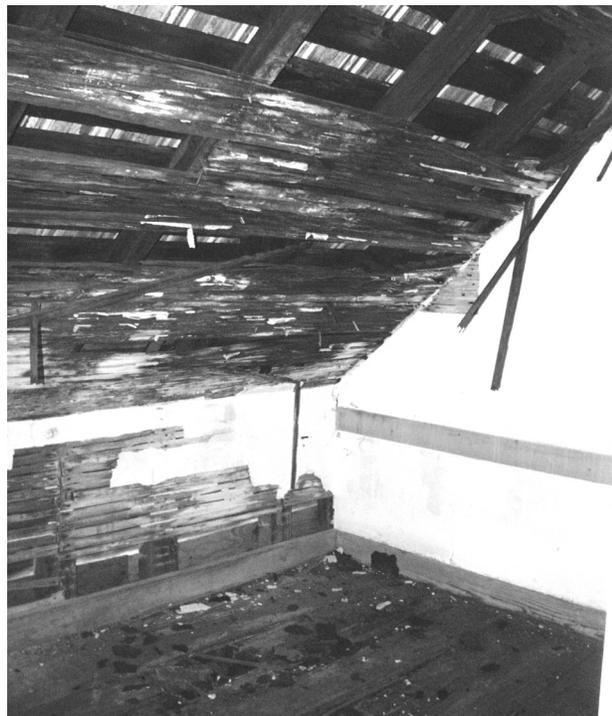
Floor. Flooring is a random mixture of tongue-and-grooved boards, 8" to 12-1/2" wide. The southwest quadrant of the floor has suffered major damage from water penetration through a failed roof covering.

Walls and Ceiling. Walls and ceiling were plastered over split lath, but most of the plaster has been lost from the ceiling and the south and east walls.

FIGURE 72. View southwest in Room 203. (NPS-SERO-CR, 2002)

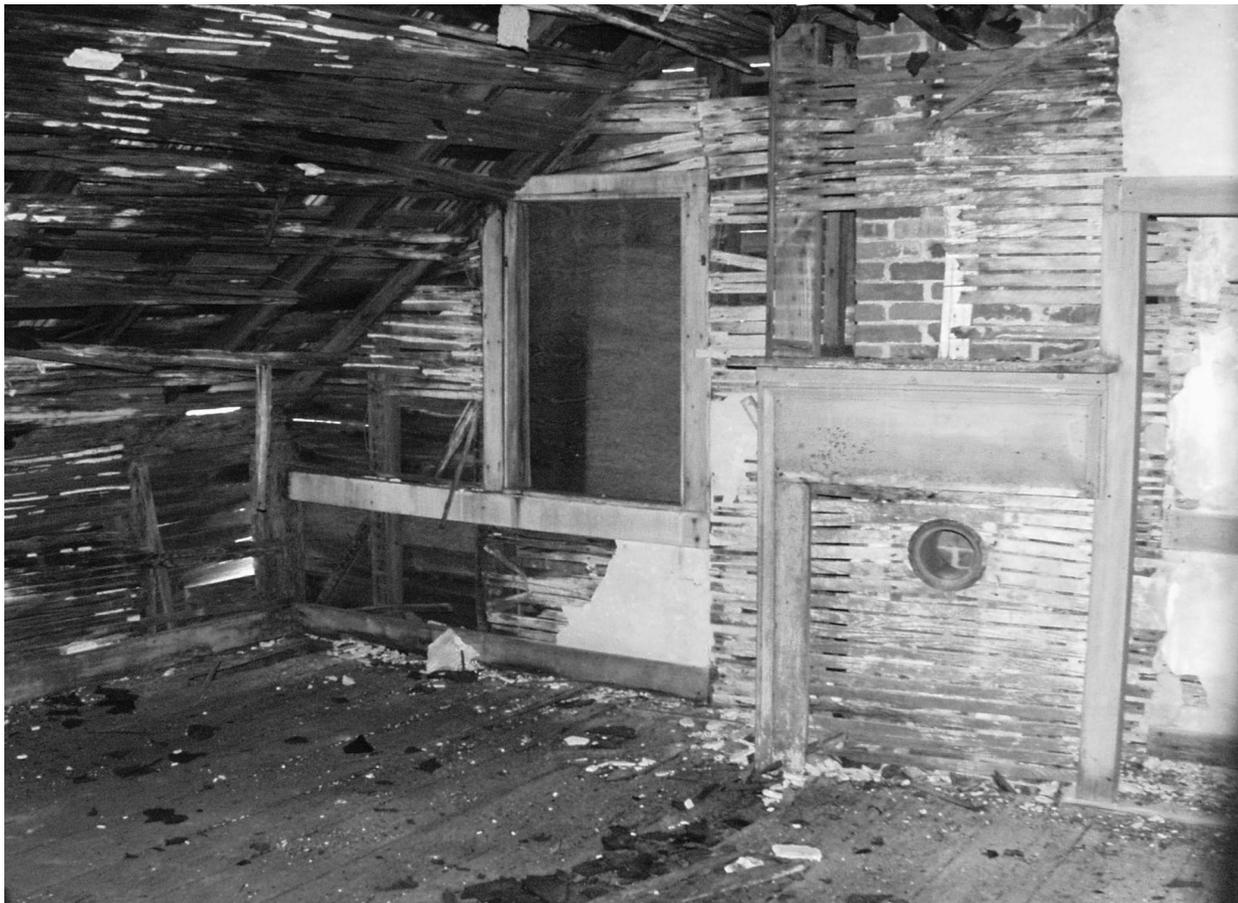
Water penetration has seriously damaged much of this room. Measuring 12'-3" by 13'-5", this is the largest of the three bedrooms and the only one that was heated. The fireplace and the closet were apparently added along with the new fireplace on the first floor.

damage from water penetration along the west side of the room.

FIGURE 71. View west in Room 202. (NPS-SERO-CR, 2002)

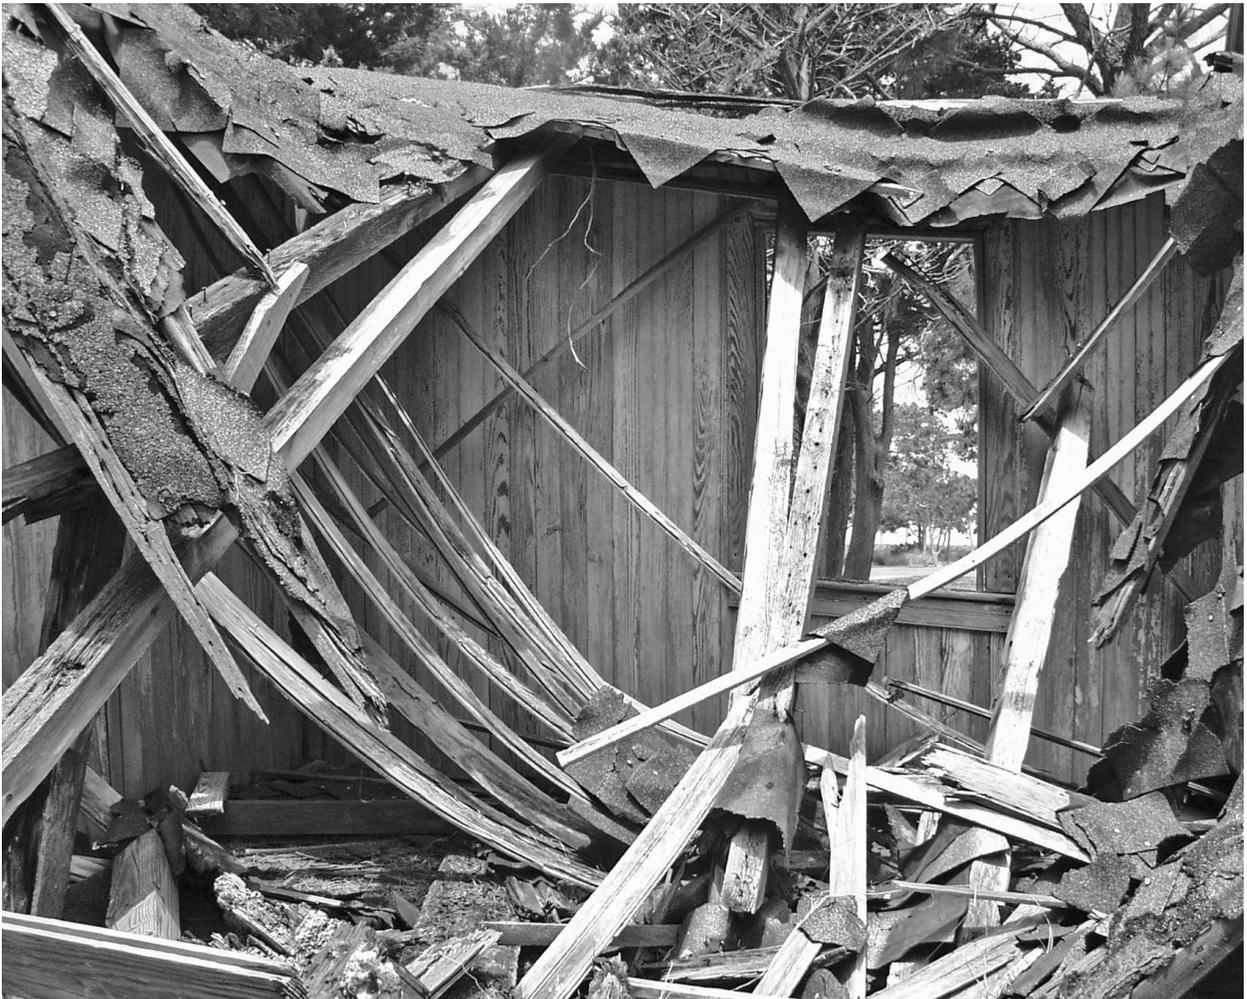
FIGURE 74. View north of Room 104. (NPS-SERO-CR, 2002) the main house, this room was clearly used as a dining room. (NPS-SERO-CR, 2002)

Thompson recorded the dimensions of this room as 13' by 14'. Although badly deteriorated, the original features and materials of the room can still be identified. Entered either from the hall (Room 105) or from a door that opened on to the front porch of

Floors. Flooring appears to be 3"-wide tongue-and-groove. Its condition could not be ascertained, but there is likely to be major deterioration of the material.

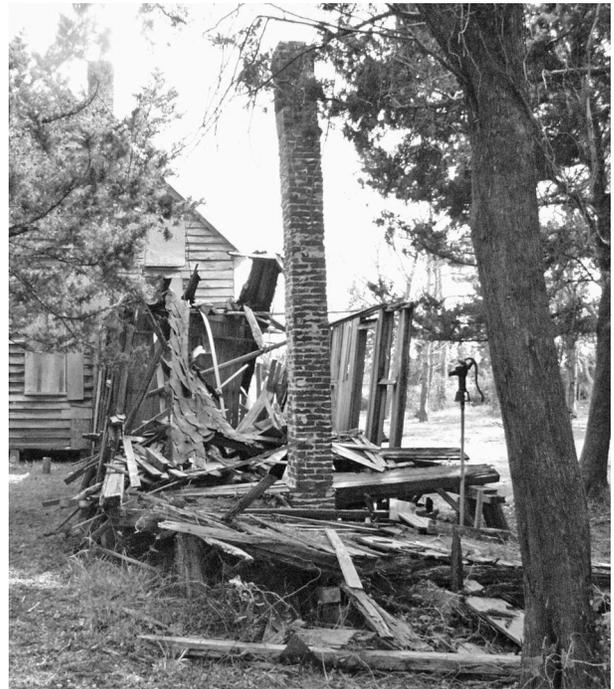
FIGURE 76. View southeast of kitchen wing. (NPS-SERO-CR, 2002)

The chimney at the west end of the kitchen wing is intact, but is tilted several degrees from the vertical. The slight tilt may be a feature of its original construction, since brick and mortar remain in reasonably good condition, in spite of the collapse of the walls of the room itself. Measuring about 14-1/2" by 14-1/2" in plan and rising approximately 16'-6" above ground, it was constructed of hard-fired, red brick and a white, Portland-cement mortar.
